**Elsecar Rail Station**

Outline Geotechnical  
Desk Study Report

February 2010

**Ove Arup & Partners Ltd**

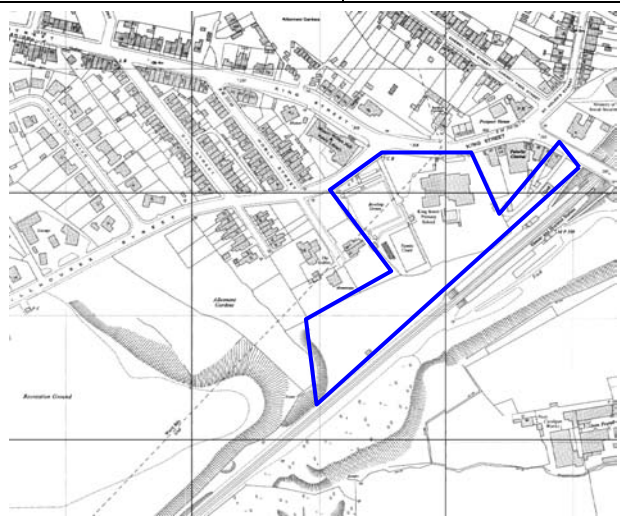
| | Extract Date | Original Scale |
|---|---|---|
| <p>There has been no significant change to the site.</p> <p>Off the site area, to the west, some significant earthworks appear to have been created to provide an area of flat land for recreational use. This platform has side slopes that extend parallel to the railway.</p> | 1968-76 | 1:1,250 |

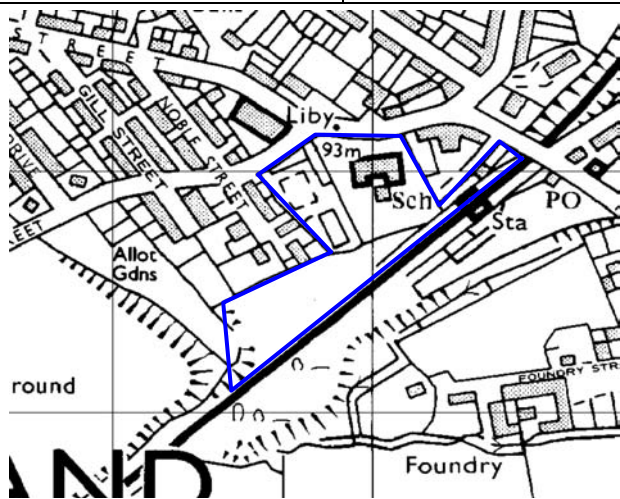
| | Extract Date | Original Scale |
|---|---|---|
| No significant change to the site. | 1989-1991 | 1:10,000 |

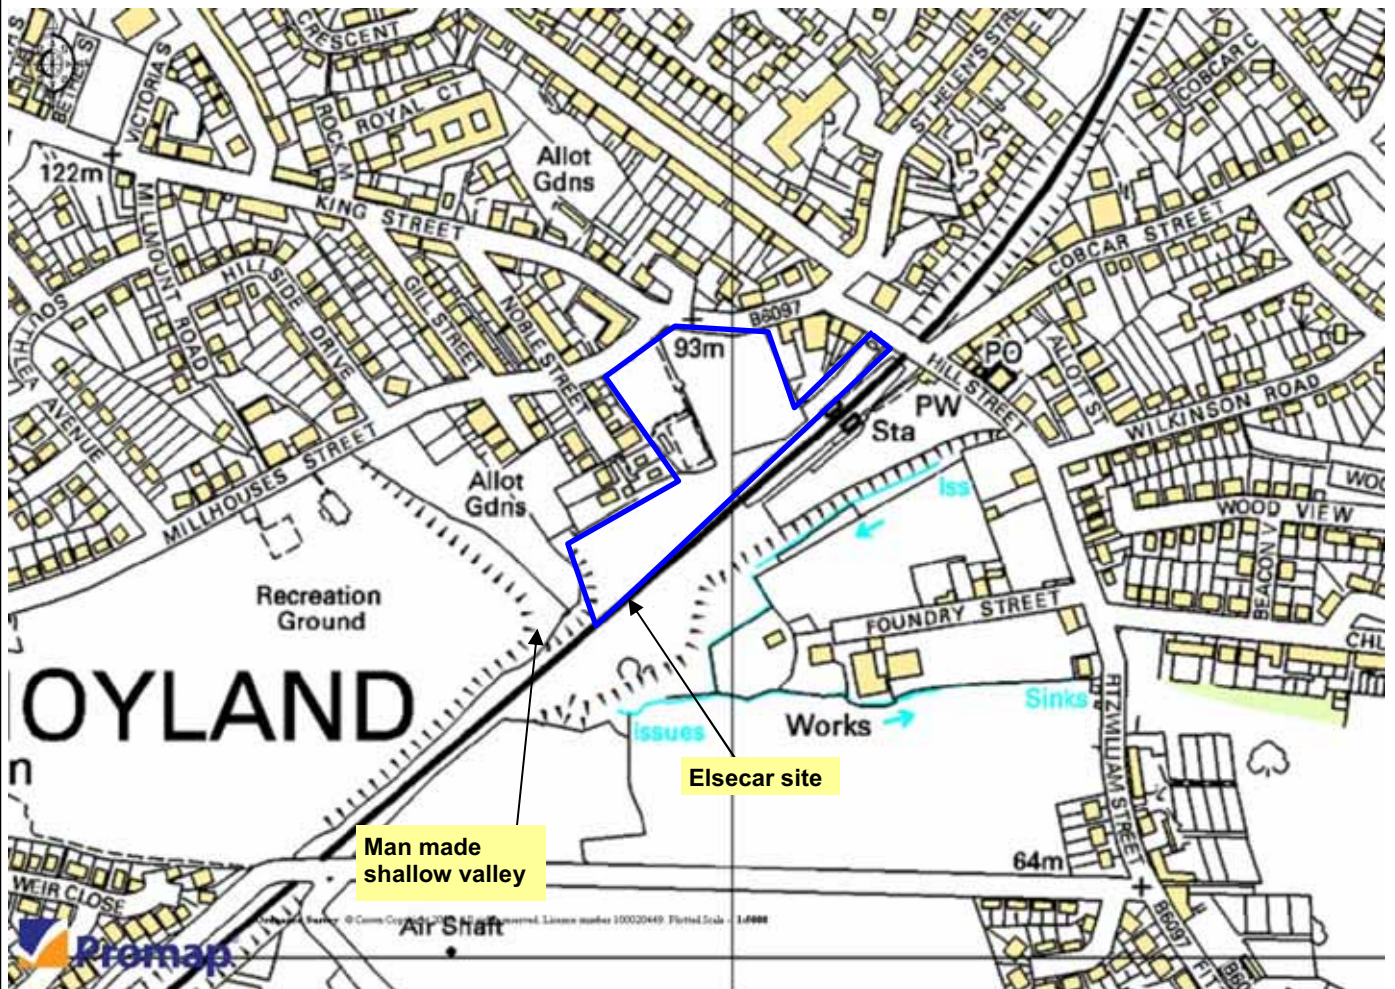
Figure 3

To the north of the free standing wall (marked on figure 3) the site has a gradual gradient sloping high to low from north to south. However, the ground has been landscaped to provide level platforms for the bowling green and tennis court, creating a two tier effect. To the south and south-west of the free standing wall the ground is relatively flat. The lowest point on the site is approximately 80mAOD, beside the railway, sloping up to the north to a height of 92mAOD. There is a small, steep valley on the western boundary sloping down to below 70mAOD, where a small watercourse is shown flowing into a culvert under the railway in a north-west to south-easterly direction.

Field studies to date include a walkover survey and a topographical study (undertaken by others and not reported here). A walkover survey was undertaken on 2<sup>nd</sup> February 2010 to establish any geotechnical issues that could be interpreted from a visual inspection of the site (see figure 3 for walkover notes and position of photographs)

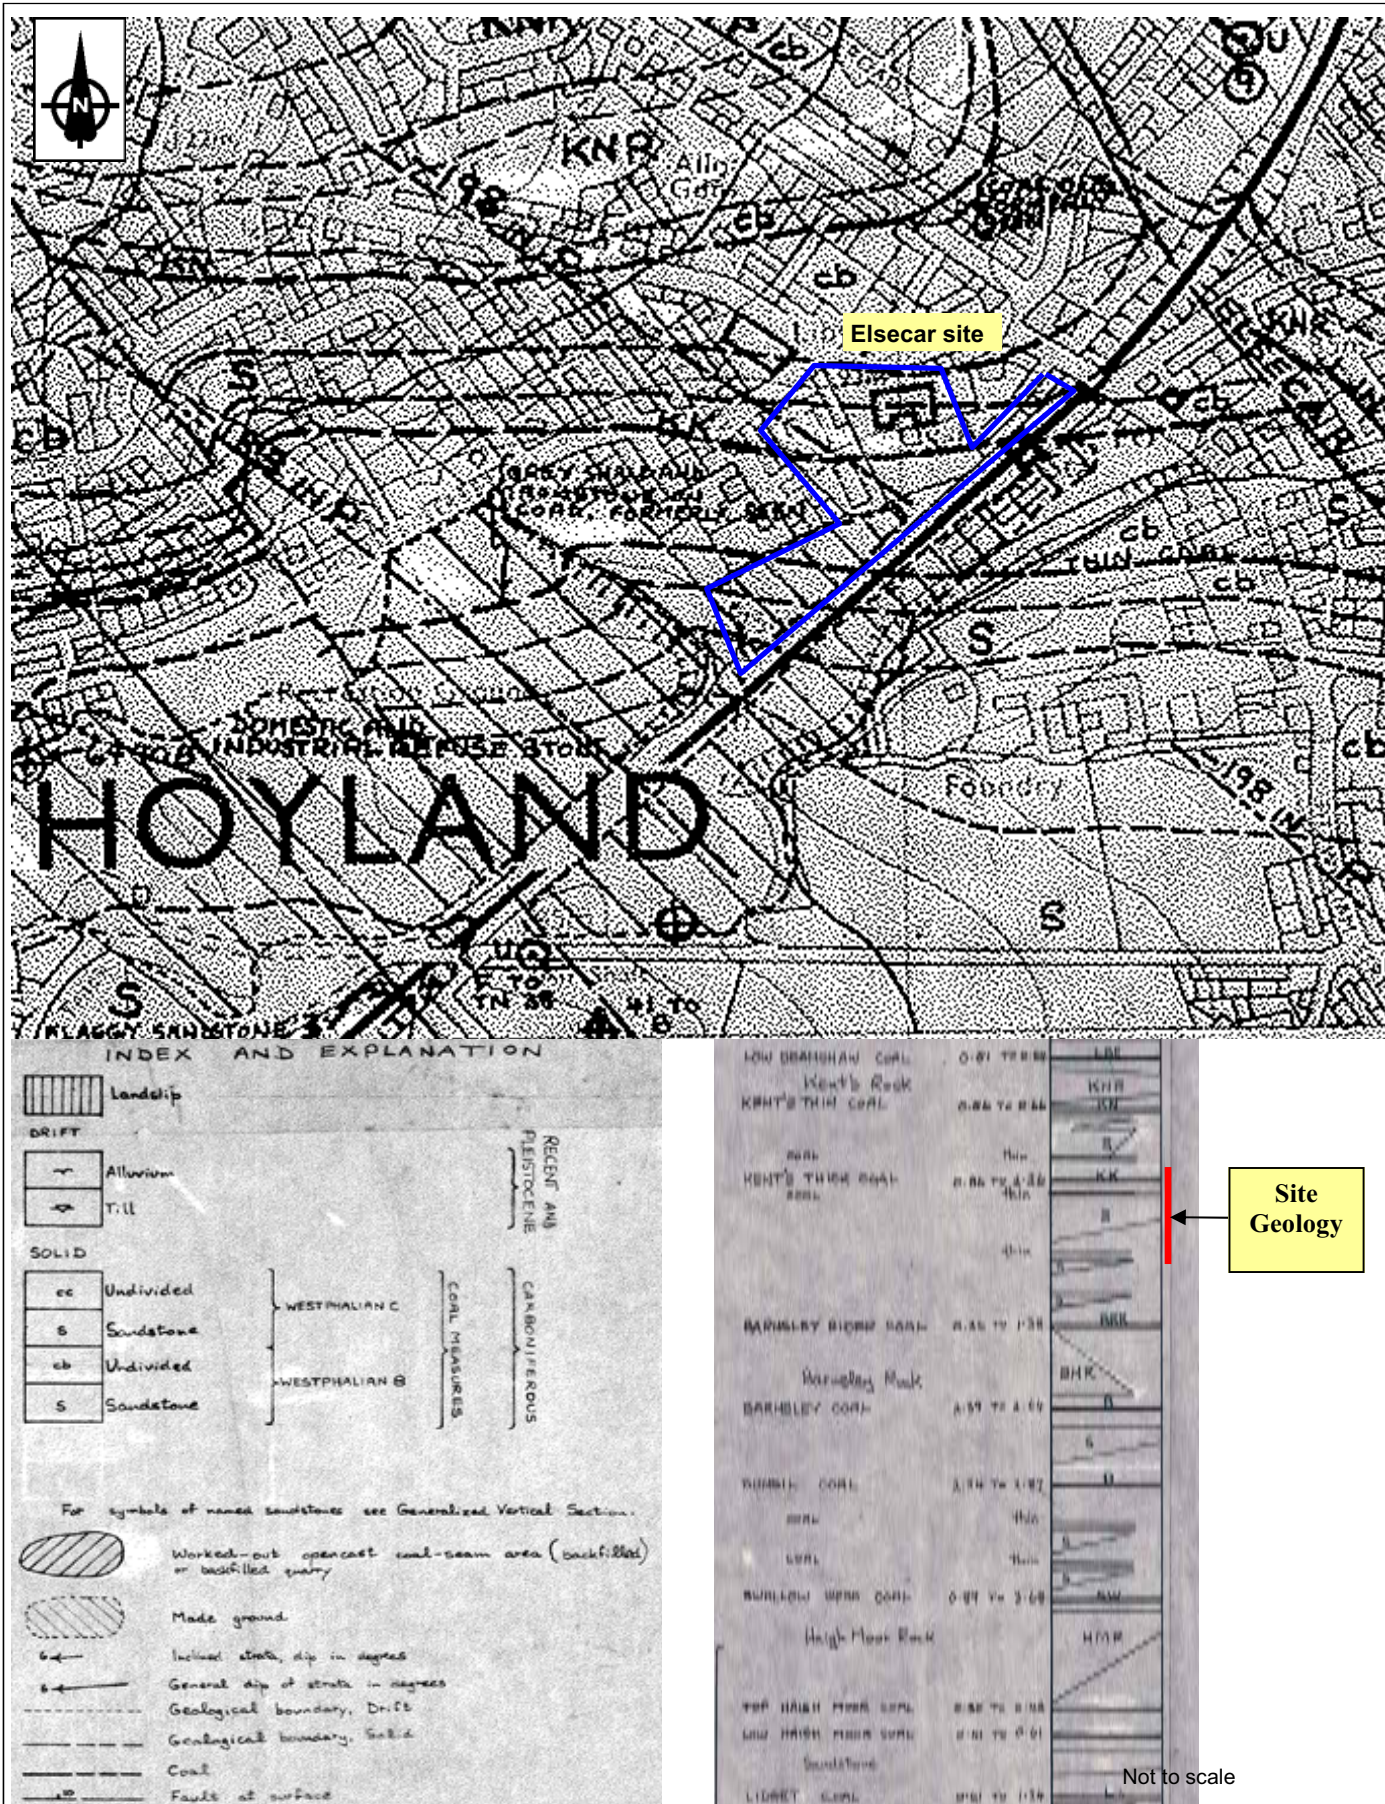
Figure 4

Reference has been made to the relevant, Wombwell – SE30SE 1:10,000, geological map (1980) and the BGS Digital 1:10,000 Geological map of Great Britain (2005). An extract from the Wombwell map, marked with the site, is shown in figure 4 and figure 5 shows the BGS artificial ground and landslip map extract.

The Iron Works, seen on the 1855 historical map, is likely to have been an excavated open pit. This is evident as a note on the Wombwell geological map states a shallow seam of ironstone (see figure 4) as being present above the Thin Coal outcropping along the south of the site.

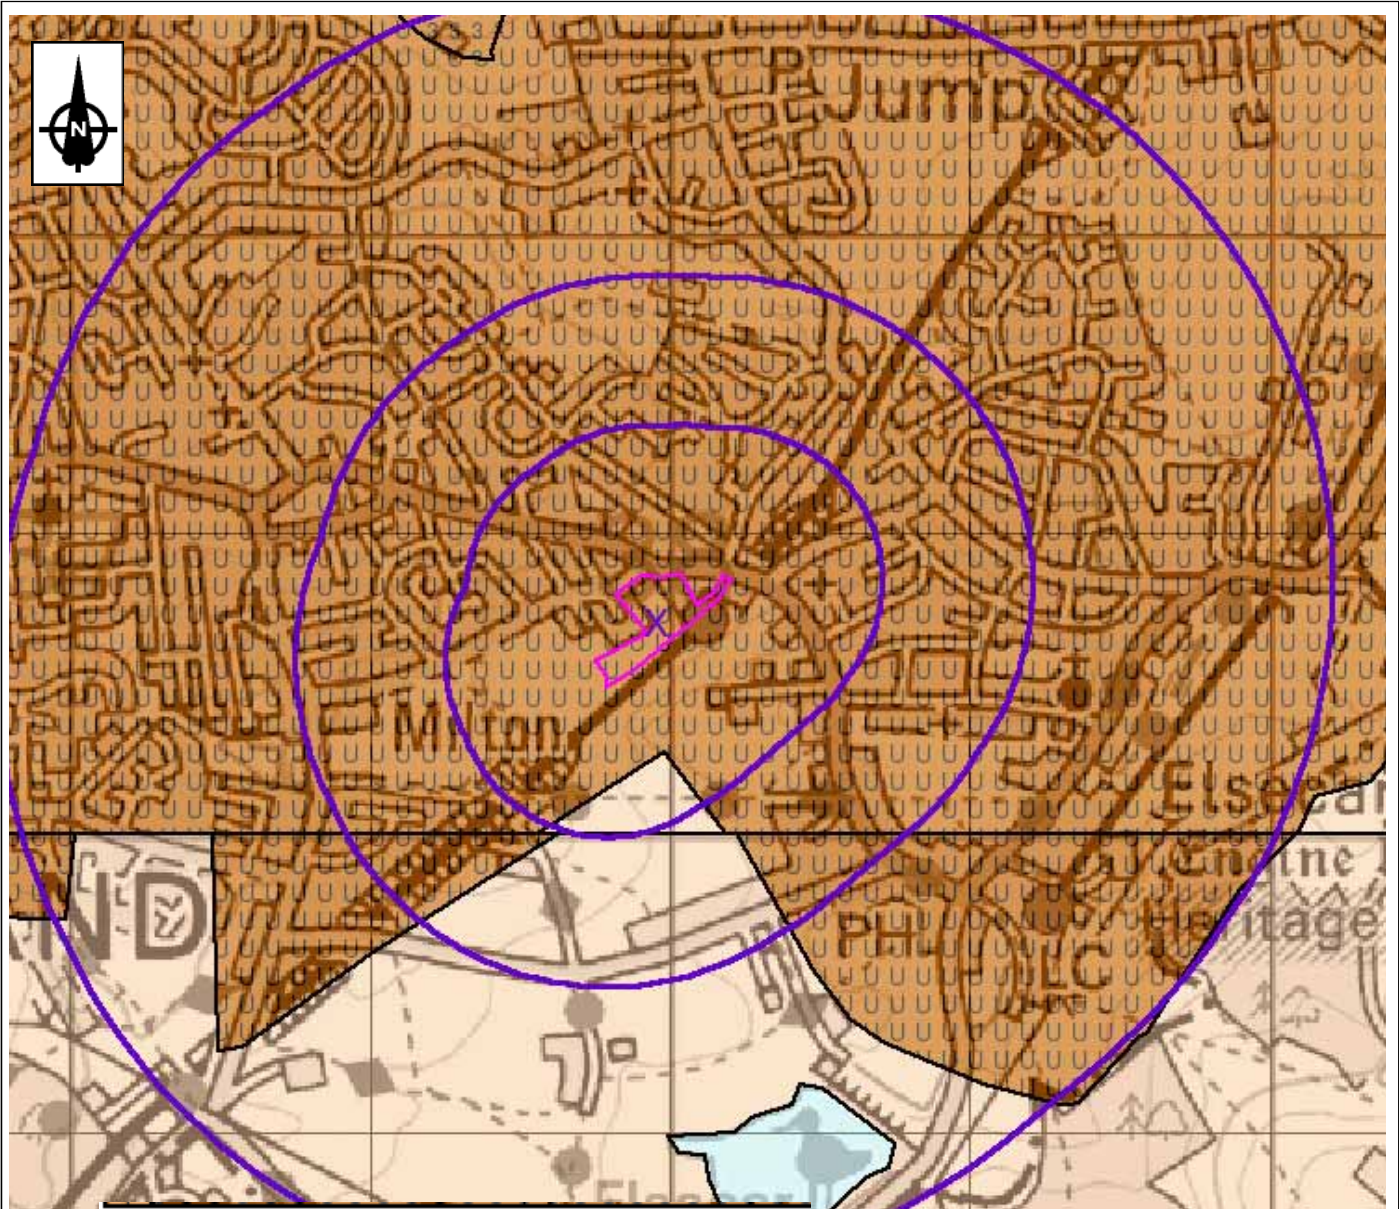
Figure 7

From the Envirocheck Report covering the site area, the Environment Agency's classification of the groundwater conditions is a 'minor aquifer' (see figure 7). The soils have been classified as soils of high leaching potential (U) as soil information in urban areas are based on fewer observations than elsewhere. A worst case vulnerability classification (H) is assumed.

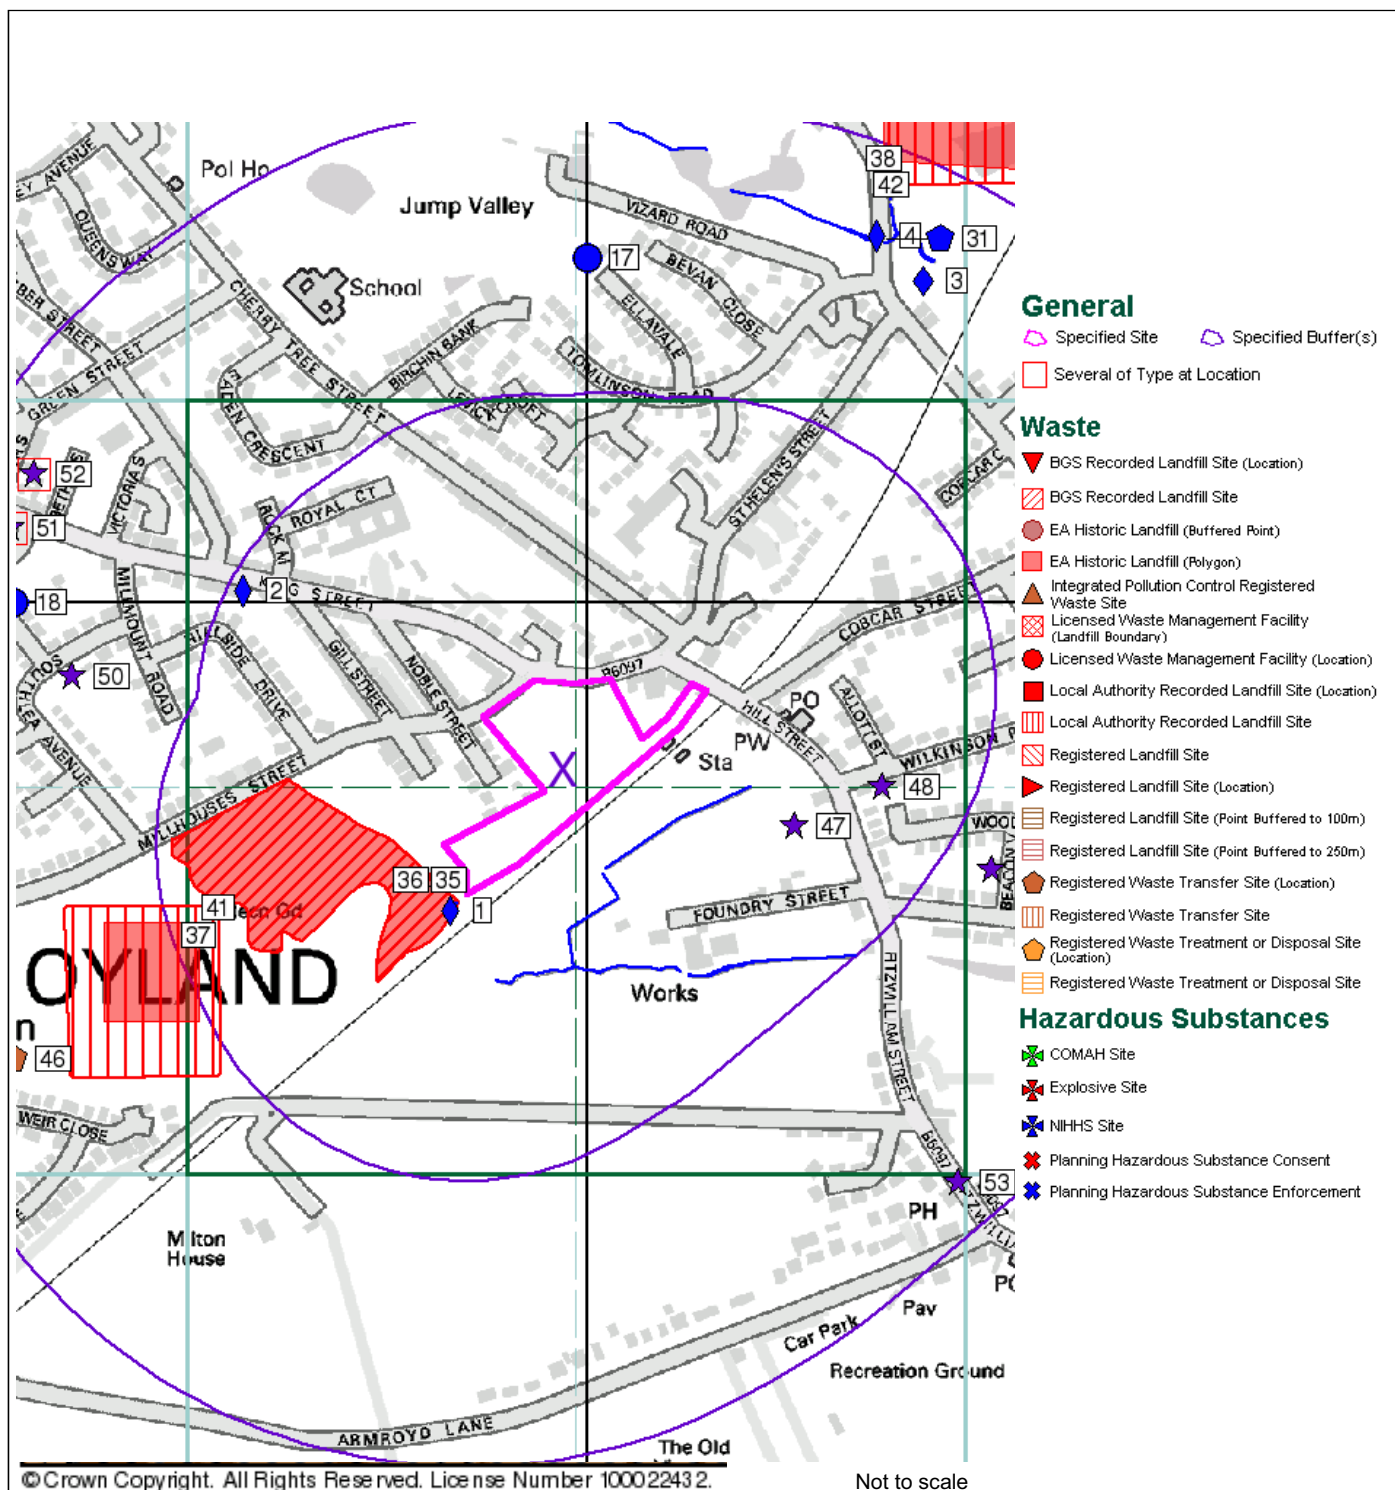
Figure 8

Although there are no landfills within the site extent, there are two large historic and recorded landfill sites underlying the recreational grounds to the west. The closest section of these landfills is less than 50m from the site boundary (see figure 8). The Wombwell geological map also states that the underlying the Recreational Grounds, from 3mbgl – 15mbgl, is Made Ground comprising domestic and industrial refuse.
