## **Report on an Inspection of an existing building at Hill Top Farm, Hood Green**

| <p>PETER THOMPSON</p> <p>HILL TOP FARM – BARN BUILDING SURVEY PHOTOGRAPHS</p> | |

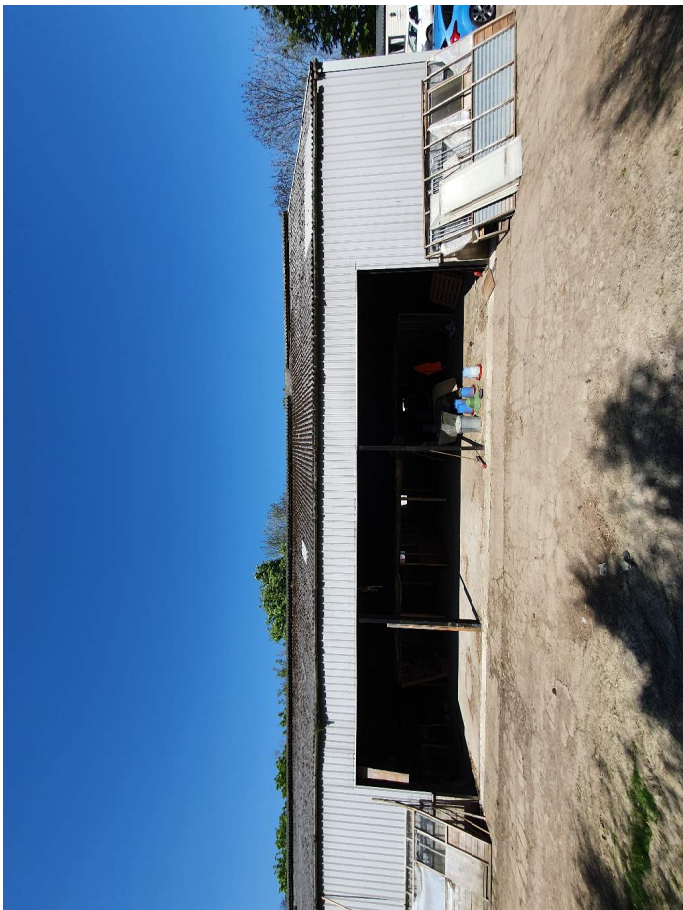
South elevation

- In the bottom three courses of blockwork in the first bay of the south elevation.
- In the top two courses of blockwork about a third of the way along the gable elevation, immediately below the soleplate of the timber framed panel above.
- In the top courses of blockwork in the north east corner of the building. Here, the mortar appeared to have deteriorated in some of the perpend joints leaving some substantial gaps in the masonry.

In all instances, the cracking is not considered to be significant and has likely been caused by thermal shrinkage of the blockwork.

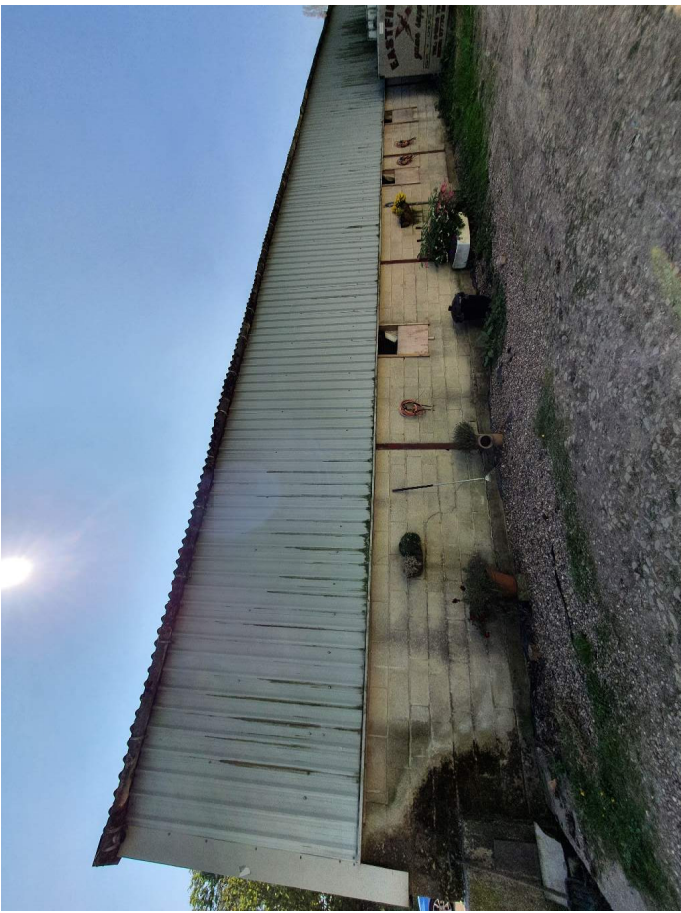
North elevation

There was a vertical crack in the external masonry in the gable elevation extending up the wall from external ground level up to the bottom of the cladding. There was some further cracking to the external masonry in the northern elevation. Here, staggered diagonal cracks were observed extending from ground level through the full height of the blockwork. In all instances, the cracking was not considered significant, and is likely due to thermal shrinkage.
