# STRUCTURAL REPORT

Bank House Farm, A628  
Silkstone, Barnsley  
S75 4FZ

NE5559

**STRUCTURAL REPORT ON** Bank House Farm, A628, Silkstone, Barnsley, S75 4FZ

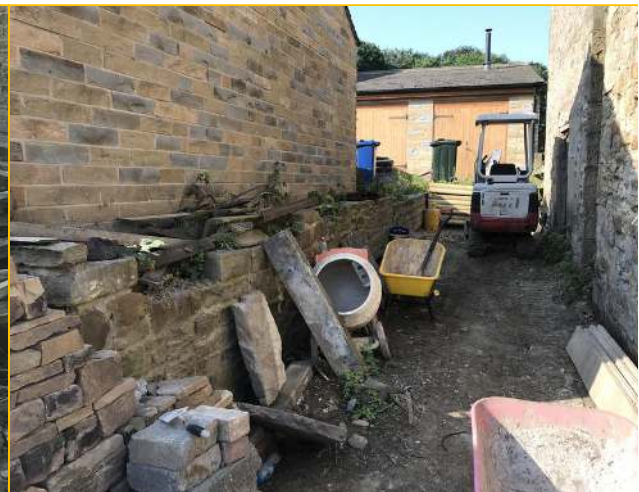
Photograph - 4 - Rear boundary walls

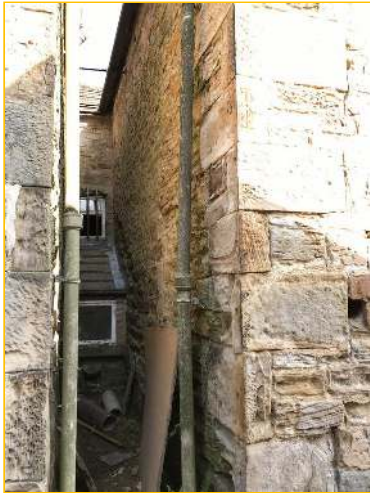
Photograph - 13 - Left extension right wall

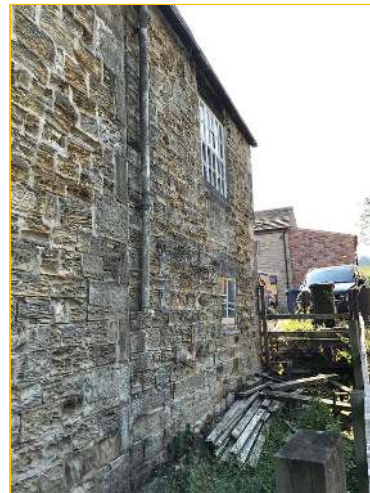
Observations along the right hand eaves line of the right hand extension identified a degree of lateral movement, typically associated with roof spread. An internal inspection of this roof structure identified that timber ties have been installed to resist this lateral movement.

Photograph - 16 - Right extension right wall

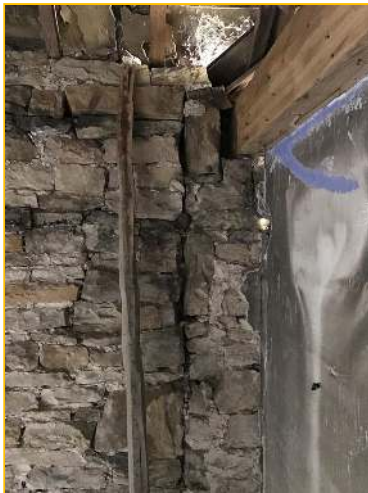
Photograph - 61 - Right hand extension
