Application for Variation of Conditions

Site Address: Cannon Hall Museum, Bark House Lane, Cawthorne,
Barnsley, S75 4AT

Additional roofing & drainage works to Cannon Hall.

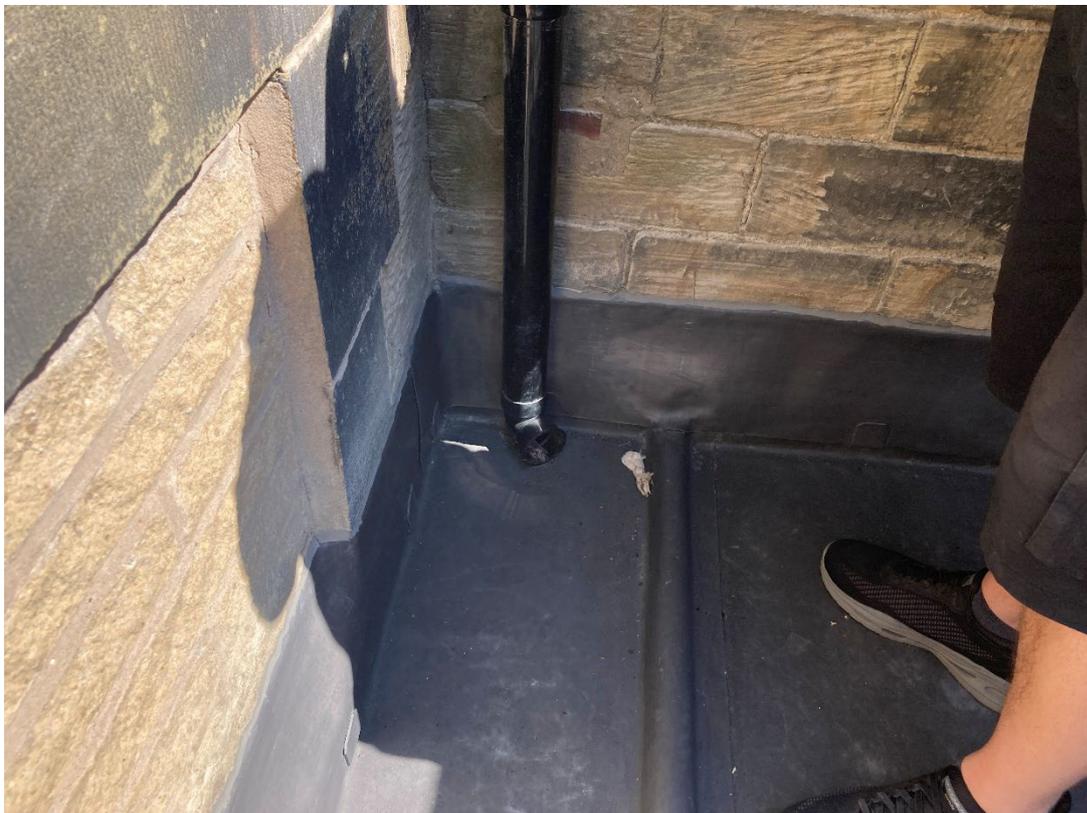
The existing rainwater goods are not of historic interest. They are likely a 20th century replacement due to their UPVC and felt lined construction. The existing rainwater drainage route runs water onto the lower section of flat roof before it is then discharged into a perimeter gutter, providing a potential source for blockage if debris built up between the newly installed lead bays.

Figure 03: Marked photograph showing element 01's proposals.

The existing black UPVC drainage pipes and felt lined timber troughs are removed. A new lead lined trough is installed, extended to the South side of the hall. A new black cast aluminium downpipe and hopper are installed and run down the side of the hall to ground level. A new drainage channel will be installed beneath the path to the south of the hall. New rainwater goods to be Marley Alutec range.
