**Hallroyd Homes Limited**

**Barnsley Road  
Silkstone**

**Highway Condition Report**

| Report Ref: | 10985/PT/001/01 | May 2019 | | |

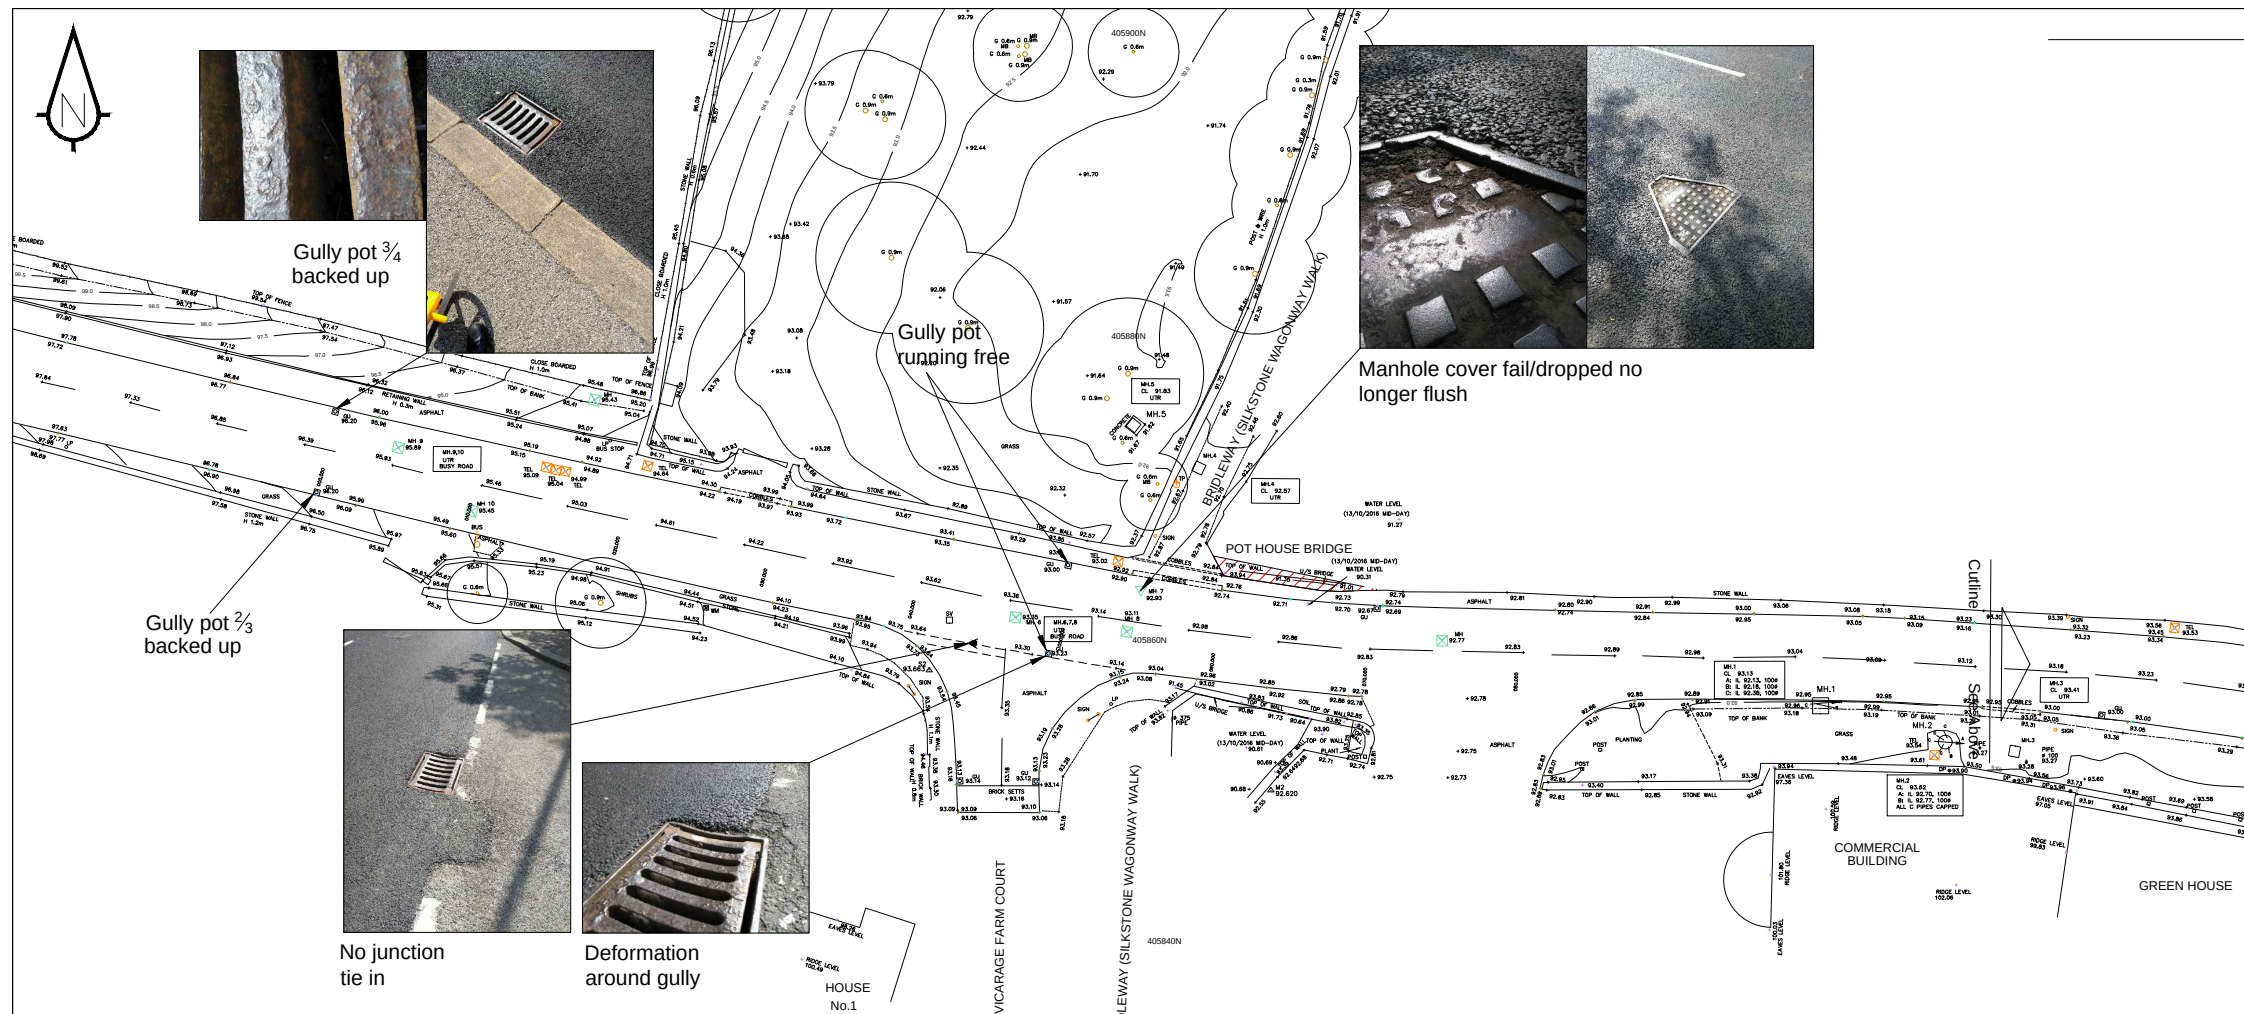
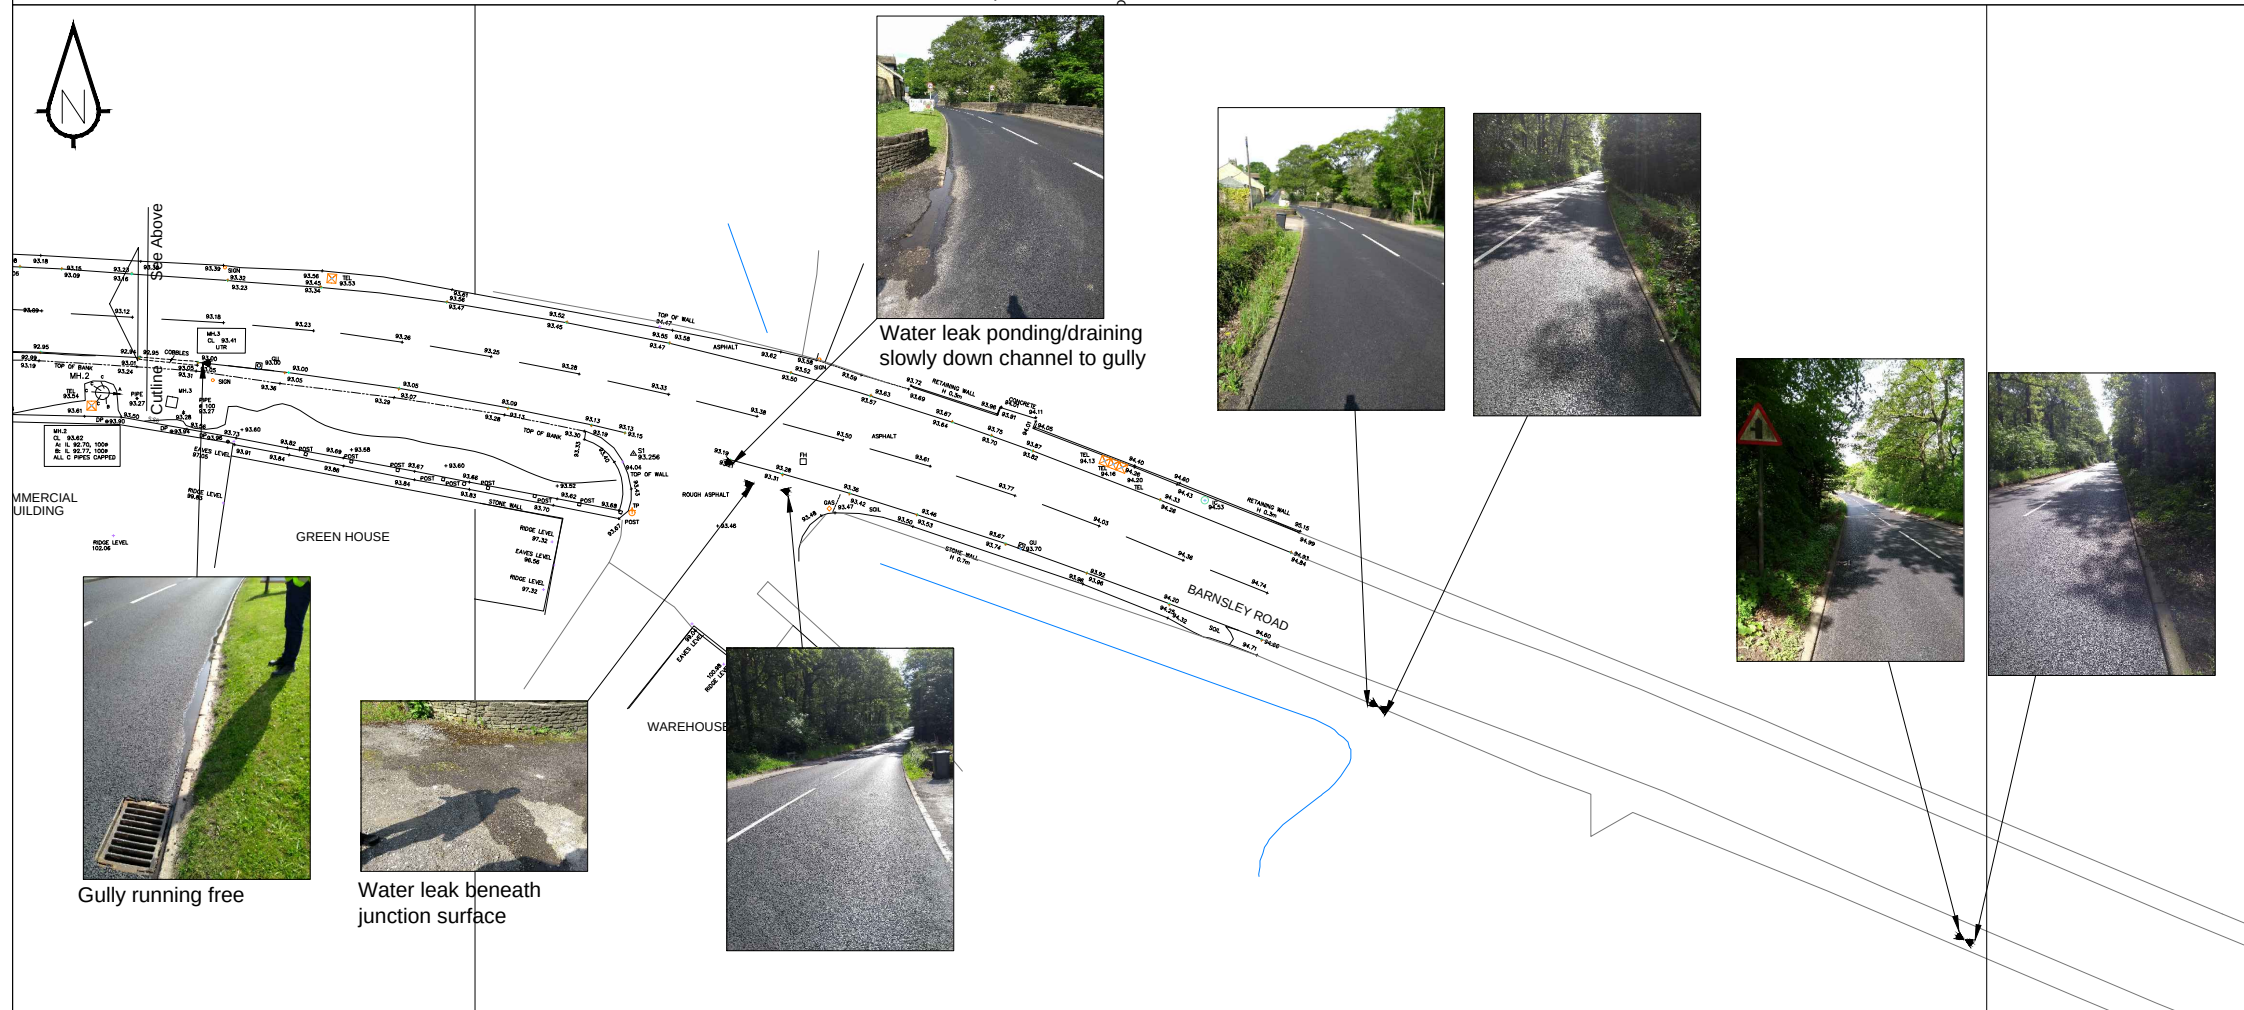
***Drawing Ref: 10985-001 – Highway Condition Survey***

- 3.1 The existing condition of Barnsley Road is very good. There are signs of some minor deterioration around the gully located at the entrance to Vicarage Farm Court and on a manhole cover adjacent to Pot House Bridge.
- 3.2 Other observations were of 2 gully's which were silted to varying degrees and a minor water leak running in the eastbound channel from a local access to a warehouse.
