**LOWER WHITELEY FARM, CROW EDGE.  
BAT SURVEY.**

**OS Grid Ref:- SE 191 044.**

**Ref No:- 140838**

**Date: 25<sup>th</sup> August 2014.**

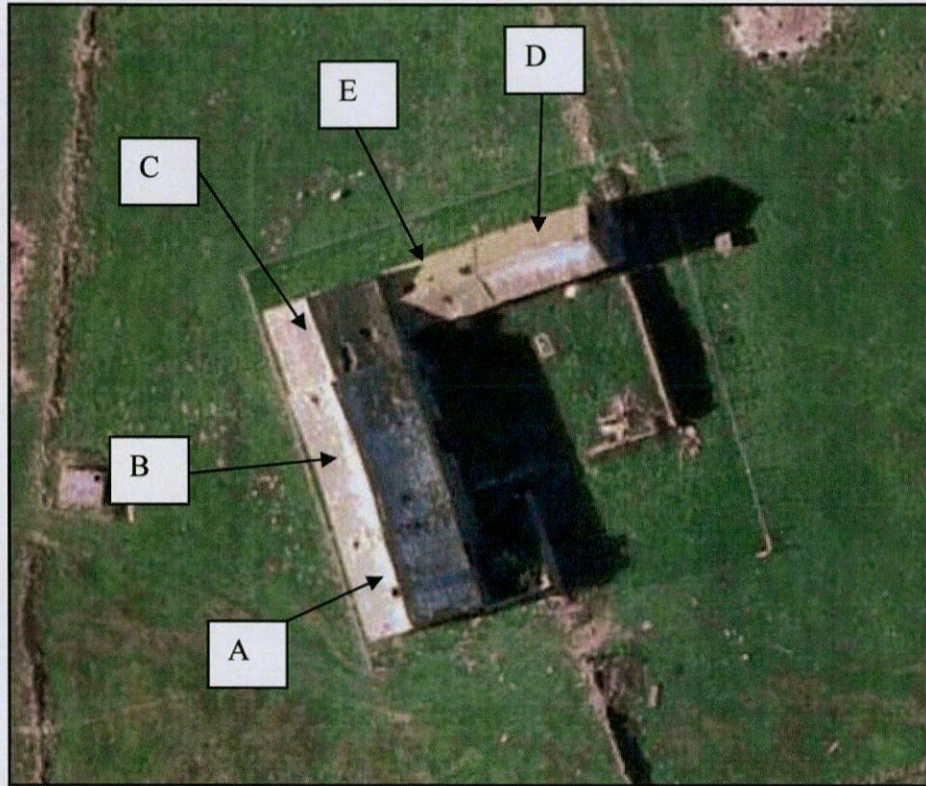
3.2.2. The site comprises a group of five buildings as shown below. Each building has been labeled in the aerial photograph below and is dealt with separately below.

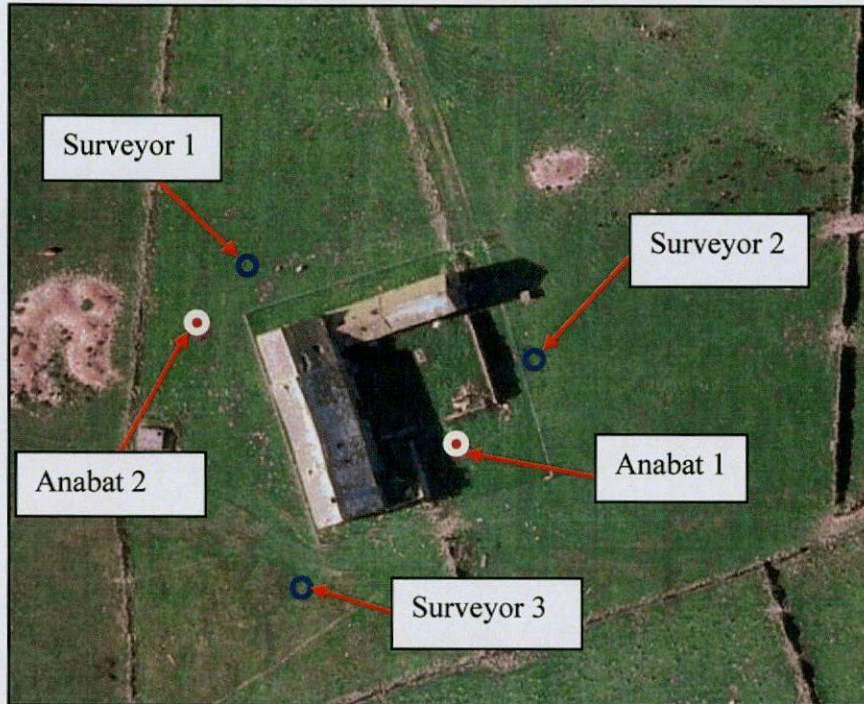
3.4.2. The three surveyors were positioned at three corners of the building to provide all round visibility, as shown in the diagram below. Each was equipped with a Batbox Duet detector and two static Anabat recorders were also used.

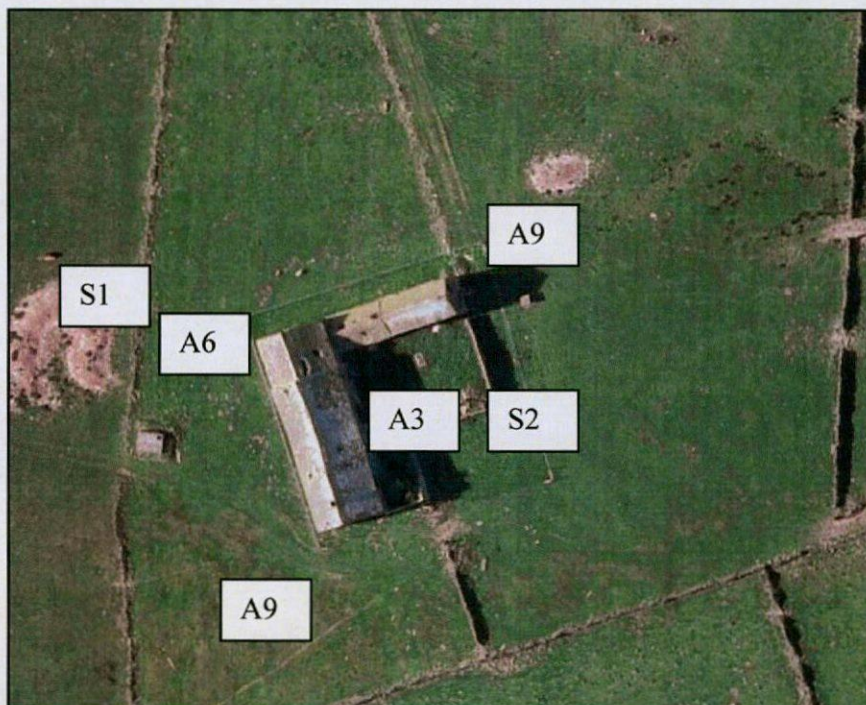
3.5.2. The two surveyors were positioned to provide all round visibility of the buildings present on the site, as shown in the diagram below. Each was equipped with a Batbox Duet detector and a two way radio. In addition, four static Anabat recorders were deployed around the site to record all bat activity for subsequent computer analysis using Analook software. S is a surveyor and A is an Anabat.
