A Refurbishment and Demolition Asbestos Survey  
The Butchers  
Sheffield Road  
Penistone  
S36 6HH

Survey Date: 7<sup>th</sup> March 2014

- A survey Refurbishment and Demolition –Sampling and identification survey was carried out on the site, the purpose being to identify any asbestos containing materials (ACMs) and to keep a copy of the findings for future references.

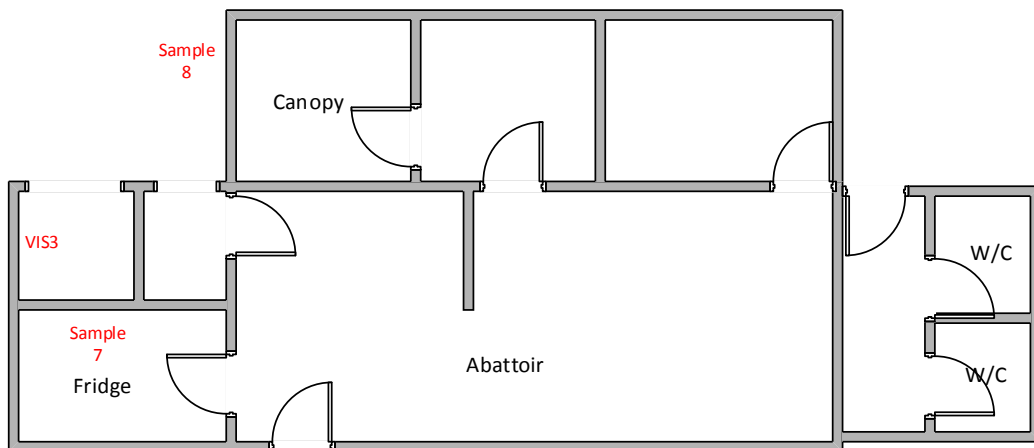
Sample  
9

<b>Sample Location:</b>	Abattoir side corrugated sheets
<b>Sample Reference:</b>	VIS8
<b>Result:</b>	Chrysotile
<b>Recommendations:</b>	Programme for planned removal

<b>Sample Location:</b>	Back yard woven debris
<b>Sample Reference:</b>	Sample 8
<b>Result:</b>	<b>Chrysotile</b>
<b>Recommendations:</b>	Programme for planned removal
