P&M STRUCTURAL
Design

Structural Inspection

Client:	Philip Pearce
Address:	1 Church Hill, Royston, Barnsley, S71 4NG
Prepared By:	Peter Stokoe BEng (Hons) CEng MStructE
Date of Inspection:	13 December 2023
Revision:	01

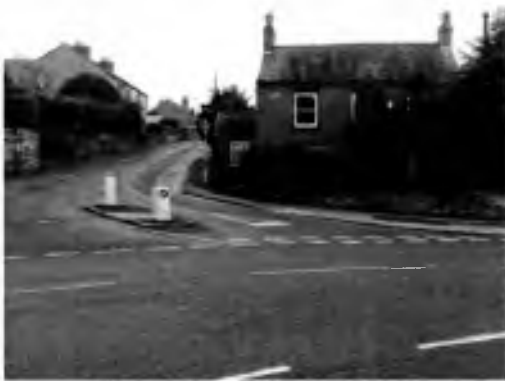
Photo 3: Front of Property

There are no visible signs of slope instability.

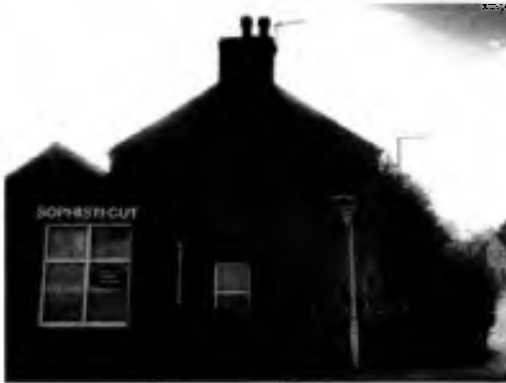
There are two corroded pattress plates on the LHS gable which mirror those on the RHS gable. The brickwork around around the rear and front pattress plate dishes inwards and there are a number of stepped cracks in the brickwork although significantly more pronounced around the rear plate.

Photo 18: Oh wall

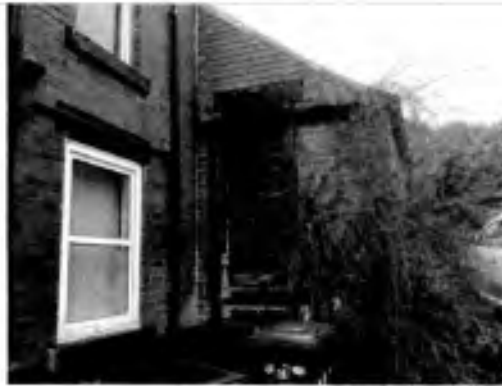
Photo 29: Rear Wall

Cracking and gapping are evident over the rear wall lintel although this appears to be of a historic nature.
