**PLOT 4B & 5, ASHROYD BUSINESS PARK, HOYLAND**

**POST COMPLETION HIGHWAY CONDITION INSPECTION**

**11717**

**JUNE 2020**

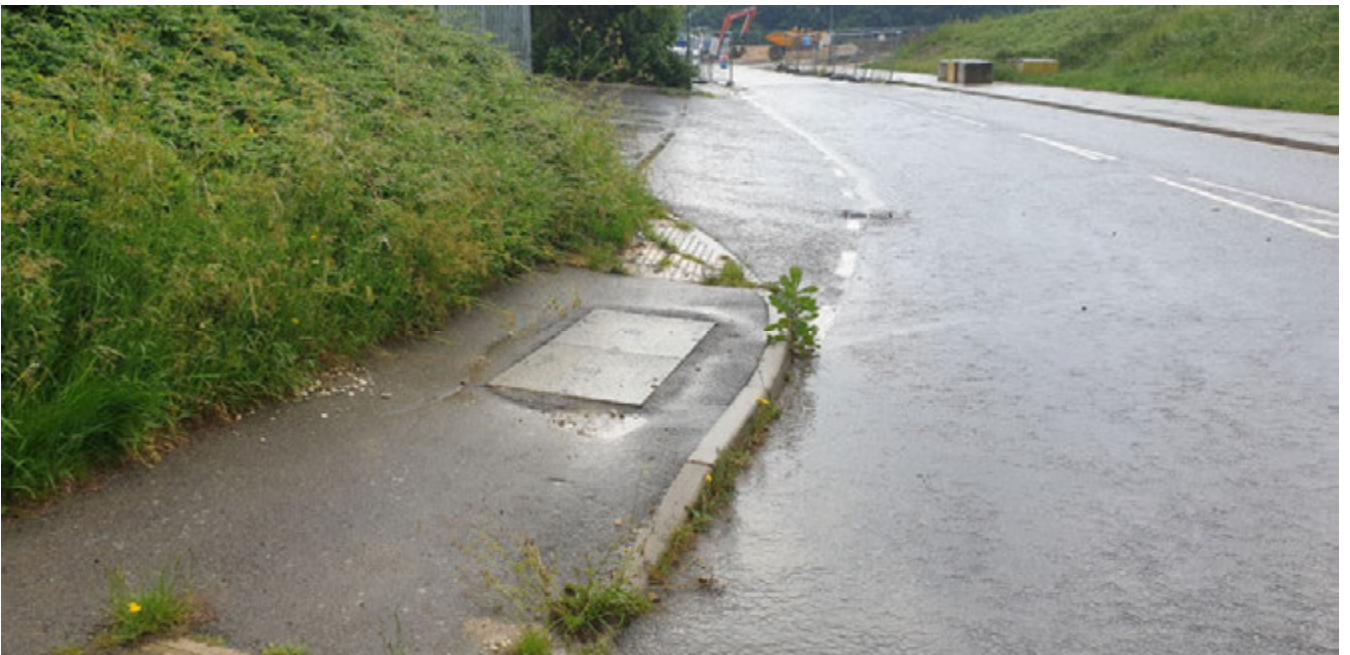
*Figure 24 - Footway surrounding BT cover is sunken, this was present prior to works commencing and shown in the pre-start inspection photos. Refer to Figure 27 appendix B.*

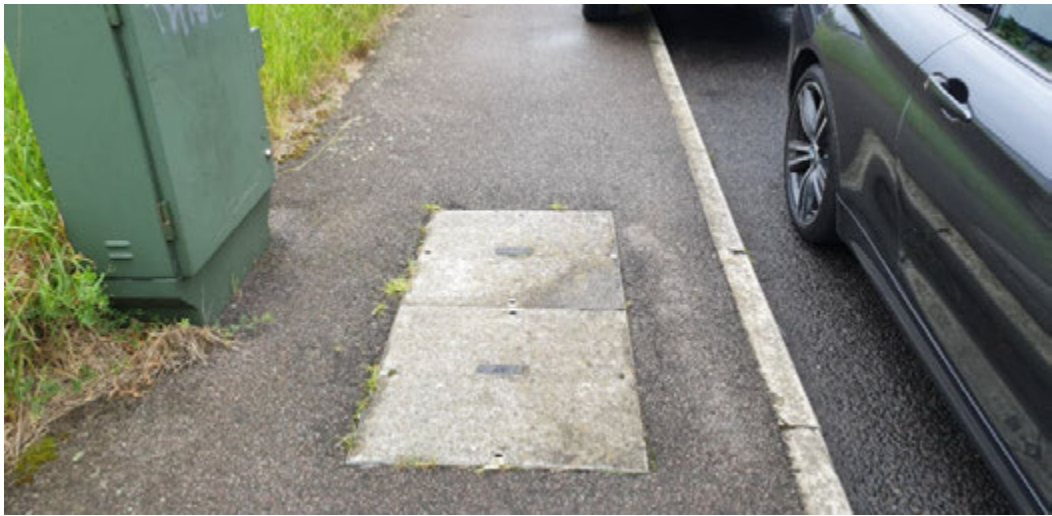
*Figure 9 - BT chamber in southern footway.*

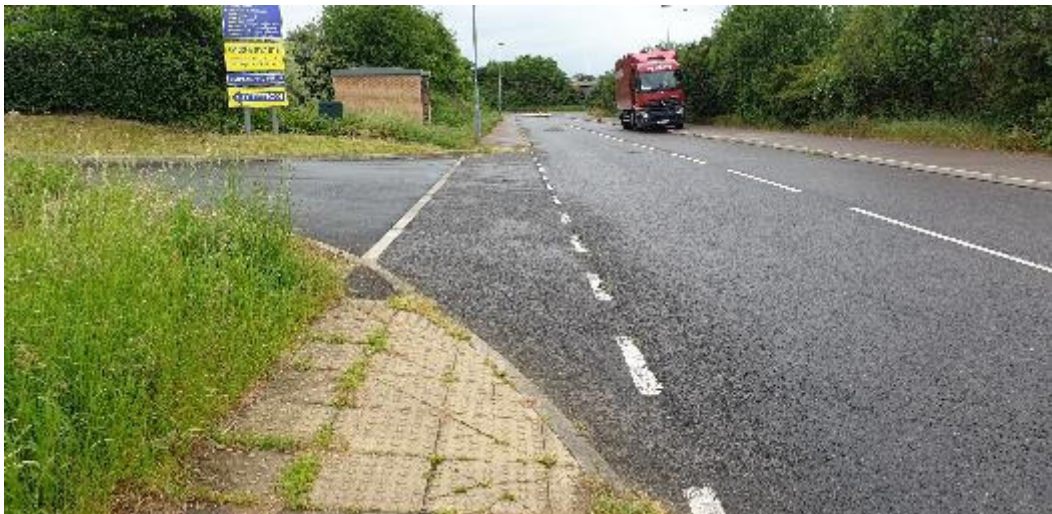
*Figure 10 - View across entrance to Self-Store site/ Plot 4B entrance. Vegetation in tactile pavers.*

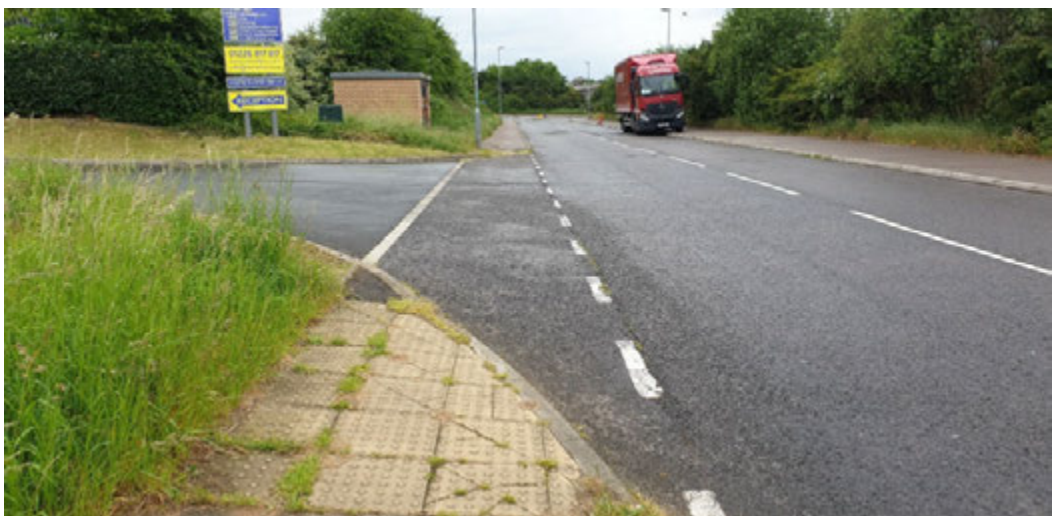
*Figure 11 - Western side of entrance. Heavy vegetation in between tactile pavers.*

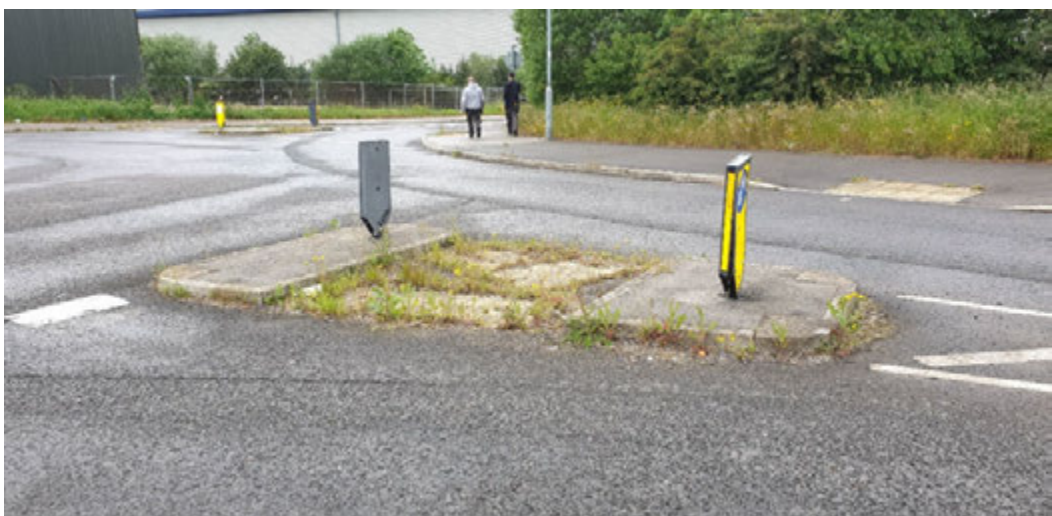
*Figure 17 - View across pedestrian crossing point on eastern leg of mini roundabout. Very heavy vegetation on tactile paving in island.*

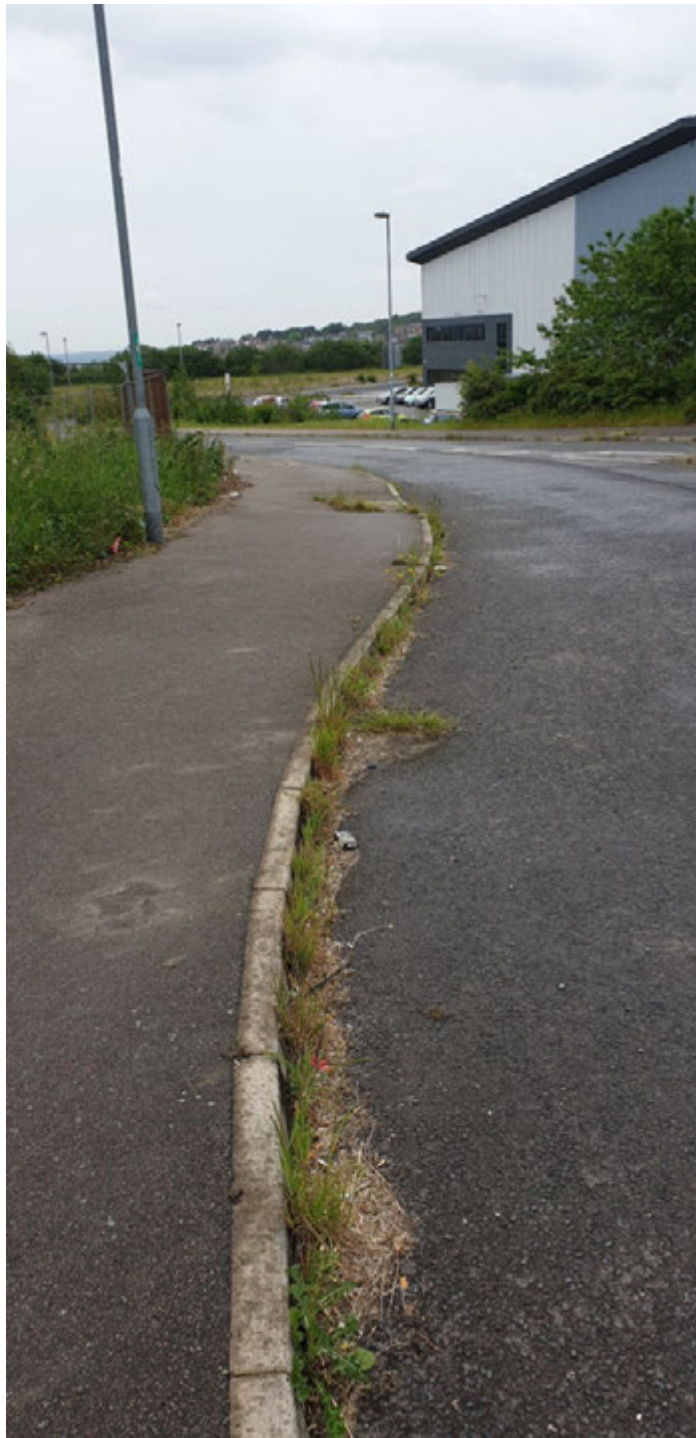
*Figure 29 - Kerb line on western side of roundabout looking toward the northern leg.*

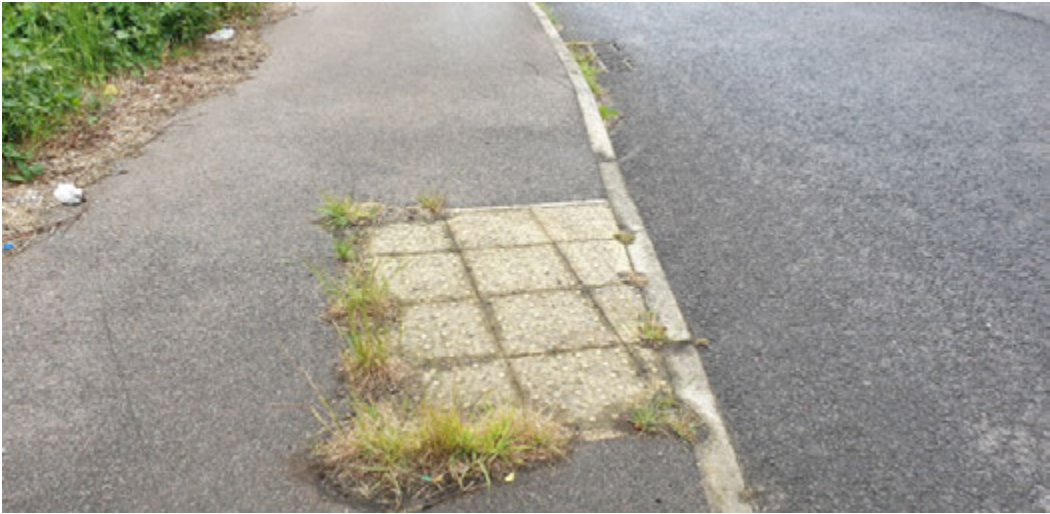
*Figure 30 - West side of northern leg - tactile pavers.*

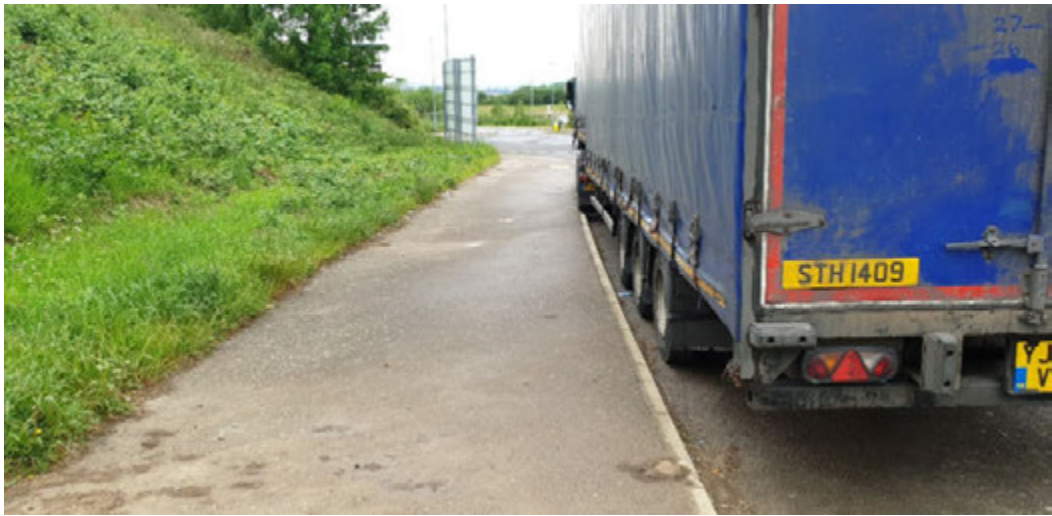
*Figure 36 - Western footway looking north toward roundabout.*

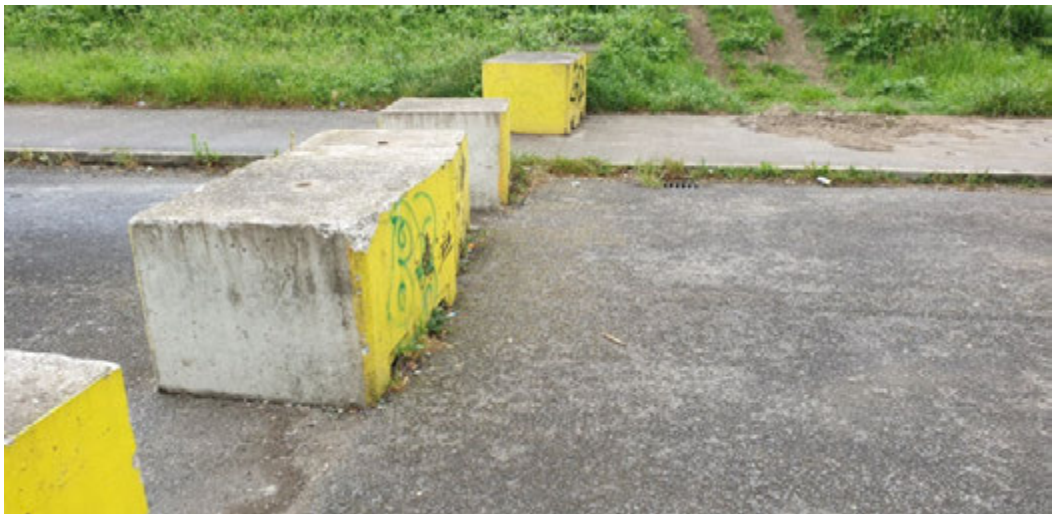
*Figure 37 - Concrete blocks prevent access onto unmade section of road which is not yet adopted.*

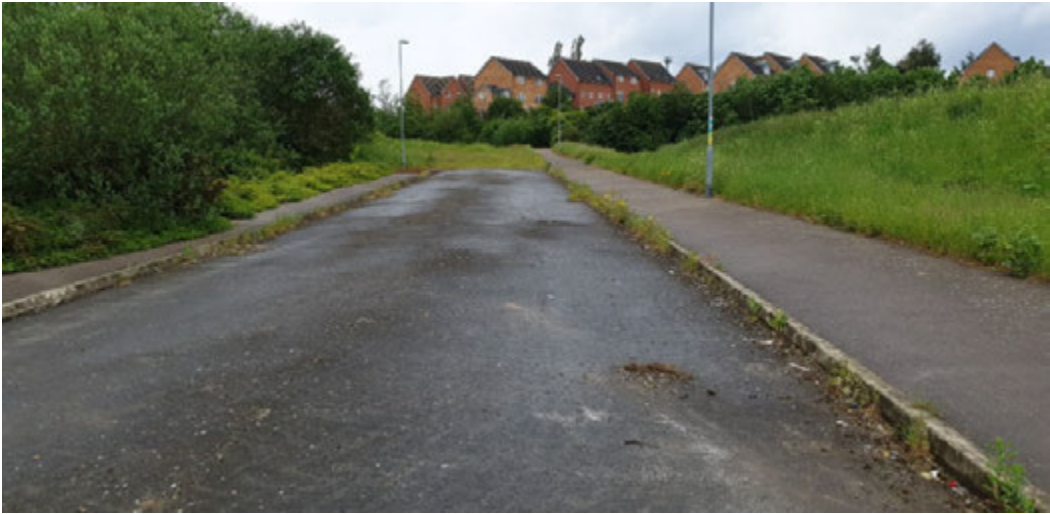
*Figure 39 - View south beyond concrete blocks. Footway on western side is complete and surfaced. Carriageway is incomplete.*

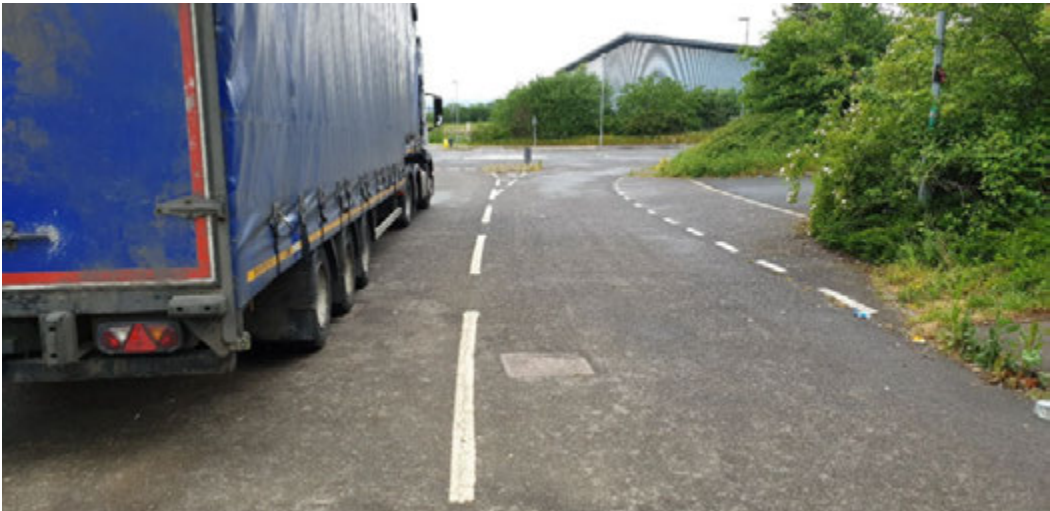
*Figure 40 - Looking south - eastern side tactiles heavily overgrown, vegetation over footway.*

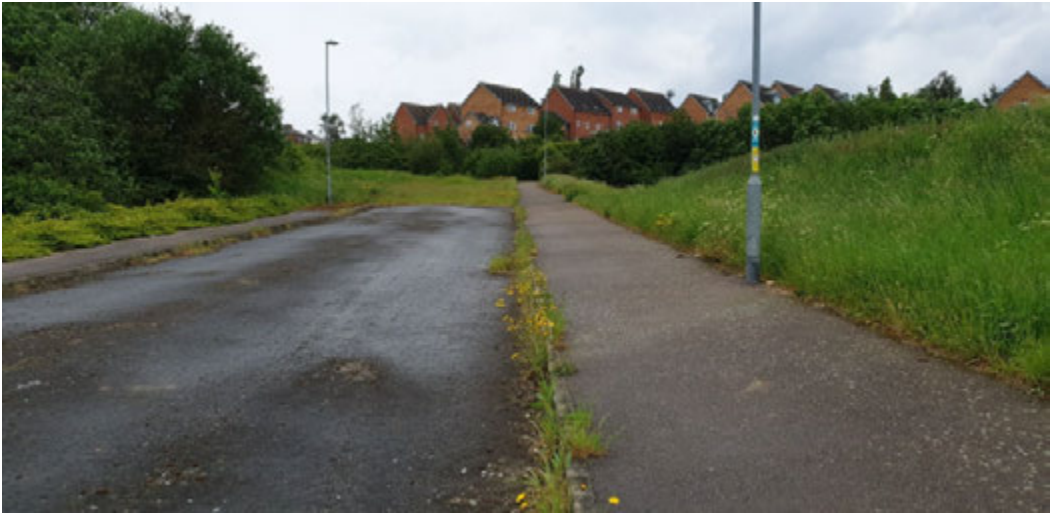
*Figure 42 - Western channel looking south.*

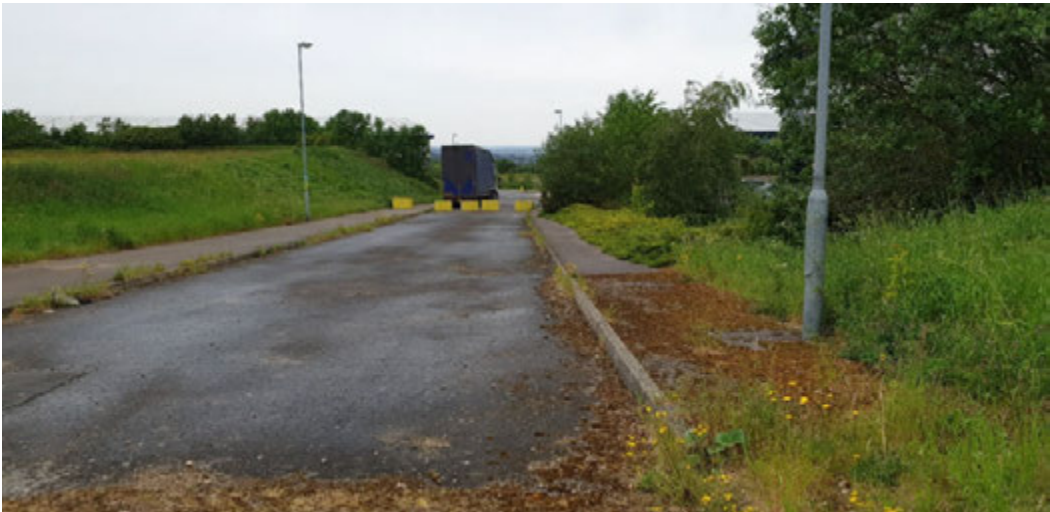
*Figure 47 - Footway on eastern side heavily covered in moss.*

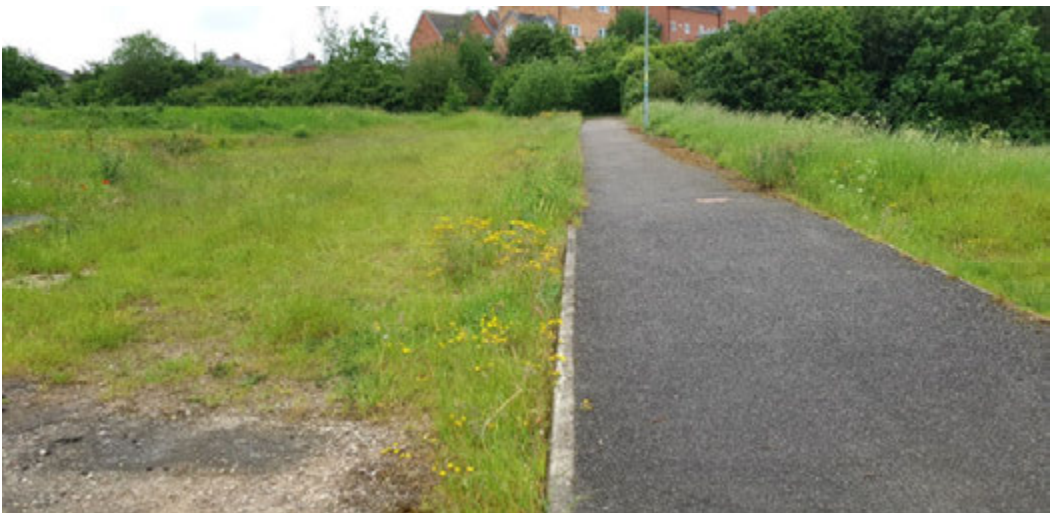
*Figure 48 - Footway continuing south toward end of site boundary. Footway in good condition. Carriageway incomplete.*

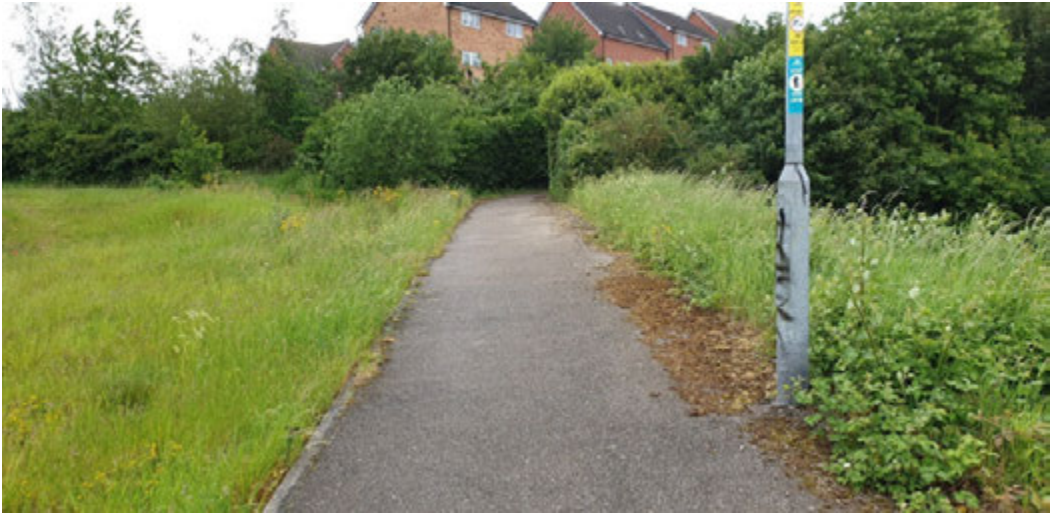
*Figure 49 - Footway in good condition toward link through to beyond site boundary.*

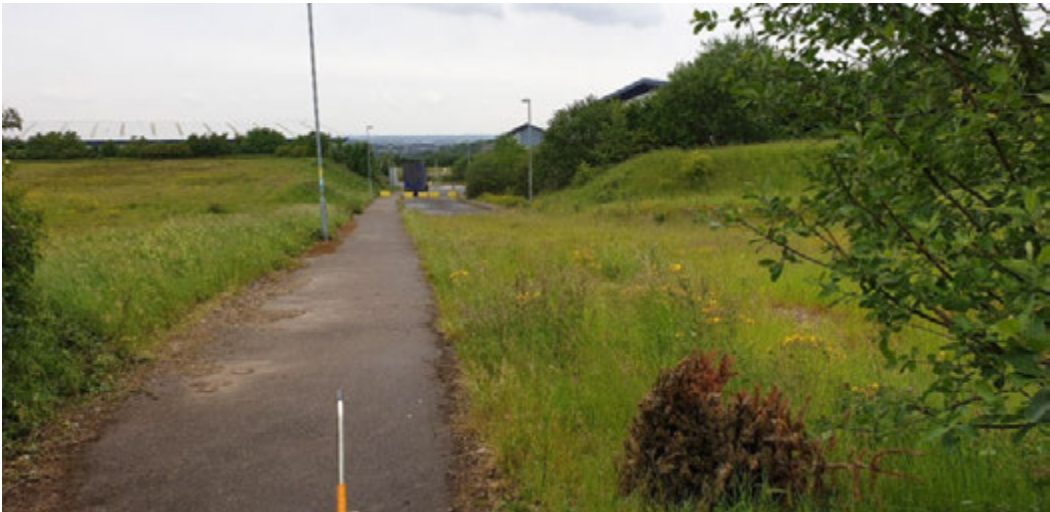
*Figure 50 - View north from footway on site boundary.*
