CROSS STREET, WOSBOROUGH

ARBORICULTURAL IMPACT ASSESSMENT AND ARBORICULTURAL  
METHOD STATEMENT

September 2026

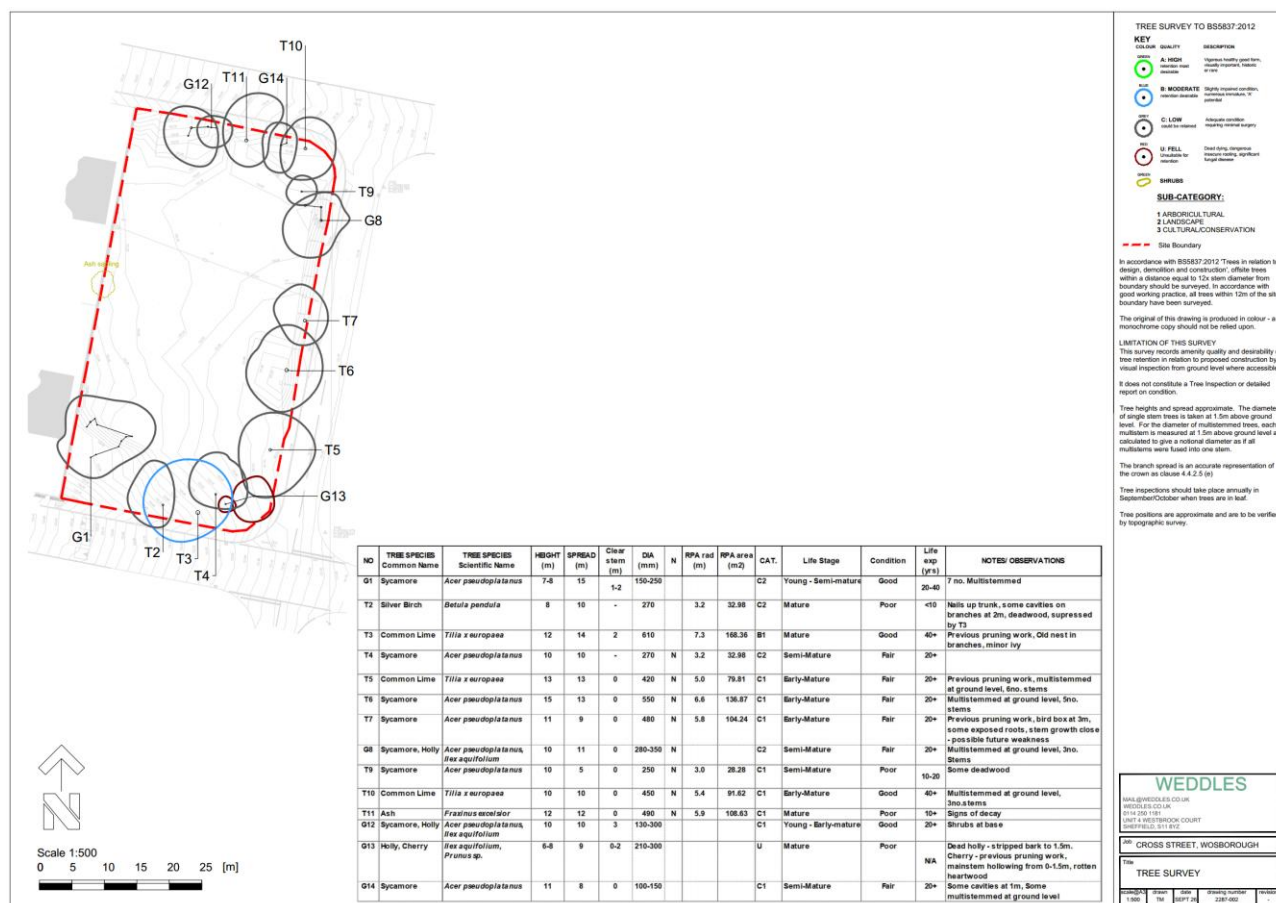
Figure 2: Tree Survey extract

A Tree Survey to BS 5837:2012 'Trees in Relation to Design, Demolition and Construction – Recommendations' was carried out by Weddles in September 2026, as shown on the Tree Survey drawing. A previous survey was carried out by Anderson Tree Care in June 2026 and is included in **Appendix B**, and provides supplementary tree information.

The tree survey includes an assessment of life stage, life expectancy, general observations on condition and categorisation in accordance with BS 5837:2012 'Trees in Relation to Design, Demolition and Construction – Recommendations' Section 4.5 and Table 1.

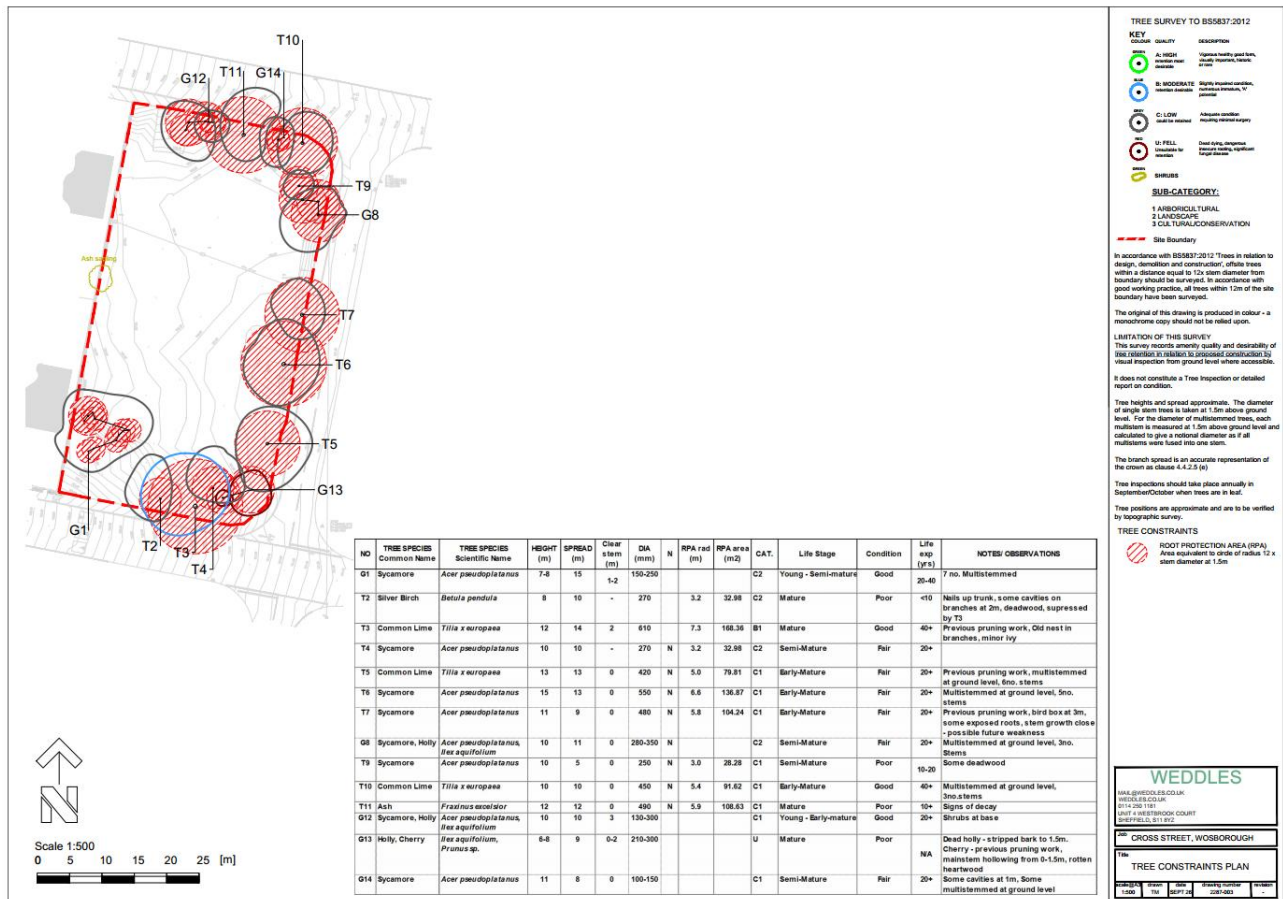
Figure 3: Tree Constraints Plan extract

The Root Protection Area (RPA) as defined by BS 5837:2012 'Trees in Relation to Design, Demolition and Construction – Recommendations' has been identified and shown on the Tree Constraints Plan. This is the zone of roots which should be protected against damage during construction.

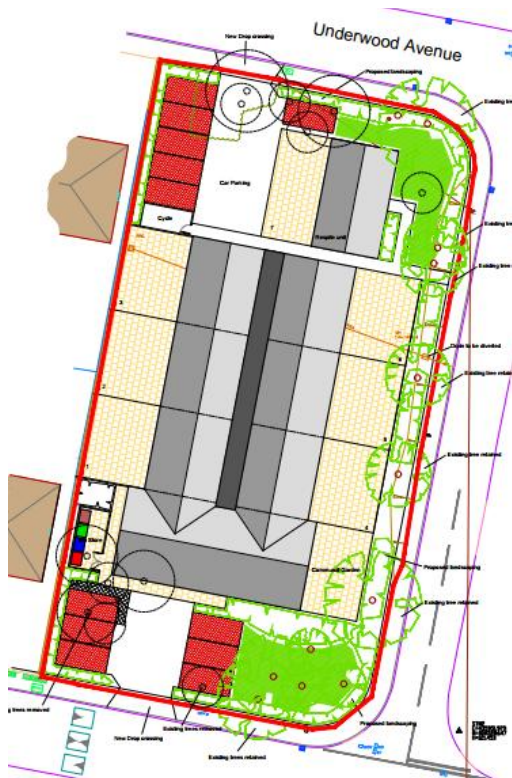
Figure 1.

Figure 1 is the plan prepared for the site. this is to be a residential home and fairly obviously will occupy a large proportion of the vacant space. I've appended a larger version of the plan and marked upon it the various trees and tree groups, numbering them 1 to 12.
