**Land North of Keresforth Road, Dodworth,
Barnsley**

Road Safety Audit Combined Stage 1 & 2

TMS reference no: 18507
Date: 5th June 2024
Revision: 0

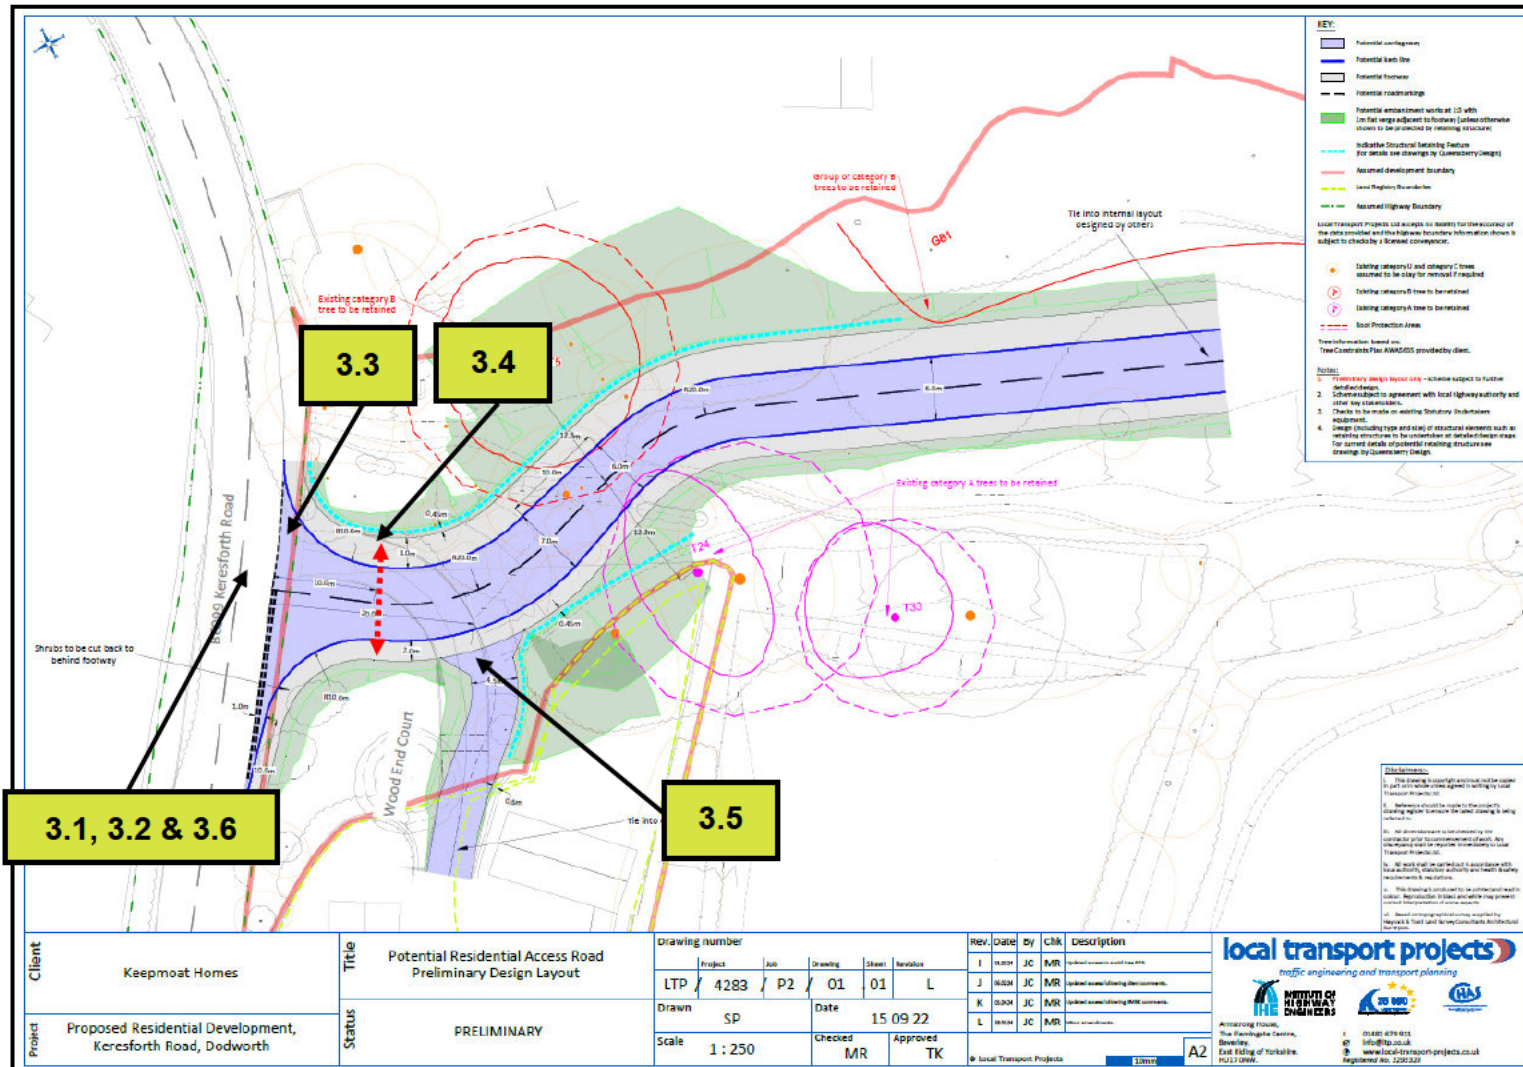
Please refer to the following page for a plan illustrating the locations of the problems identified as part of this audit (location numbers refer to paragraph numbers in the report).
