## **STRUCTURAL REPORT - EXISTING BARN (BUILDING 1)**

### **RESIDENTIAL CONVERSION**

Hill End Farm, Hill End Road, Mapplewell, Barnsley, S75 6DU

**Report Ref:** TH/Hill End/Bldng1/ClassQ/Struct/01/June2022/v01

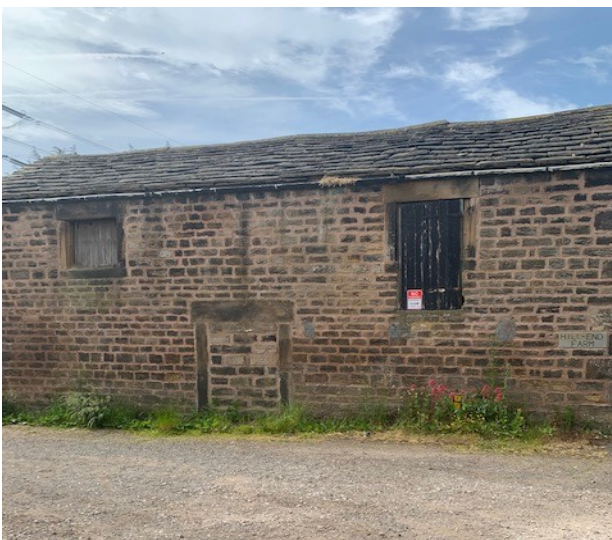
The building is in good general order situated within the courtyard of Hill End Farm, with front-facing off a side track at the bend of Wentworth Road / Hill End Road. The current land use is vacant land, and there is good access off Wentworth Road / Hill End Road and very good general curtilage to the Barn itself within at Hill End Farm.

Fig 4 – Existing Barn: Front – as viewed off Hill End Road looking south.

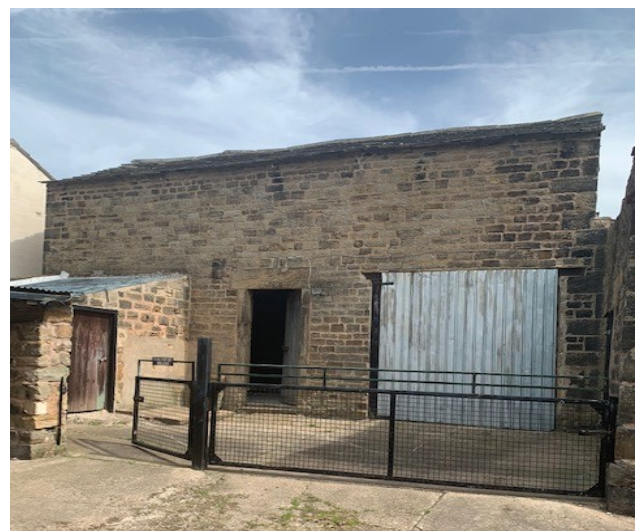
Fig 5 – Barn: Rear – as viewed from courtyard side looking north.

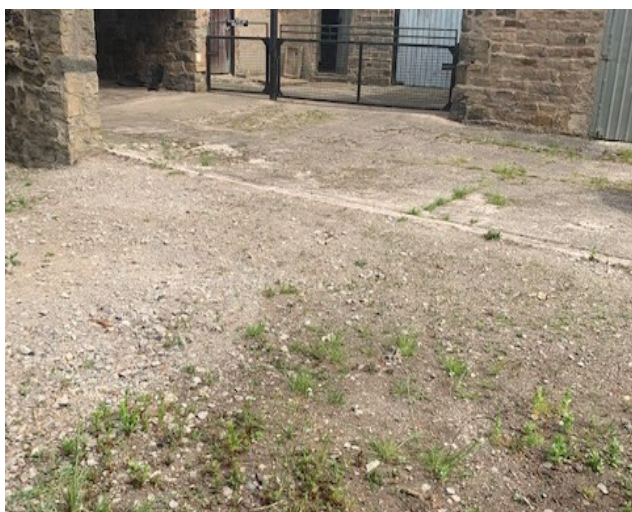
There is good general curtilage to the property and the present surfacing consists of concrete, compacted stone at the entrance off Wentworth Road / Hill End Road, and compacted gravel road to the front. The site is generally level with well-defined boundaries, and there are established residential settlements to the north and north-west.

Fig 13 – Rear hard-standing & concreted curtilage

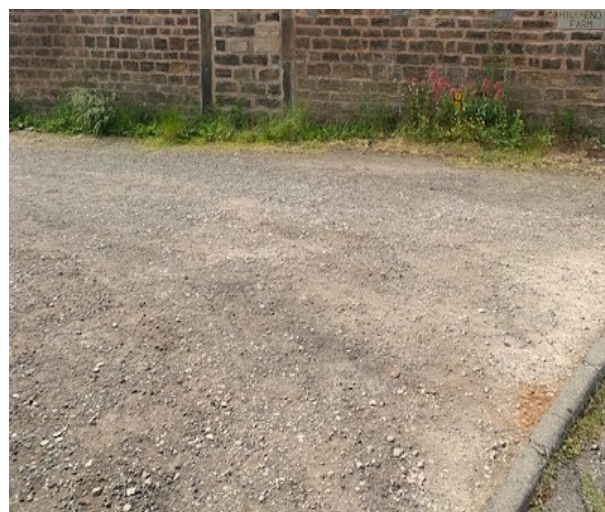
Fig 14 – Front access track and hard-standing
