LILEY FARM LILEY LANE MILL HOUSE GREEN SHEFFIELD S36 9NG

1.0 About the Inspection

- 1.3 The survey and report (ref L2/3240) have been carried out for Mr B Marsden on behalf of Marsden's Farms Ltd care of Townsend Planning Consultants, PO Box 788, Wakefield, WF1 9UX. Our instructions are to undertake a survey of the barn and attached building at Liley Farm, Liley Lane, Mill House Green, Sheffield, S36 9NG.

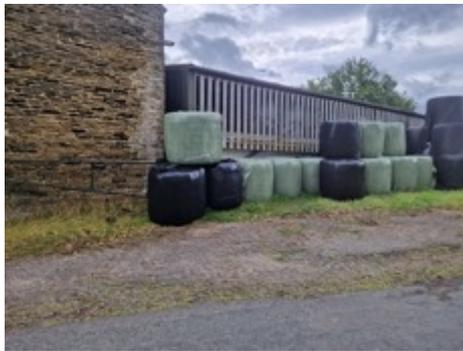
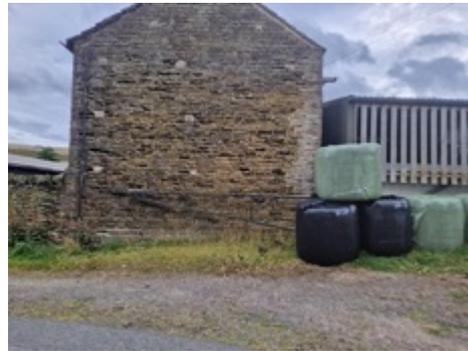
3.11 Rear Elevation

3.11.1 No access along the rear elevation was possible; the access is blocked off to prevent intruder entry into the farmyard and other barns at the rear.
