## **MANAGEMENT ASBESTOS SURVEY**

High Street Dodworth  
88 High Street, Dodworth, Barnsley,, S75 3RQ

REPORT No: R-00010  
Survey Date: 23/05/2013 to 06/03/2014

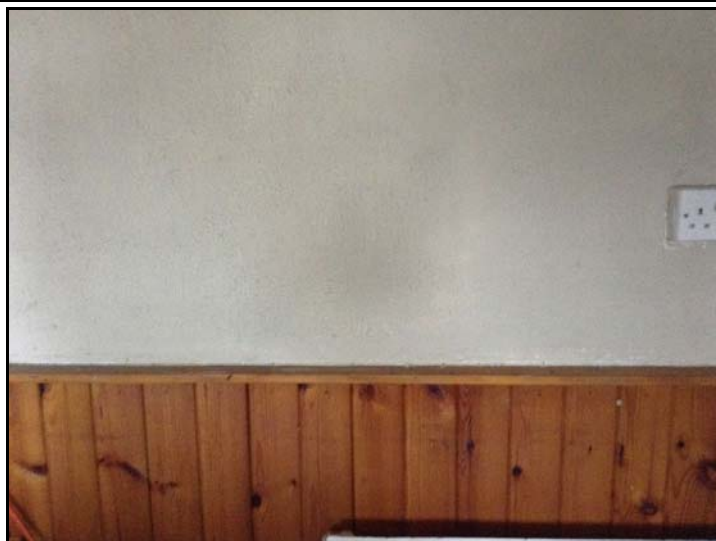
Lead Surveyor	Dan Ancliff	Building	
Survey Type	Demolition	Floor	
Survey Date		Room/Area	027 - Kitchen
Next Inspection	23/05/2014	Sample No.	S015
Level of Identification	Sampled	Laboratory Ref

**Description:** Photo Reference 541 Walls - Textured Coating

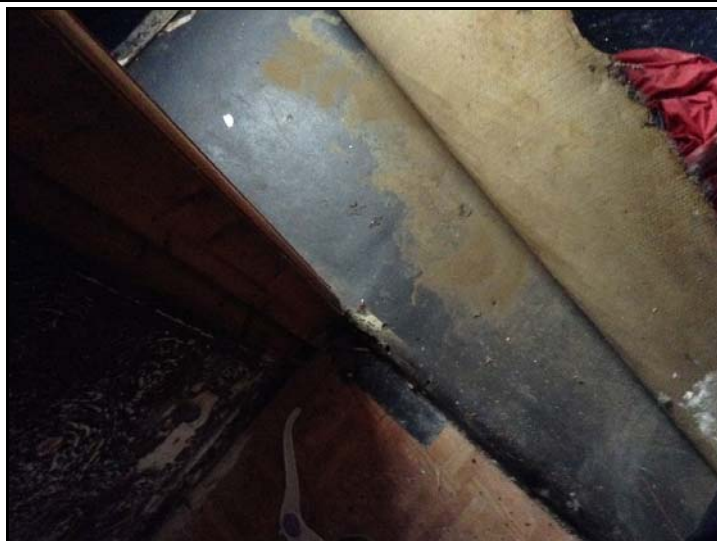
Lead Surveyor	Dan Ancliff	Building	
Survey Type	Demolition	Floor	
Survey Date		Room/Area	029 - Lounge
Next Inspection	23/05/2014	Sample No.	S017
Level of Identification	Sampled	Laboratory Ref

**Description:** Photo Reference 491 Floor - Bituminous Product

Score
<b>Product Type</b>		
<b>Extent of Damage</b>		
<b>Surface Treatment</b>		
<b>Asbestos Type</b>		
<b>Amount</b>		
<b>Accessibility</b>	Inaccessible or unlikely to be disturbed	
<b>Algorithm Score</b>		
<b>Recommendation</b>	No Asbestos Detected

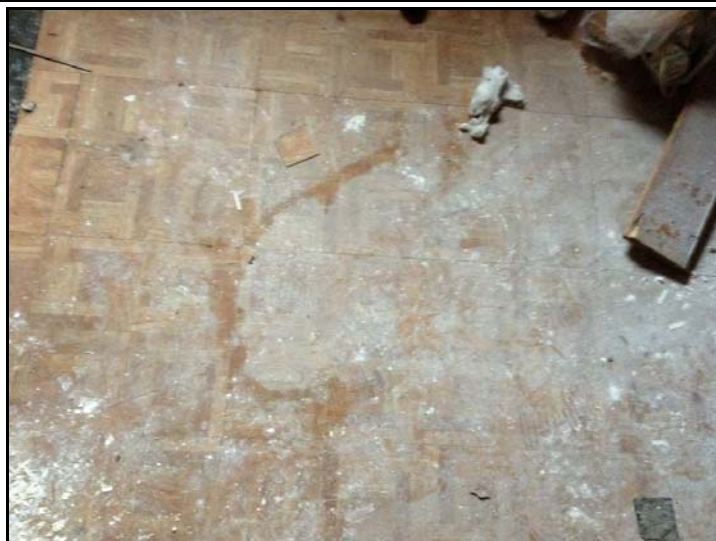
Lead Surveyor	Dan Ancliff	Building	
Survey Type	Demolition	Floor	
Survey Date		Room/Area	030 - Entrance
Next Inspection	23/05/2014	Sample No.	S018
Level of Identification	Sampled	Laboratory Ref

**Description:** Photo Reference 459 Floor - Vinyl tiled

Score
Product Type		
Extent of Damage		
Surface Treatment		
Asbestos Type		
Amount		
Accessibility	Inaccessible or unlikely to be disturbed	
Algorithm Score		
<b>Recommendation</b>	No Asbestos Detected

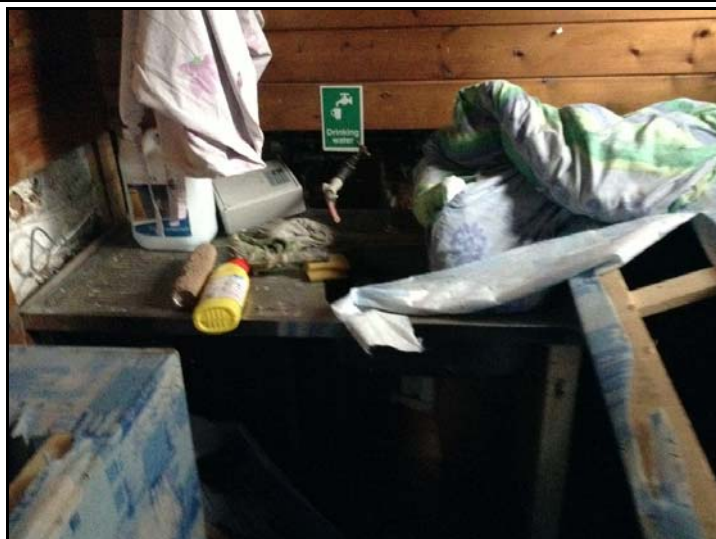
Lead Surveyor	Dan Ancliff	Building	
Survey Type	Demolition	Floor	
Survey Date		Room/Area	031 - Kitchen
Next Inspection	23/05/2014	Sample No.	S019
Level of Identification	Sampled	Laboratory Ref

**Description:** Photo Reference 458 Sink pad - Bituminous Product

Score
<b>Product Type</b>	Asbestos reinforced composites etc.	1
<b>Extent of Damage</b>	Good Condition	0
<b>Surface Treatment</b>	Self Sealed	0
<b>Asbestos Type</b>	Chrysotile	1
<b>Amount</b>	X2	
<b>Accessibility</b>	Inaccessible or unlikely to be disturbed	2
<b>Algorithm Score</b>		
<b>Recommendation</b>	Remove

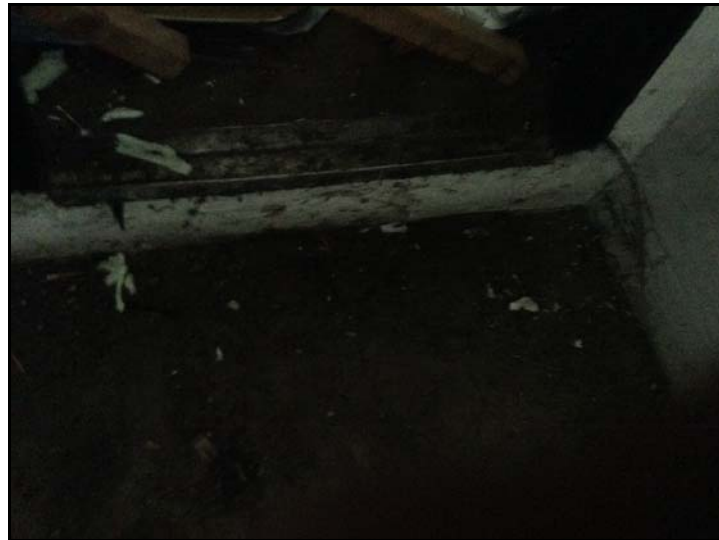
Lead Surveyor	Dan Ancliff	Building	
Survey Type	Demolition	Floor	
Survey Date		Room/Area	013 - Office
Next Inspection	23/05/2014	Sample No.	S007
Level of Identification	Sampled	Laboratory Ref

**Description:** Photo Reference 523 Stair nosings - Vinyl tiled

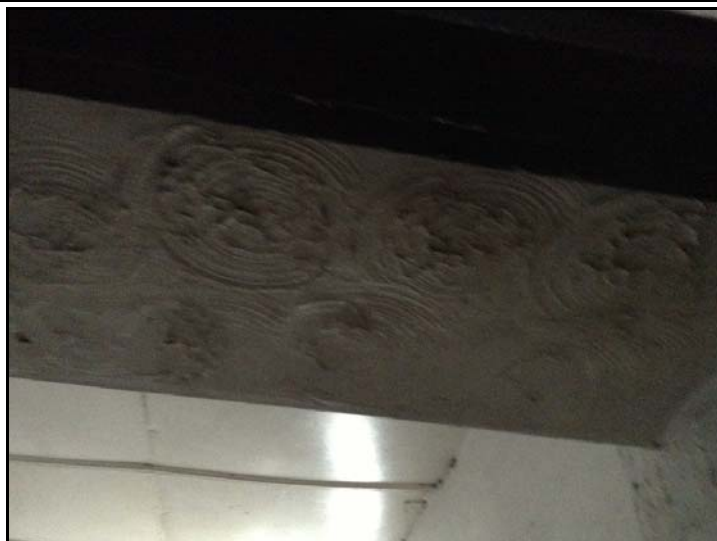
Lead Surveyor	Dan Ancliff	Building	
Survey Type	Demolition	Floor	
Survey Date		Room/Area	014 - Office
Next Inspection	23/05/2014	Sample No.	S008
Level of Identification	Sampled	Laboratory Ref

**Description:** Photo Reference 514 Walls & ceiling - Textured Coating

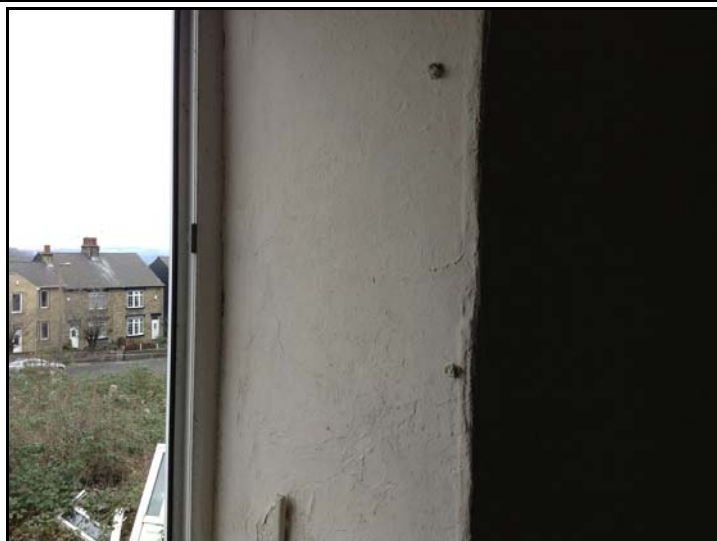
Lead Surveyor	Dan Ancliff	Building	
Survey Type	Demolition	Floor	
Survey Date		Room/Area	019 - Bedroom
Next Inspection	23/05/2014	Sample No.	S010
Level of Identification	Sampled	Laboratory Ref

**Description:** Photo Reference 571 Window reveal - Textured Coating

Score
<b>Product Type</b>		
<b>Extent of Damage</b>		
<b>Surface Treatment</b>		
<b>Asbestos Type</b>		
<b>Amount</b>		
<b>Accessibility</b>	Inaccessible or unlikely to be disturbed	
<b>Algorithm Score</b>		
<b>Recommendation</b>	No Asbestos Detected

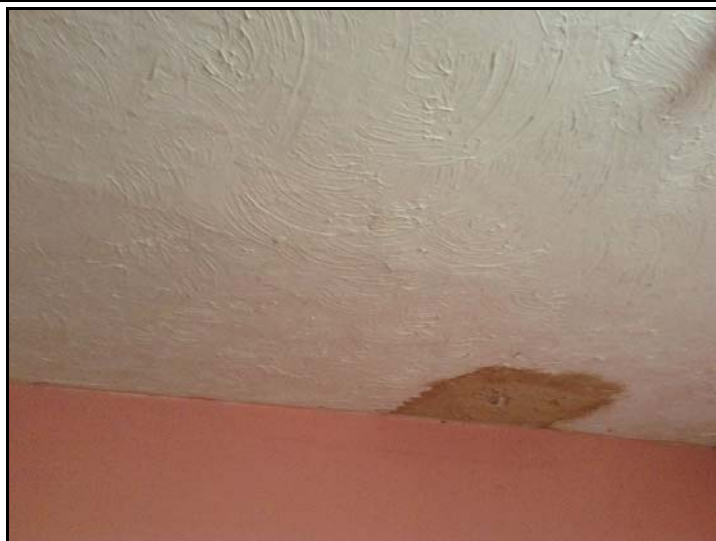
Lead Surveyor	Dan Ancliff	Building	
Survey Type	Demolition	Floor	
Survey Date		Room/Area	021 - Bedroom
Next Inspection	23/05/2014	Sample No.	S011
Level of Identification	Sampled	Laboratory Ref

**Description:** Photo Reference 394 Ceiling - Textured Coating

Score
<b>Product Type</b>		
<b>Extent of Damage</b>		
<b>Surface Treatment</b>		
<b>Asbestos Type</b>		
<b>Amount</b>		
<b>Accessibility</b>	Inaccessible or unlikely to be disturbed	
<b>Algorithm Score</b>		
<b>Recommendation</b>	No Asbestos Detected

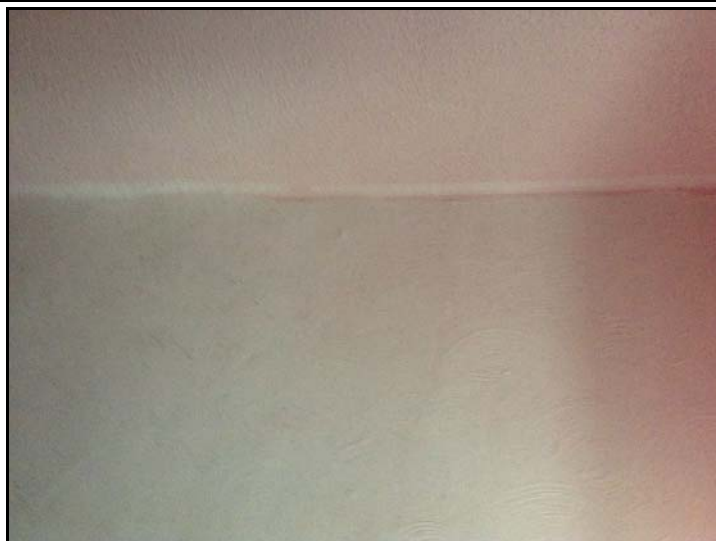
Lead Surveyor	Dan Ancliff	Building	
Survey Type	Demolition	Floor	
Survey Date		Room/Area	032 - WC
Next Inspection	23/05/2014	Sample No.	S020
Level of Identification	Sampled	Laboratory Ref

**Description:** Photo Reference 483 Walls & ceiling - Textured Coating

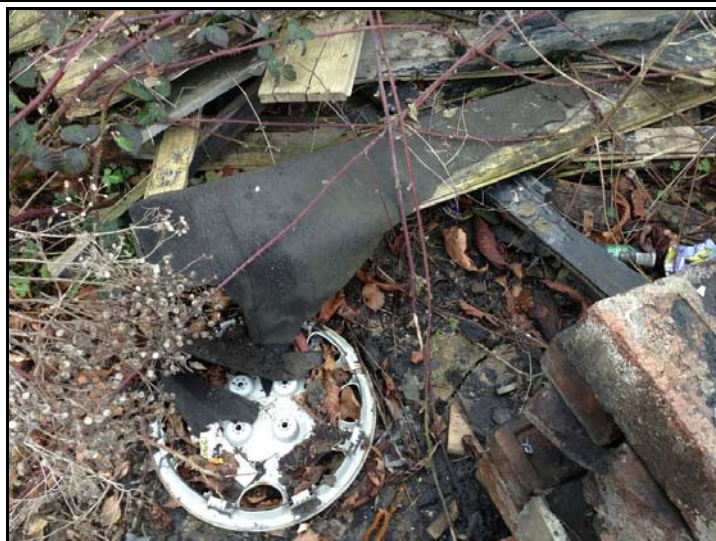
Lead Surveyor	Dan Ancliff	Building	
Survey Type	Demolition	Floor	
Survey Date		Room/Area	036 - Externals
Next Inspection	23/05/2014	Sample No.	S023
Level of Identification	Sampled	Laboratory Ref

**Description:** Photo Reference 393 Bitumen roof felt debris - Bituminous Product

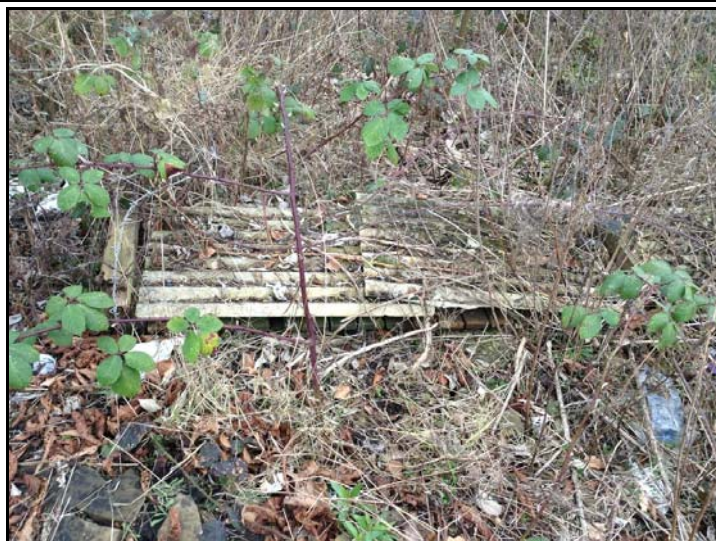
Lead Surveyor	Dan Ancliff	Building	
Survey Type	Demolition	Floor	
Survey Date		Room/Area	036 - Externals
Next Inspection	23/05/2014	Sample No.	S022
Level of Identification	Sampled	Laboratory Ref

**Description:** Photo Reference 444 Cement debris - Debris

Score
<b>Product Type</b>	Thermal insulation, sprayed asbestos, loose asbestos etc.	3
<b>Extent of Damage</b>	High Damage	3
<b>Surface Treatment</b>	Self Sealed	0
<b>Asbestos Type</b>	Chrysotile	1
<b>Amount</b>	50m <sup>2</sup>	
<b>Accessibility</b>	Inaccessible or unlikely to be disturbed	7
<b>Algorithm Score</b>

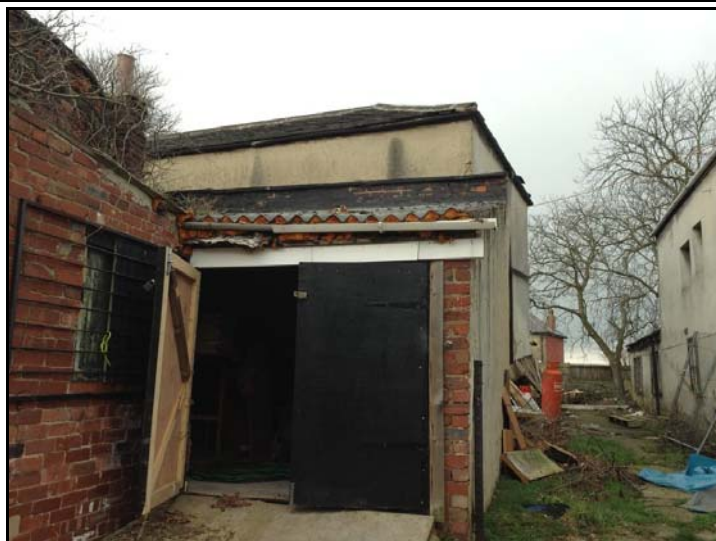
Lead Surveyor	Dan Ancliff	Building	
Survey Type	Demolition	Floor	
Survey Date		Room/Area	036 - Externals
Next Inspection	23/05/2014	Sample No.	As Sample 009
Level of Identification	Sampled	Laboratory Ref

**Description:** Photo Reference 475 Roof - Pitched, profiled cement sheet

Score
<b>Product Type</b>	Asbestos reinforced composites etc.	1
<b>Extent of Damage</b>	High Damage	3
<b>Surface Treatment</b>	Self Sealed	0
<b>Asbestos Type</b>	Chrysotile	1
<b>Amount</b>	35m <sup>2</sup>	
<b>Accessibility</b>	Inaccessible or unlikely to be disturbed	5
<b>Algorithm Score</b>

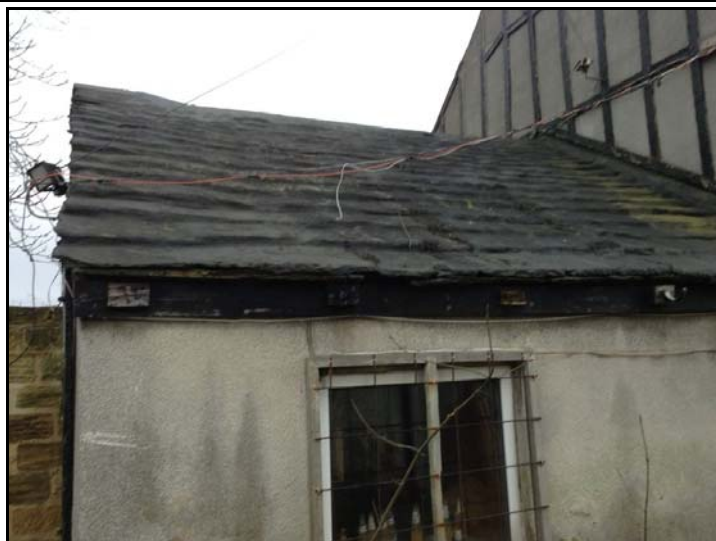
Lead Surveyor	Dan Ancliff	Building	
Survey Type	Demolition	Floor	
Survey Date		Room/Area	036 - Externals
Next Inspection	23/05/2014	Sample No.	S024
Level of Identification	Sampled	Laboratory Ref

**Description:** Photo Reference 476 Roof - Bituminous Product

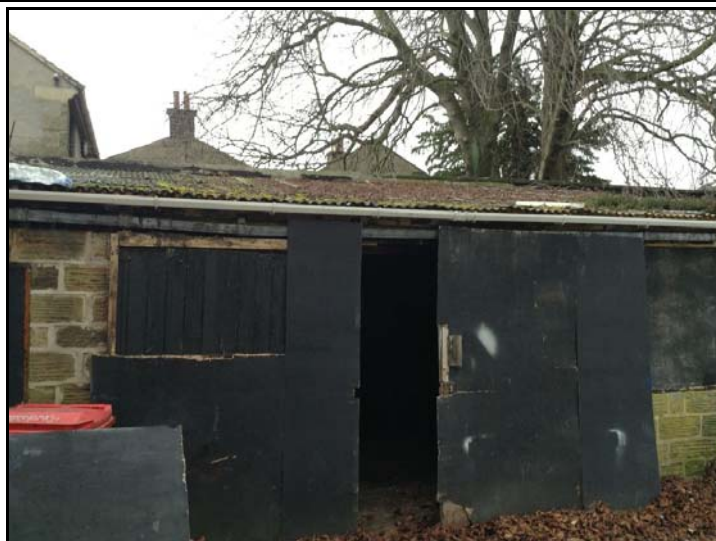
Lead Surveyor	Dan Ancliff	Building	
Survey Type	Demolition	Floor	
Survey Date		Room/Area	036 - Externals
Next Inspection	23/05/2014	Sample No.	As Sample 001
Level of Identification	Sampled	Laboratory Ref

**Description:** Photo Reference 502 Roof - Pitched, profiled cement sheet

Score
<b>Product Type</b>	Asbestos reinforced composites etc.	1
<b>Extent of Damage</b>	High Damage	3
<b>Surface Treatment</b>	Self Sealed	0
<b>Asbestos Type</b>	Chrysotile	1
<b>Amount</b>	35m <sup>2</sup>	
<b>Accessibility</b>	Inaccessible or unlikely to be disturbed	5
<b>Algorithm Score</b>

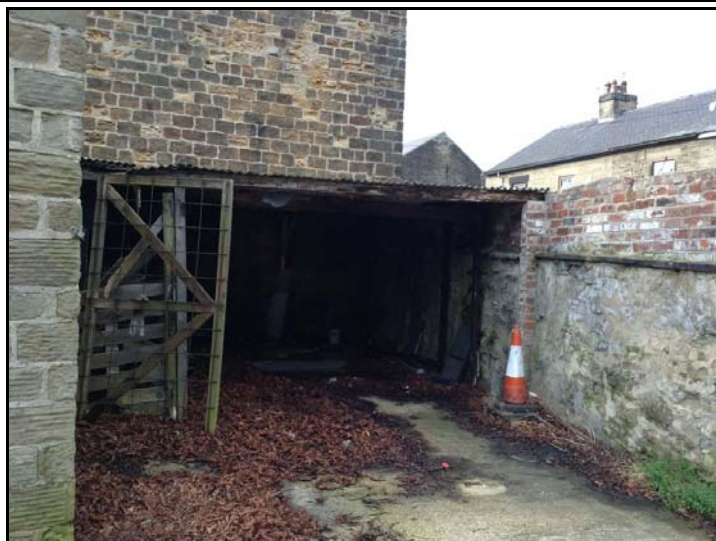
Lead Surveyor	Dan Ancliff	Building	
Survey Type	Demolition	Floor	
Survey Date		Room/Area	036 - Externals
Next Inspection	23/05/2014	Sample No.	As Sample 001
Level of Identification	Sampled	Laboratory Ref

**Description:** Photo Reference 548 Roof - Sloped, profiled cement sheet

Score
<b>Product Type</b>	Asbestos reinforced composites etc.	1
<b>Extent of Damage</b>	High Damage	3
<b>Surface Treatment</b>	Self Sealed	0
<b>Asbestos Type</b>	Chrysotile	1
<b>Amount</b>	15m <sup>2</sup>	
<b>Accessibility</b>	Inaccessible or unlikely to be disturbed	5
<b>Algorithm Score</b>
