Project Name: Gleeson - Off Wakefield Road	Project number:	Date: 17/12/2024	Contact:	
---	-----------------	---------------------	----------	--

Profile Report	1
Inspection: 1	
Project Information	2
Section: 1, S1 --- Outfall	5
Section: 2, F1 --- F2	6
Section: 3, F2 --- F3	11
Section: 4, F3 --- F4	16
Section: 5, F4 --- F5	20
Section: 6, F4 --- Boundary	24
Section: 7, F6 --- F3	26
Section: 8, F7 --- F5	31
Section: 9, F7 --- F5	38
Section: 10, F7 --- F5	41
Section: 11, F5 --- F8	45
Section: 12, F8 --- F9	50
Section: 13, F8 --- F9	58
Section: 14, F9 --- F10	62

Project name :
Gleeson - Off Wakefield Road - Ather

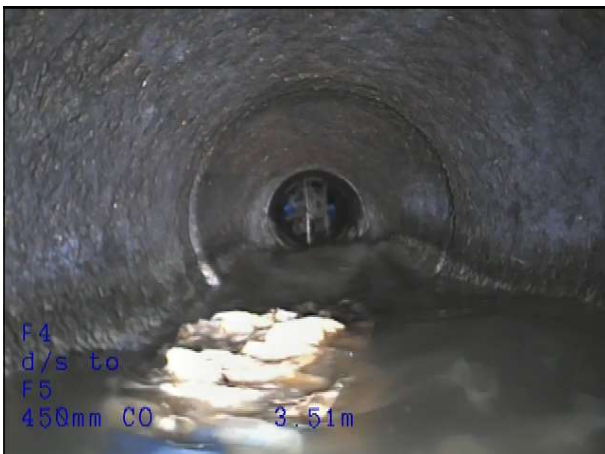
Photo: 5_6A
 3.51m, Settled deposits, coarse, 20% cross-sectional area loss

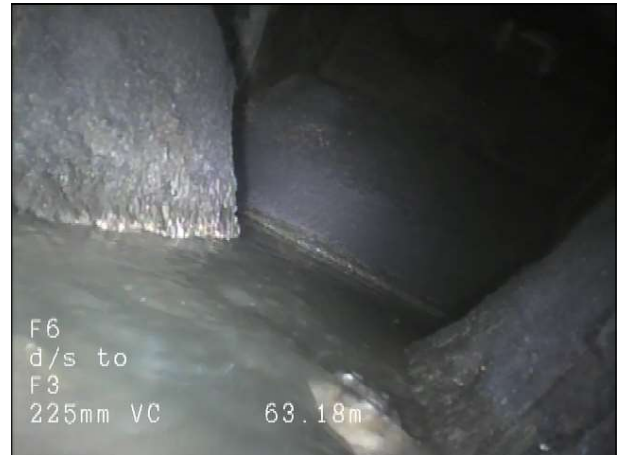
Photo: 7_7A
 63.2m, Finish node type, manhole reference number: F3

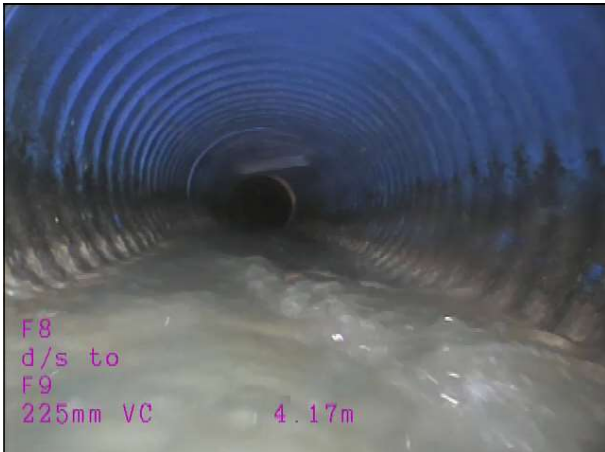
Photo: 12_3A
 0m, General remark Remarks: PVC ribbed pipe installed
