ARBORICULTURAL REPORT & Impact Assessment to BS 5837:2012 at:

***Plumpton Lodge,
Manchester Road,
Thurlstone,
Barnsley,
S36 9QW***

Report Date: *April 2025*

Reference: *AWA6560*

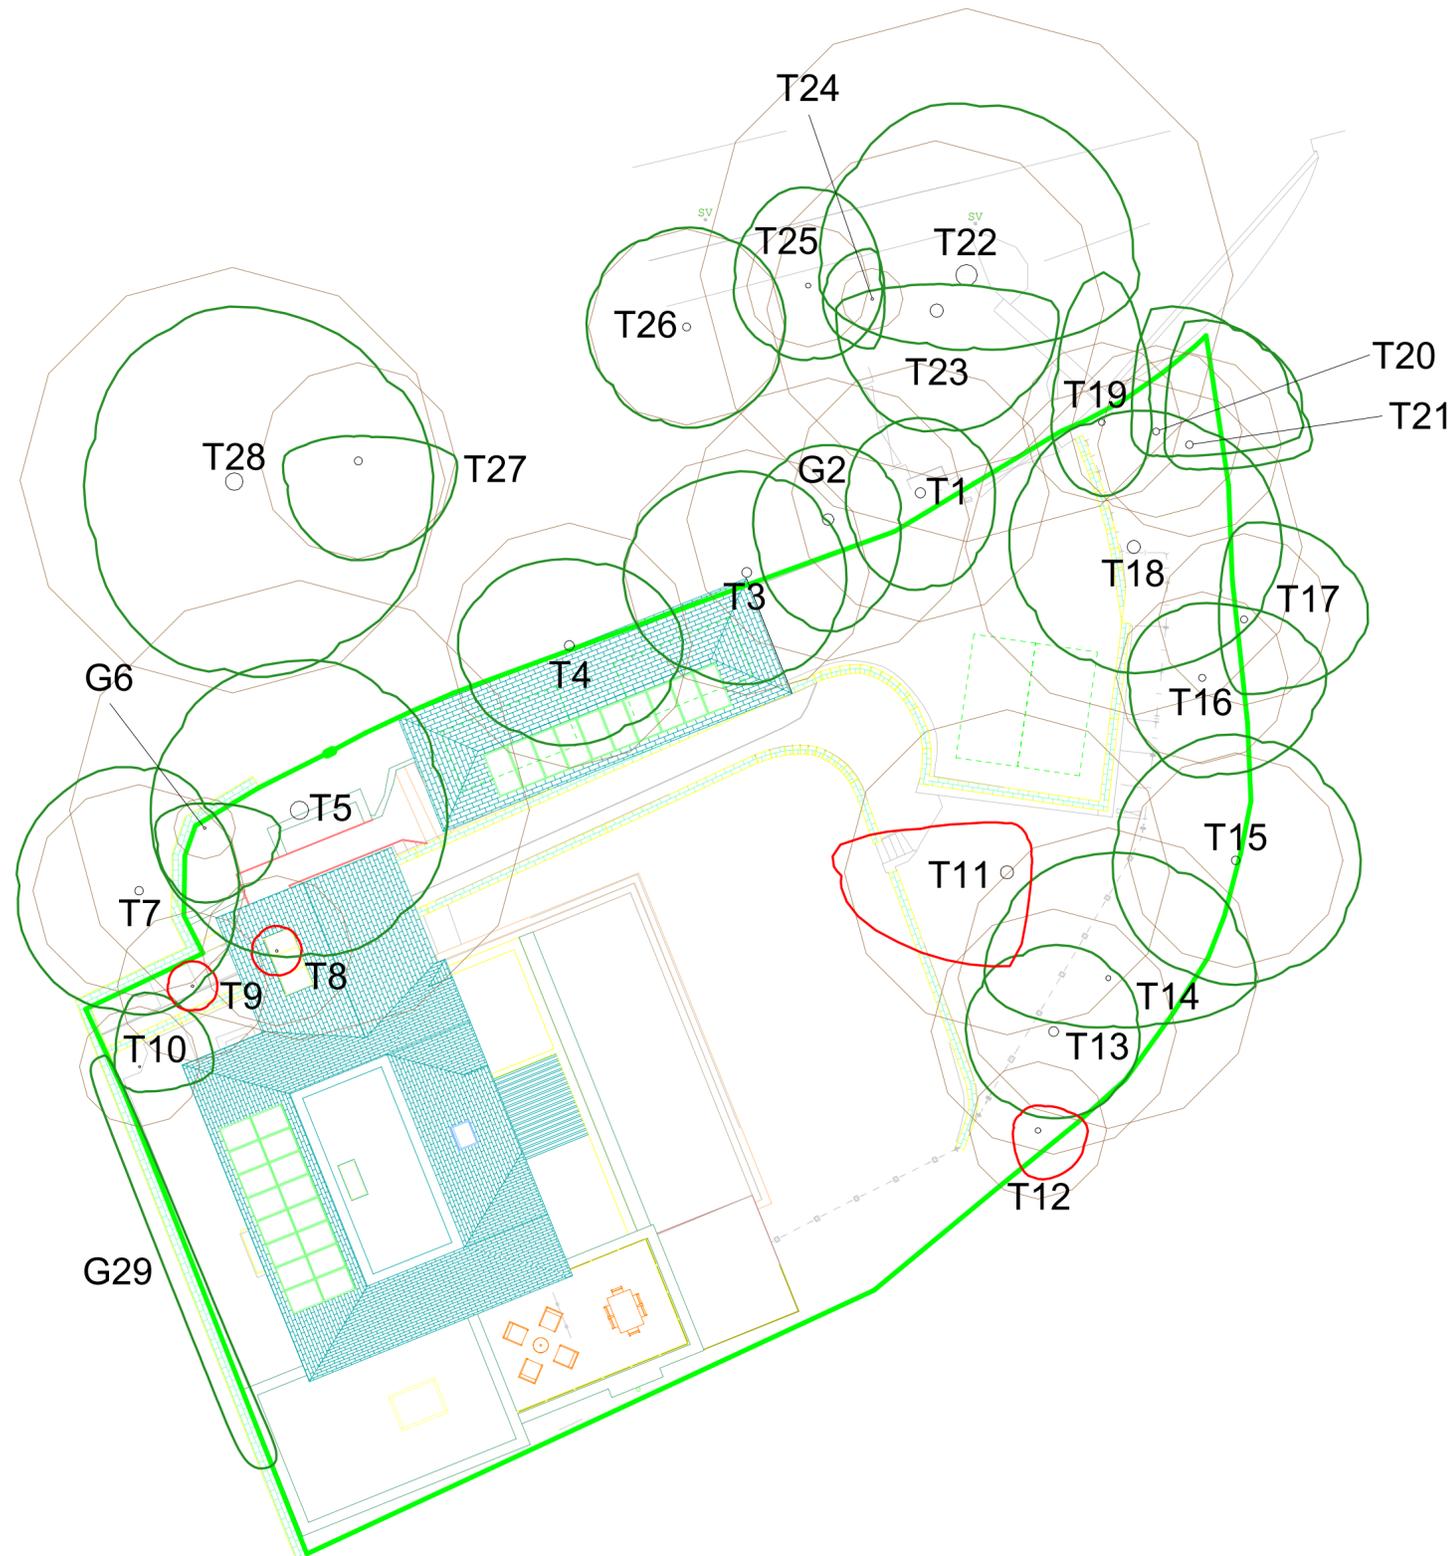
**Appendix 6:
Tree Impacts Plan**

The proposed development will require the removal of two low-value trees. No high or moderate value trees are proposed for removal. This will result in a negligible negative arboricultural impact.

The layout of the development has been designed to minimise encroachment into Root Protection Areas (RPAs), with only minor incursions into a trees' RPAs, which are not expected to significantly affect tree health.
