**Nether Mill Barn  
Penistone  
South Yorkshire**

Level 3 Historic Building Recording  
Report No. Y582/22

**Report No. Y582/22**

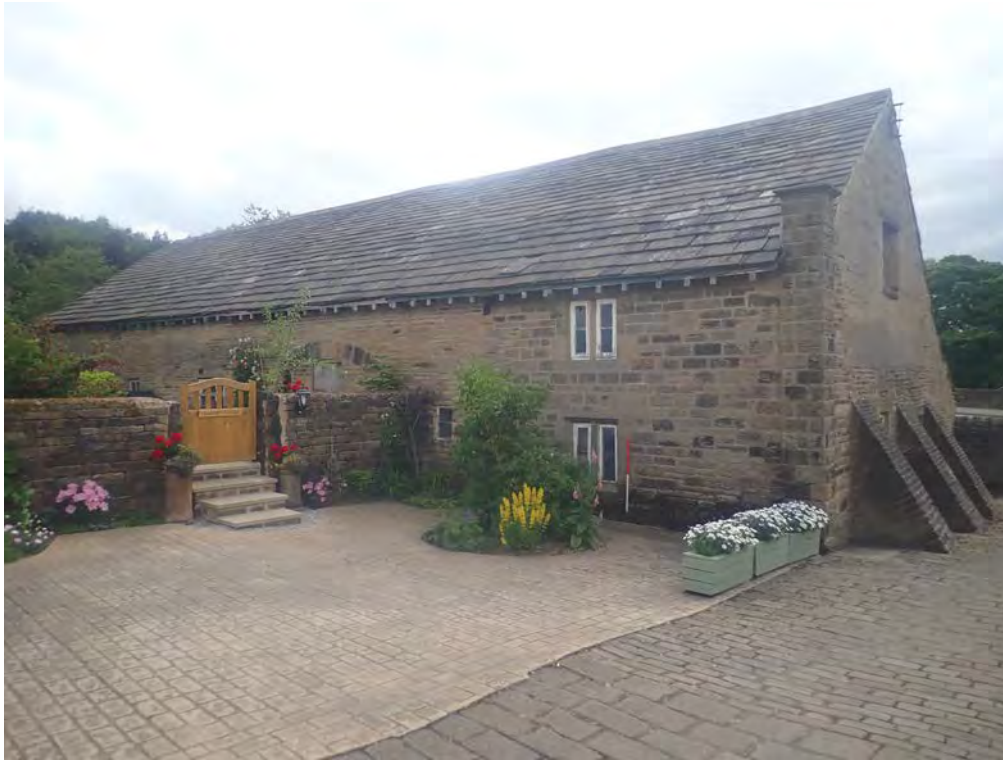
Photograph:3 Direction: E  
Digital Ref: NEMB2\_0007

Description: General view of NW elevation from west corner. Details of elevated ground level, NW projecting stone wall, chimney or pier, and change in stonework in ground.

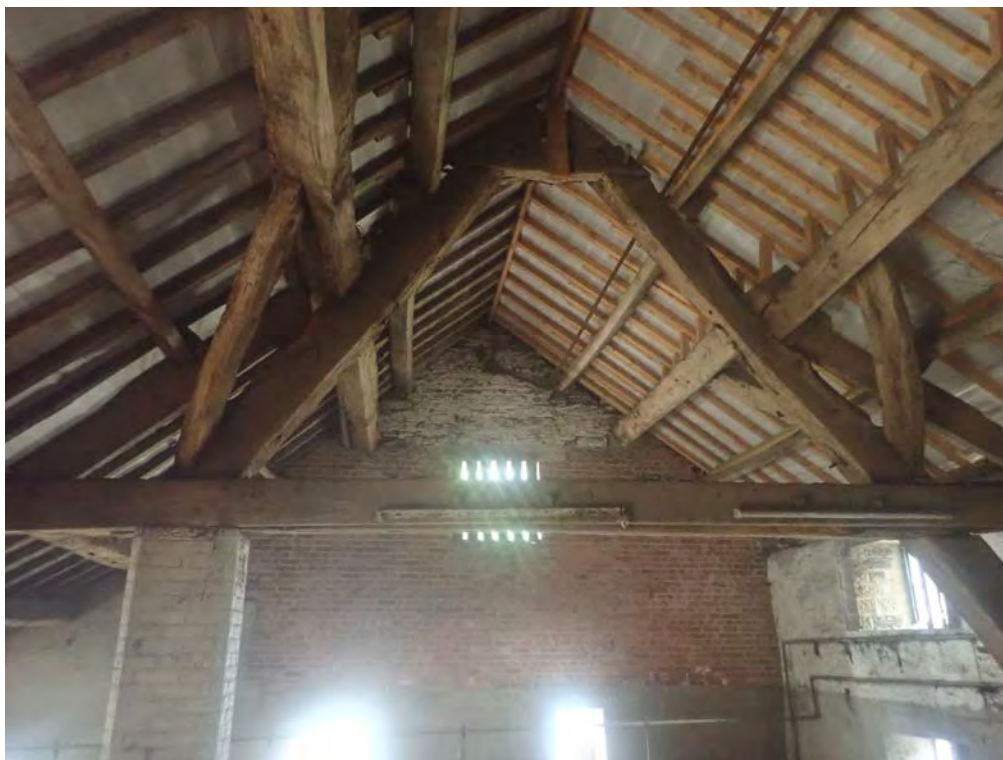
Photograph:4 Direction: SW  
Digital Ref: NEMB2\_0057

Each truss was comprised of pegged collared blades which extended from ridge to ground. The SE cruck blade of Truss 1 has been truncated below the tie beam and was supported by a chamfered brick pier (fig. 3g; Photograph 4). The SE cruck blade of Truss 2 extended the full length to the ground (figs. 3h and 4h; Photograph 26). However, both NW cruck blades were supported by the NW wall (Photographs 27 and 28). At the top, the blades met with a notable gap from which the former ridge beam had been replaced with machine-cut timbers (figs. 3g and 3h; Photograph 29). At approximately 1.5m high, both Truss 1 and 2 NW blades contained 0.3m high empty lap mortices on the NE faces (Photograph 30 and 28). The pegged double notched joint tie beams of each truss extended beyond the blades to the cruck base, joined to the blades at the NE faces. Between the tie beam and former ridge, each cruck supported pegged scarf joint historic purlins, however, additional machine-cut timbers were placed between to support machine cut rafters (Photograph 31). The historic purlins were secured to the blades through upward angled pegs (Photograph 32). The Bay 1

Description: Truss 1 NE face with brick pier at SE (left) and partially brick SW wall in background.

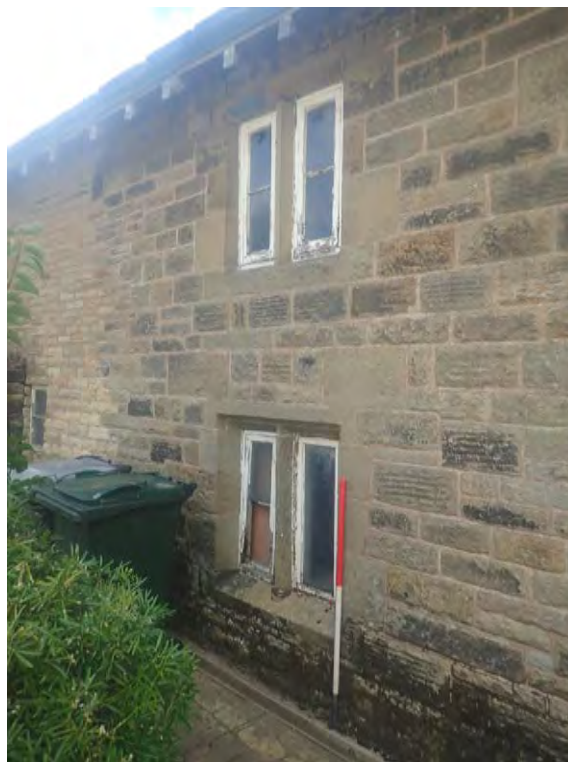
Photograph:5 Direction: E  
Digital Ref: NEMB2\_0016

Description: Detail of change in stone coursing and mullion windows on SW side of NW elevation.

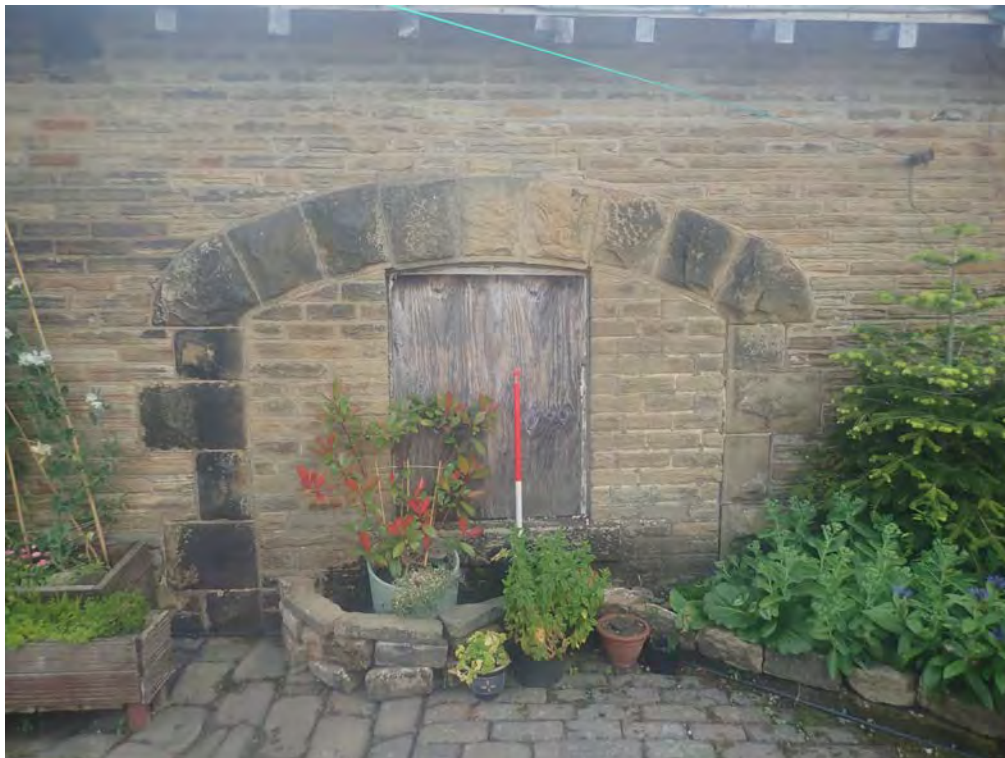
Photograph:8 Direction: SE  
Digital Ref: NEMB2\_0014

There was a 2.13m wide former cart door located just SW of the centre of the elevation (Photograph 8). The former door was headed with a rough-hewn sandstone segmental arch and alternating jamb stones. The doorway had been partially blocked by even courses of elongated sandstones that were slightly higher than the elevation courses. The centre of the arch contained a projecting sandstone cill below a 0.92m wide by 1.15m high window.

Description: Detail of blocked cart door in Bay 2 of NW elevation.

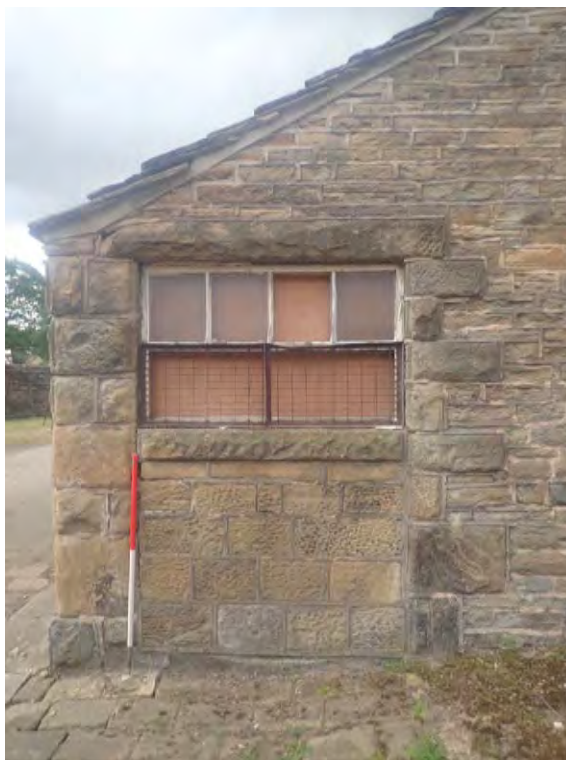
Photograph:9 Direction: SW  
Digital Ref: NEMB2\_0020

At the ground floor, the SE door measured 1.43m by 2.18m high and the NW door measured 1.27m by 2.3m high. The doors were separated by shared flush jamb stones at 0.74m between each surround. Both doors had flush sandstone lintels and cills. At the SE extent, the former door had been blocked in five even courses of punched sandstone beneath a projecting rough-hewn cill (Photograph 9). Unlike the two open doors, the jamb stones were not flush with the elevation and functioned as the SE

Description: Detail of partially blocked door and later window in SE extent of NE elevation with punched coursed stone infill below 1.1m. Jamb stones contemporary with quoins and slightly project from elevation.

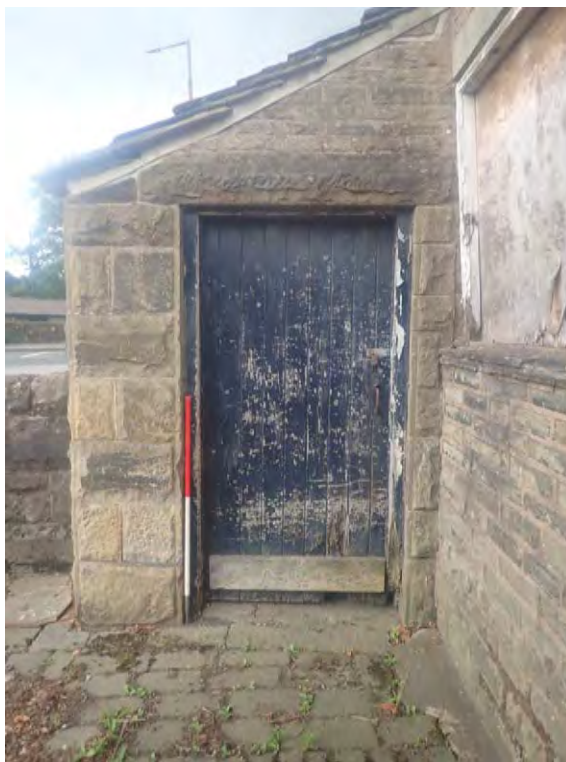
Photograph:11 Direction: SW  
Digital Ref: NEMB2\_0024

Description: NE elevation of SW outshut with sheaf roof, margined jamb stones and abutting SE elevation.

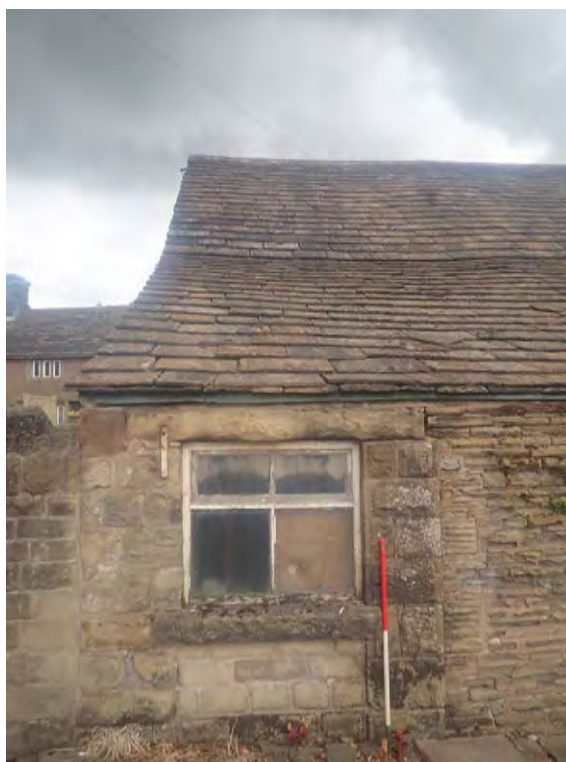
Photograph:12 Direction: NW  
Digital Ref: NEMB2\_0021

At the SW extent was a former doorway and present 1m by 1m window, headed with a flush sandstone lintel and surrounded by jamb stones which matched the quoins (Photograph 12). To the immediate NE were large, furrowed sandstones flush with the elevation. Below the projecting sandstone cill were four even courses of stone. The window was a timber framed, four pane, top opening pivot. A second similar window was located 2.3m to the NE, measuring 0.85m by 1m high with a flush sandstone header and rough-hewn slight projecting sandstone cill (Photograph 13). There were two identical windows on the NE outshut, with a slight difference of two-course high stones below each cill extent (Photograph 14). There were four evenly spaced terra cotta vents surrounding the furthest NE window.

Description: Detail of partially blocked door and later window in SW extent of SE elevation with margined jamb stones at NE that do not match combination jamb quoins at SW. Raked stones within coursing.

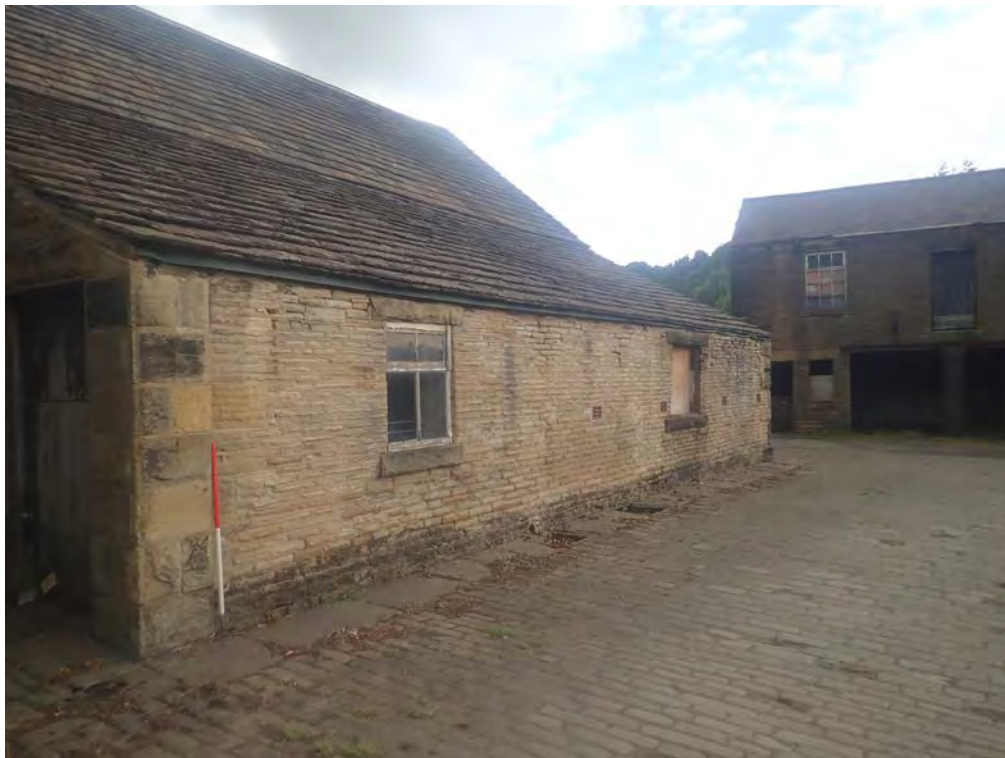
Photograph:14 Direction: NE  
Digital Ref: NEMB2\_0026

Description: SE elevation of NE outshut with two windows and slight ripple at place of internal wall. Large raked stones set within coursing to the immediate NE of quoin pier.

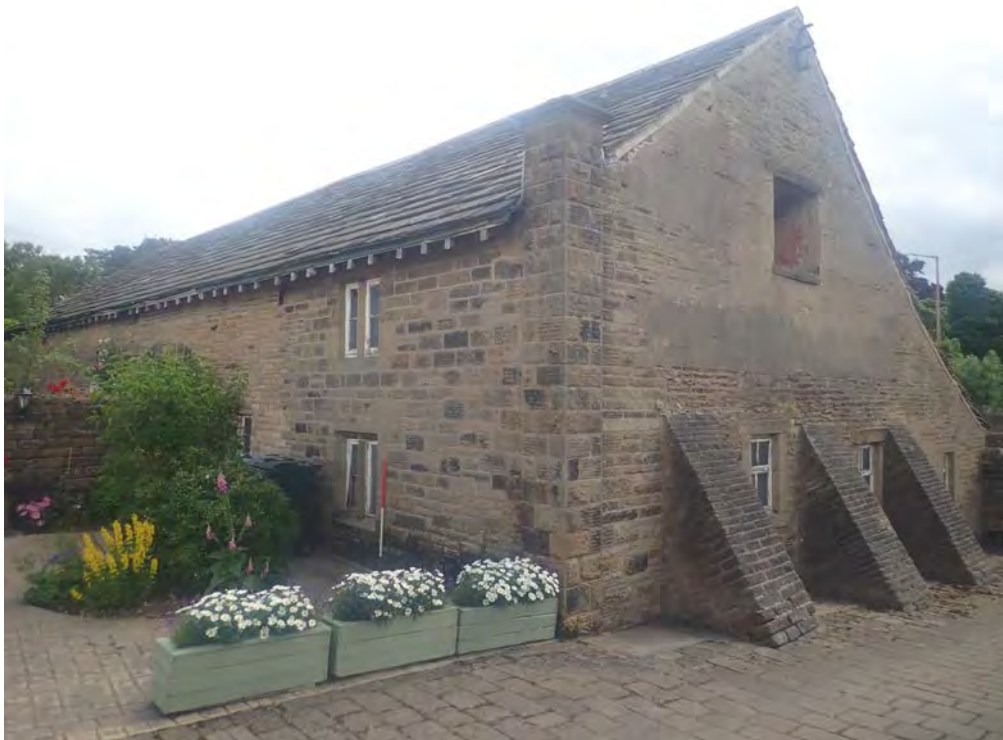
Photograph:15 Direction: E  
Digital Ref: NEMB2\_0006

Description: West corner with SW elevation (right) and NW elevation (left). Buttresses against SW gable. Change in stone coursing just NE of mullion windows. Chimney or pier on west corner.

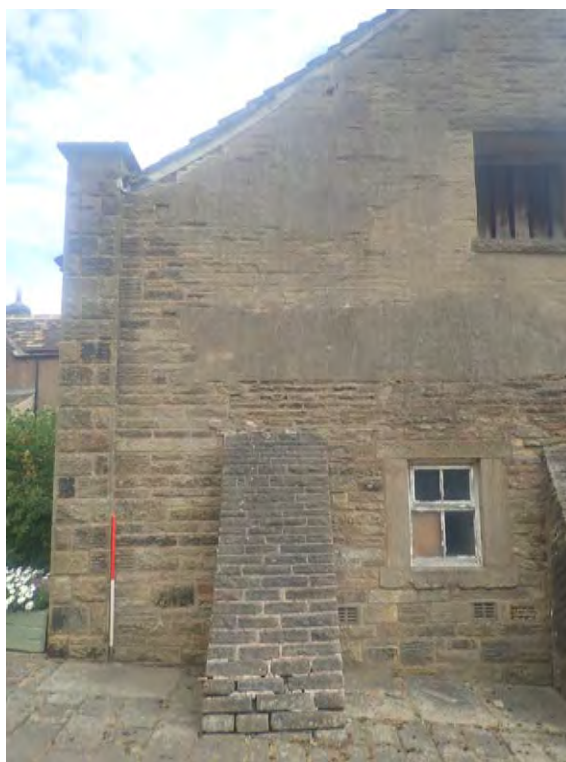
Photograph: 16 Direction: NE  
Digital Ref: NEMB2\_0017

The elevation coursing was partially rendered in a middle area from approximately 2.7m high to 5m high. While the elevation coursing was generally the elongated sandstone found throughout the Barn, the coursing from the central buttress to the chimney at the NW was comprised of uneven courses of varying stones with rough-hewn or furrowed finishes (Photograph 16).

Description: Detail of change in stone coursing, chimney or pier, buttress, and window on NW side of SW elevation.

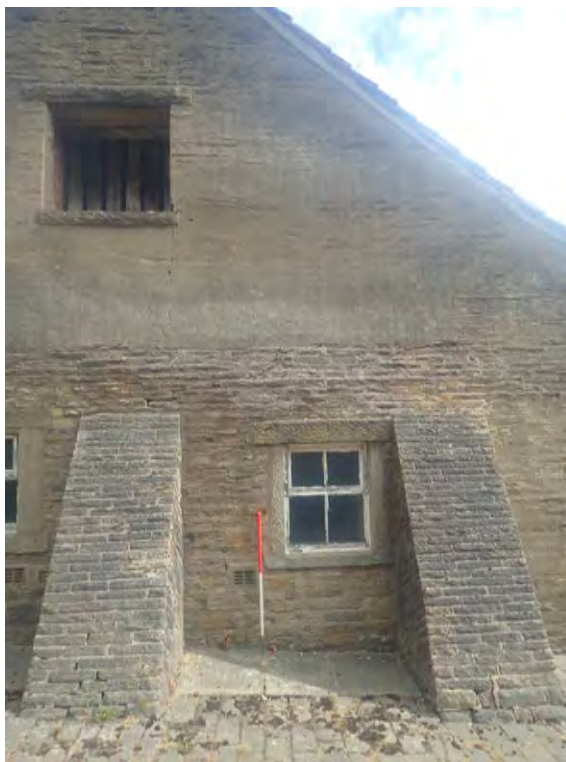
Photograph:17 Direction: NE  
Digital Ref: NEMB2\_0019

Description: Detail of window between buttresses in SW elevation with punched lintel, cill, and vertical jamb stones.

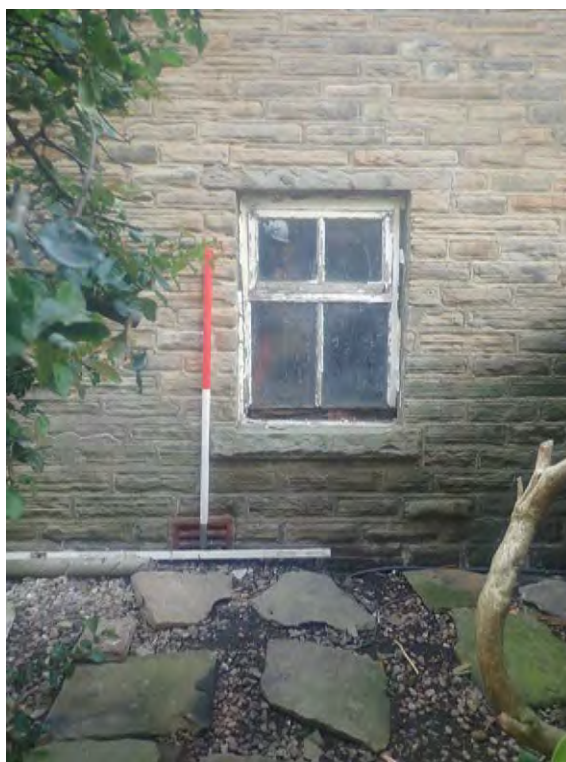
Photograph:18 Direction: SE  
Digital Ref: NEMB2\_0011

Including the window within the arch, there were a total of seven windows of varying sizes and types across the elevation. The two ground floor windows at the furthest NE were generally identical to those found on the SE elevation (Section 5.2.1; Photograph 18). To the SW the ground floor window was wider, measuring 10.84m by 0.86m high and was fitted with a six-pane timber frame. To the immediate SW of the projecting wall there was a 0.4m by 0.6m high two-pane picture window (Photograph 19). There was a straight joint and vertical stone directly above the SW window extent. At the furthest SW, within the uneven coursing, there were two stone mullion, timber framed, casement and picture windows aligned at the ground floor and first floor (Photograph 5).

Description: Four-pane top opening window in NW elevation with thin lintel, projecting cill, and vent below.

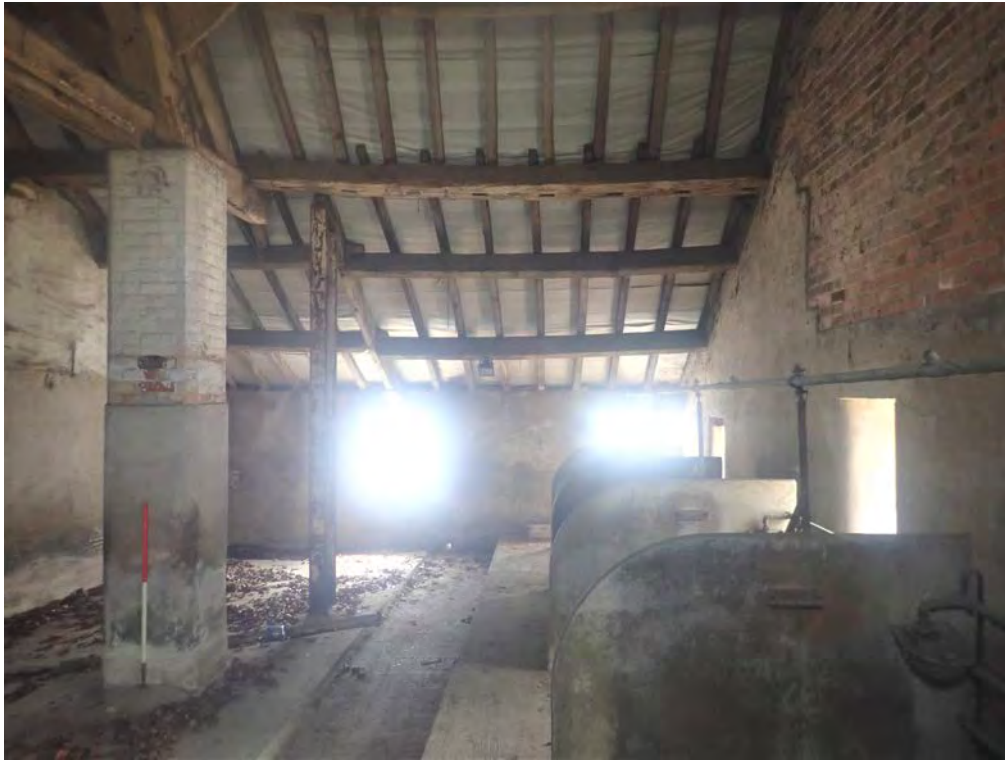
Photograph:21 Direction: SE

Description: SE view of Bay 1 with brick pier below Truss 1 to NE (left) and steel I-beam in background. Bay 1 SE wall-plate with mortices in soffit.

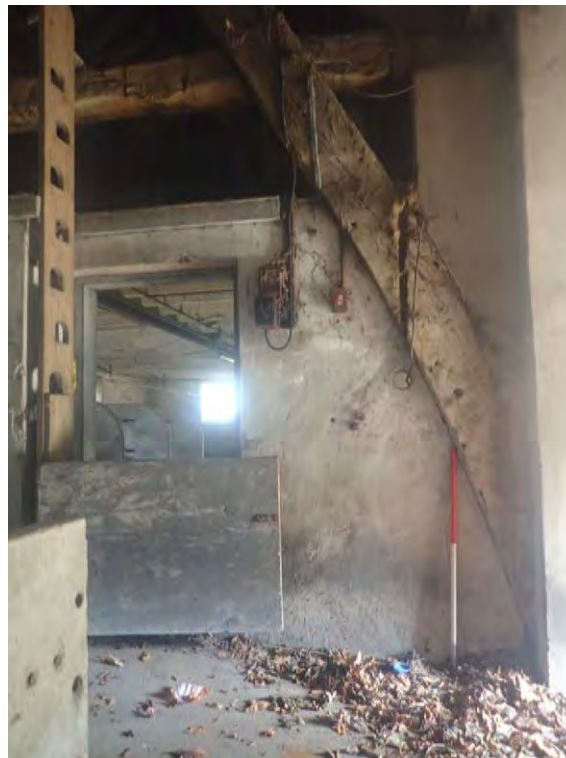
Photograph:26 Direction: NE  
Digital Ref: NEMB2\_0054

Description: Truss 2 SE cruck blade to ground level with vertical groove. Single storey internal wall constructed within cruck blade with loft above. Door to area below loft and ladder to loft at NW (left).

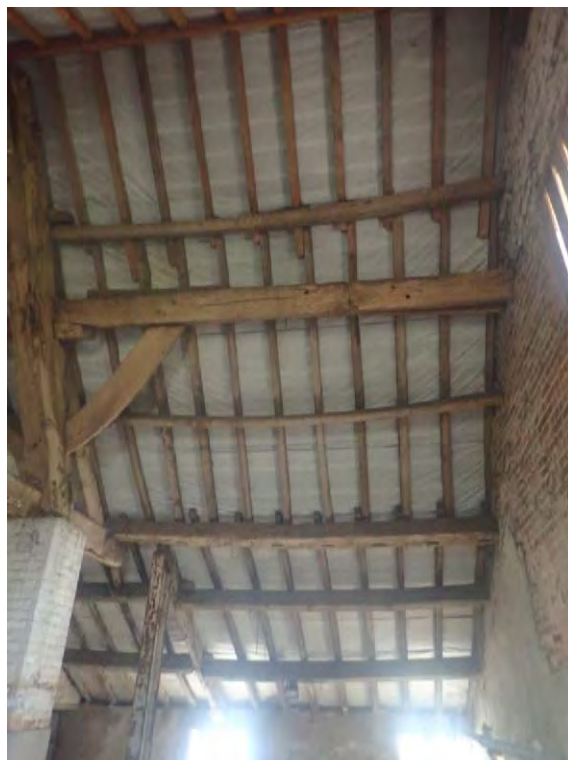
Photograph:33 Direction: SE  
Digital Ref: NEMB2\_0071

Description: Bay 1 SE roof timbers with peg holes on SW side of purlin suggesting former cruck at SW wall. Timbers set directly into wall.

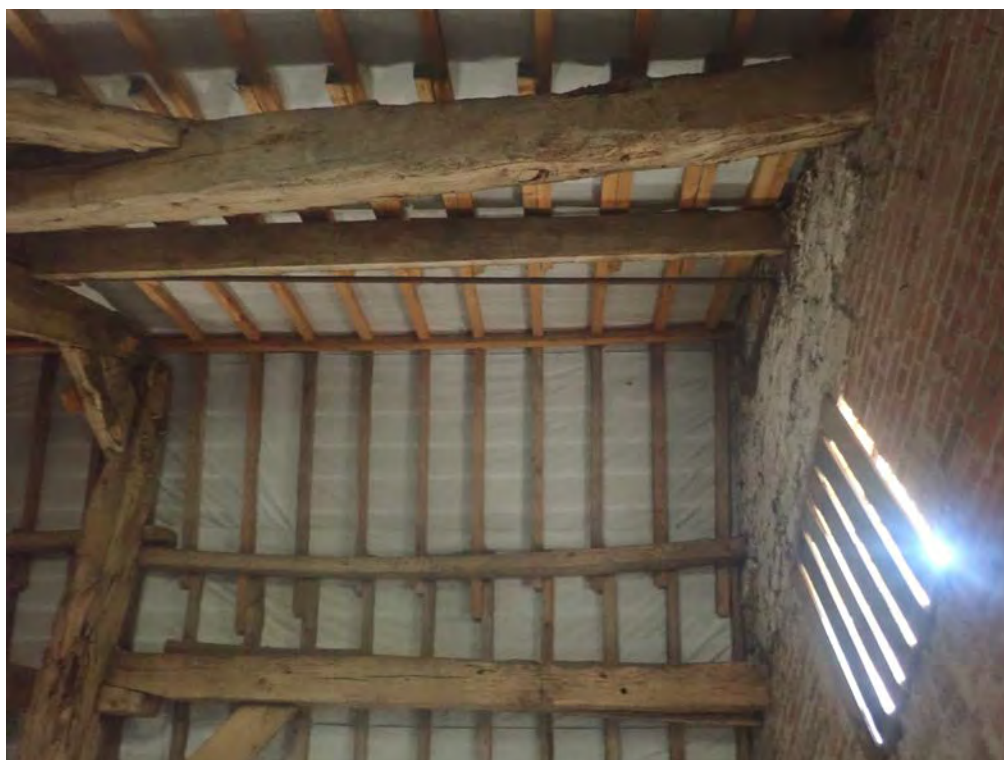
Photograph:34 Direction: SE  
Digital Ref: NEMB2\_0072

Description: Bay 1 NW roof timbers with peg holes and mortice on SW side of purlin suggesting former cruck at SW wall. Timbers set directly into wall.

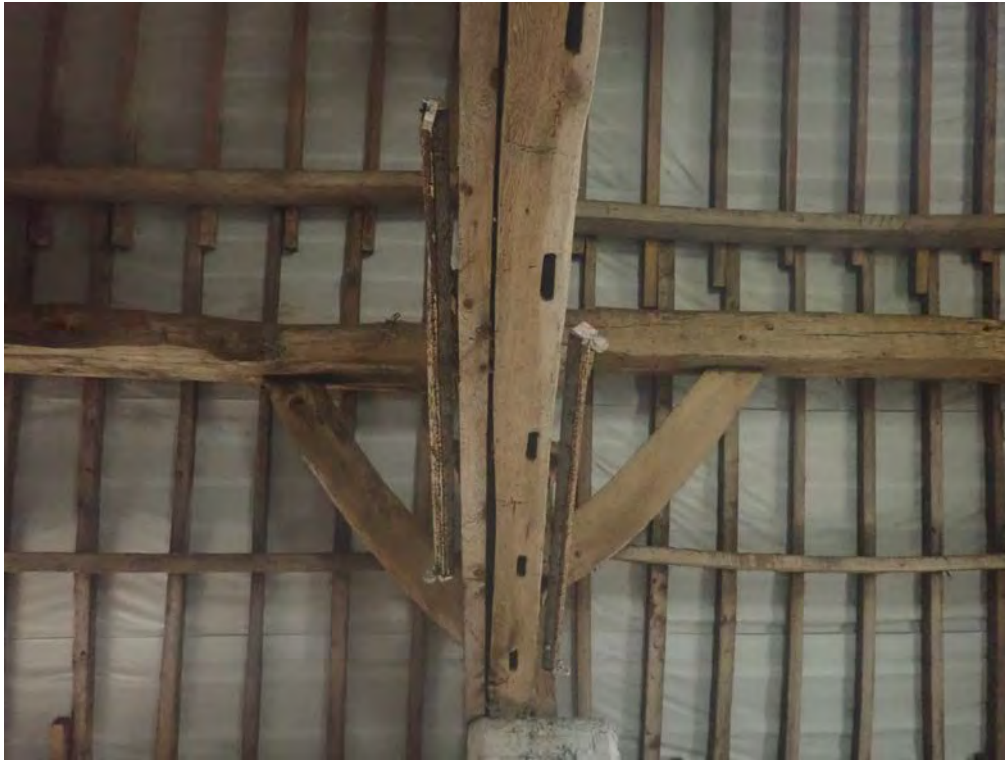
Photograph:37 Direction: NW  
Digital Ref: NEMB2\_0066

Description: NW view below Truss 1 NW showing relationship between Bay 1 and Bay 2 upward braces and purlins. Details of soffit motrices.

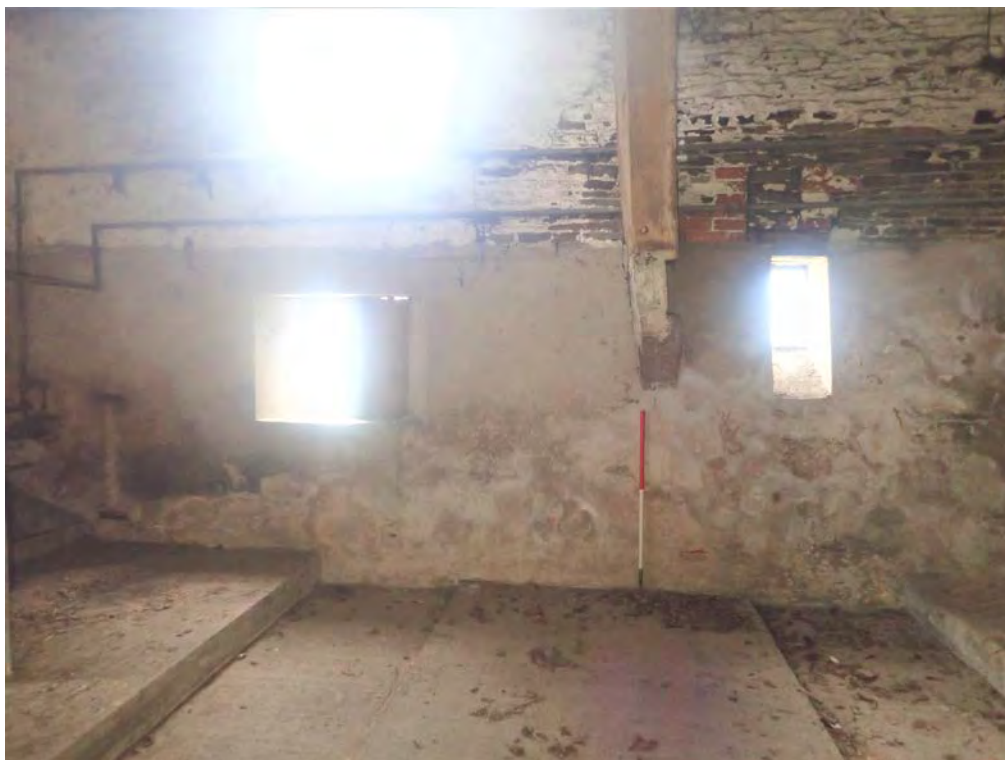
Photograph:38 Direction: NW  
Digital Ref: NEMB2\_0033

Description: SW extent of NE wall with Truss 1 set between windows. Brickwork to immediate NE of Truss 1.

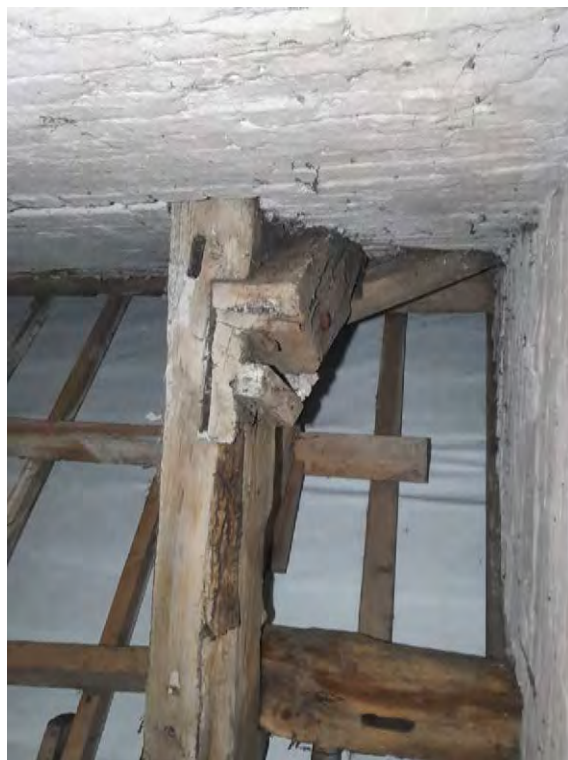
Photograph:47 Direction: SE  
Digital Ref: NEMB2\_0111

Description: SE extent of Truss 3 tie beam and sawn cruck blade with mortice through brick wall (right). Tie beam has surviving bark and mortice in soffit. Bay 3 wall-plate to SW (right) with morice in soffit.

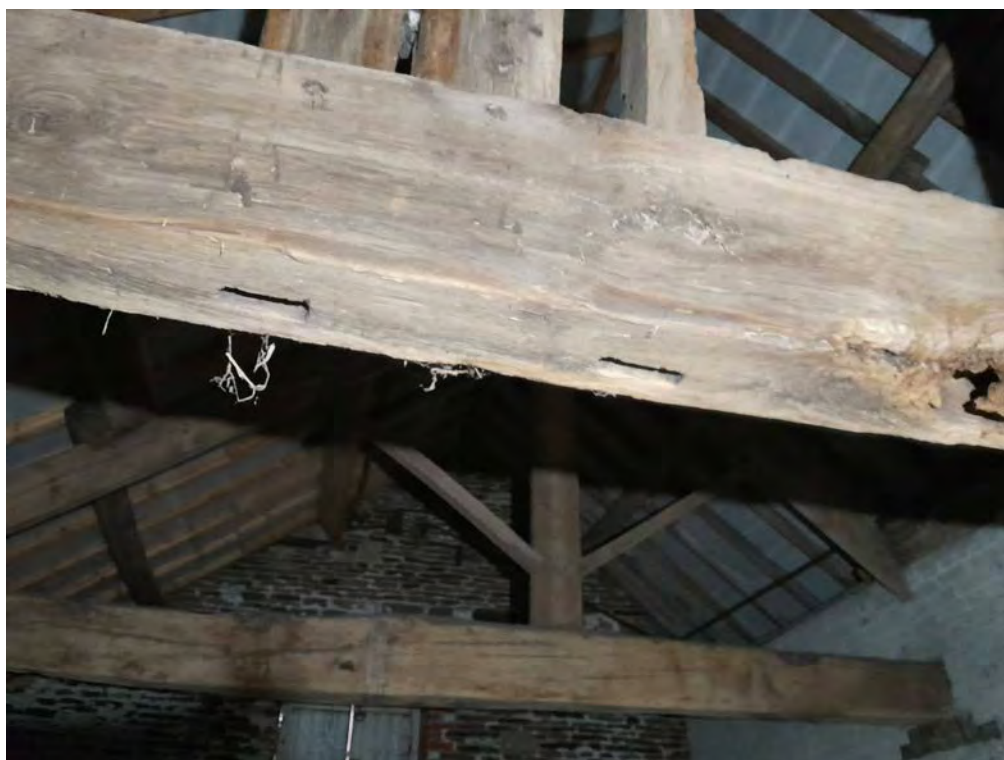
Photograph:48 Direction: NE  
Digital Ref: NEMB2\_0131

Description: Detail of tie beam soffit mortices of Truss 3

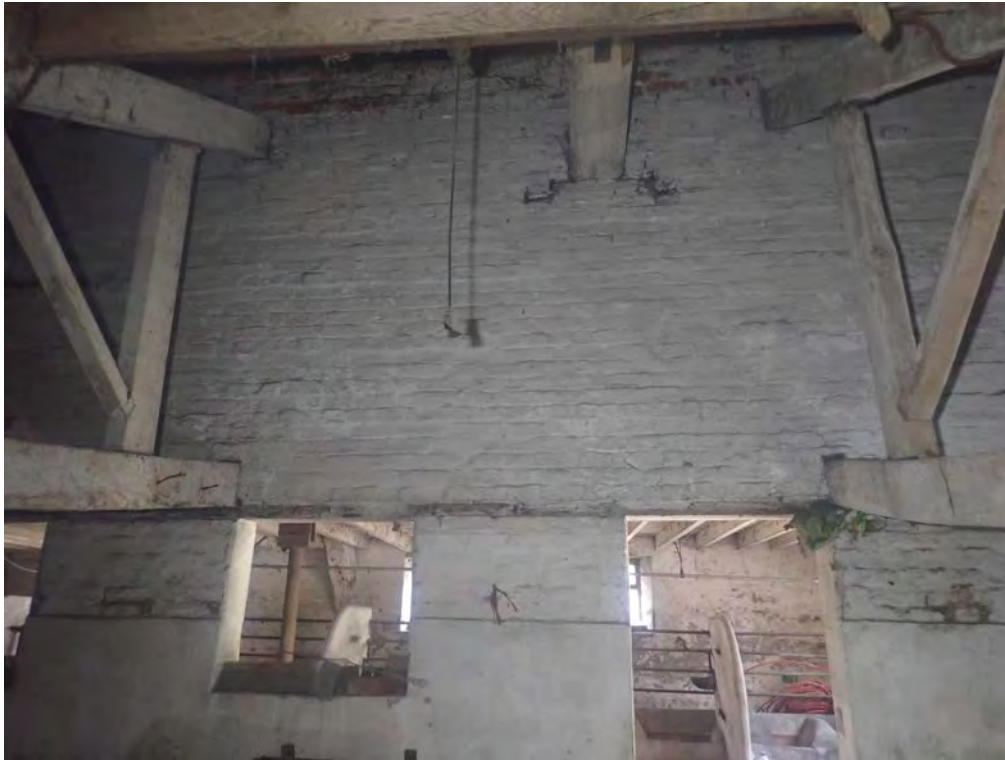
Photograph:49 Direction: NW  
Digital Ref: NEMB2\_0103

The shed roof was supported by two king post and strut mono trusses (Photograph 66). The trusses were supported by the timber plank in the NW wall and fitted between stones in the top course of the SE wall (Photograph 49). The soffit of each truss rafter contained Baltic marks (Photographs 67 and 68). The tie beam, cruck blade, and brace of Truss 3 protruded 1.55m SE from approximately 3.4m high from the NW wall and supported 0.88m of the Bay 3 SE wall-plate (figs. 3i and 4a; Photograph 46). The tie beam of Truss 4 similarly protruded at approximately 3.8m high (Photograph 52).

Description: Upper area of Area C and Area D dividing wall showing relationship between NW outshot trusses, Truss 4 tie beam, door and window with timber plank lintel between.

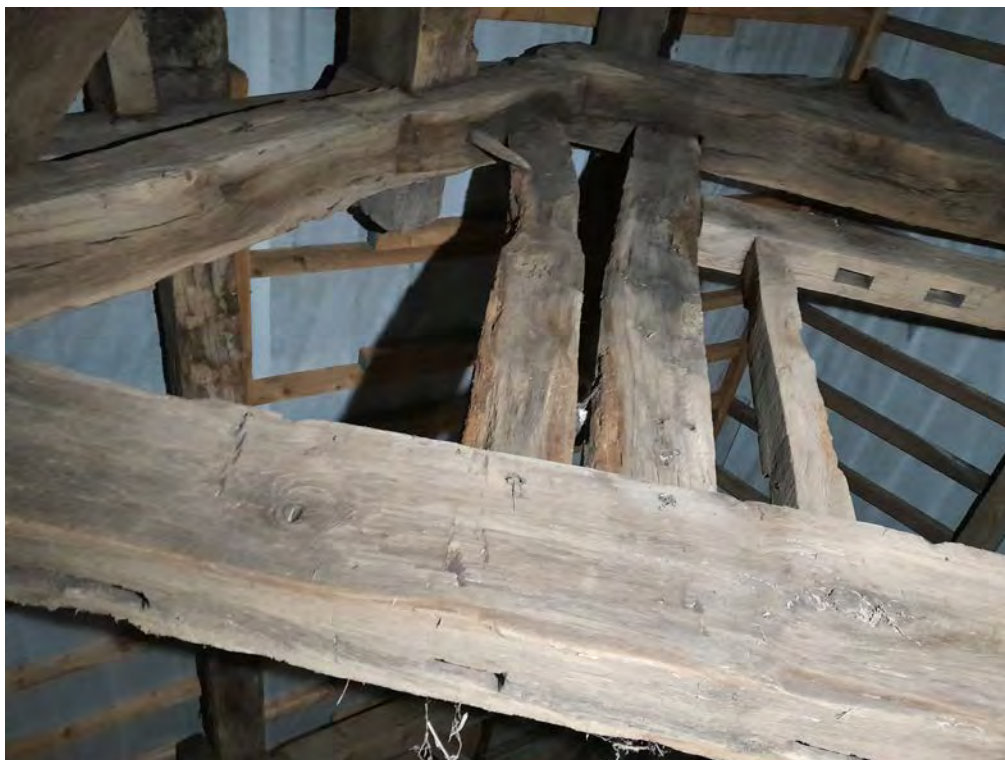
Photograph:50 Direction: NE  
Digital Ref: NEMB2\_0128

Description: General upward view of SW face of Truss 3 showing surviving pegs through NW cruck blade soffit and Bay 3 purlin.

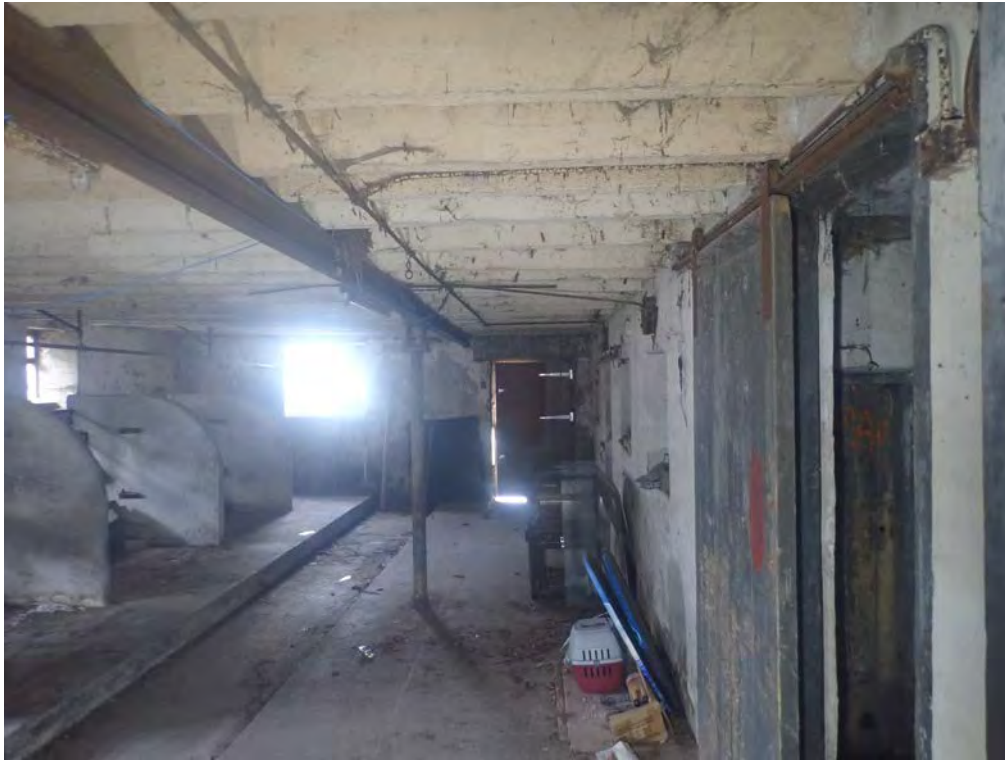
Photograph:53 Direction: E  
Digital Ref: NEMB2\_0084

Description: General eastern view of space under loft (Area C) with external door in NE wall, door to NE outshut in foreground (right), steel I-beam and pole, and ceiling joists above.

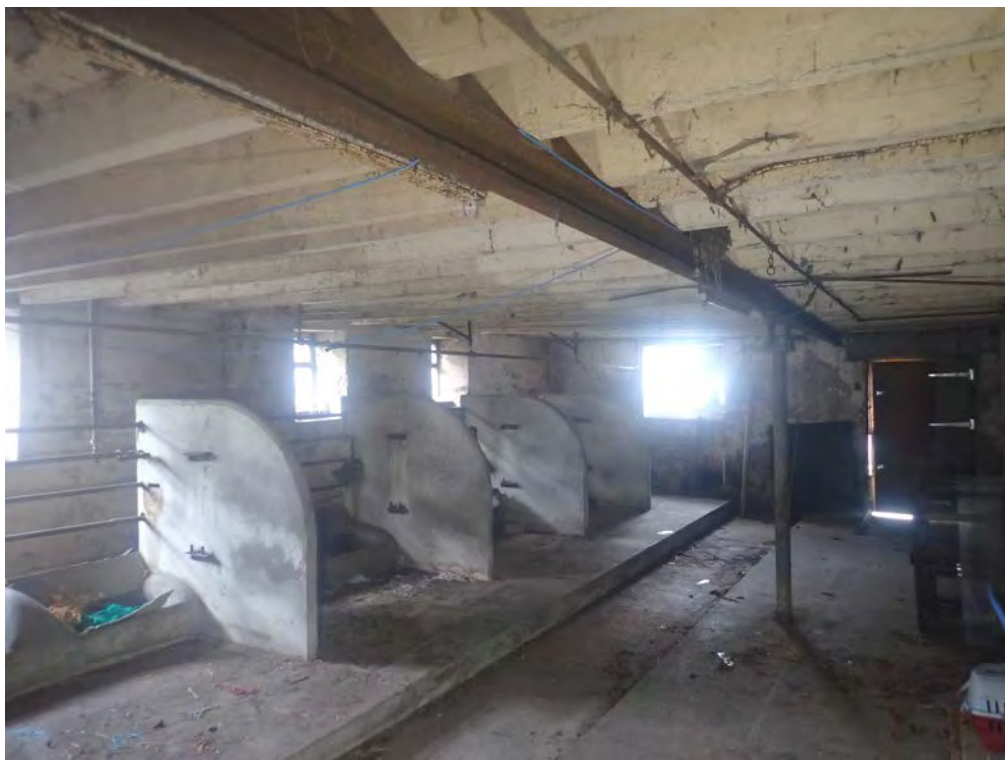
Photograph:54 Direction: N  
Digital Ref: NEMB2\_0085

Approximately 1.52m NW of the SE wall there was a 6cm wide steel I-beam which ran the full length of the room on a NE-SW orientation (fig. 3a; Photograph 54 and 56). The I-beam was supported by a central steel pole. Florescent lights were fitted to the beam.

Description: General northern view of space under loft (Area C) with external door in NE wall, windows in NW wall and cow stalls and troughs (left), and ceiling joists above.

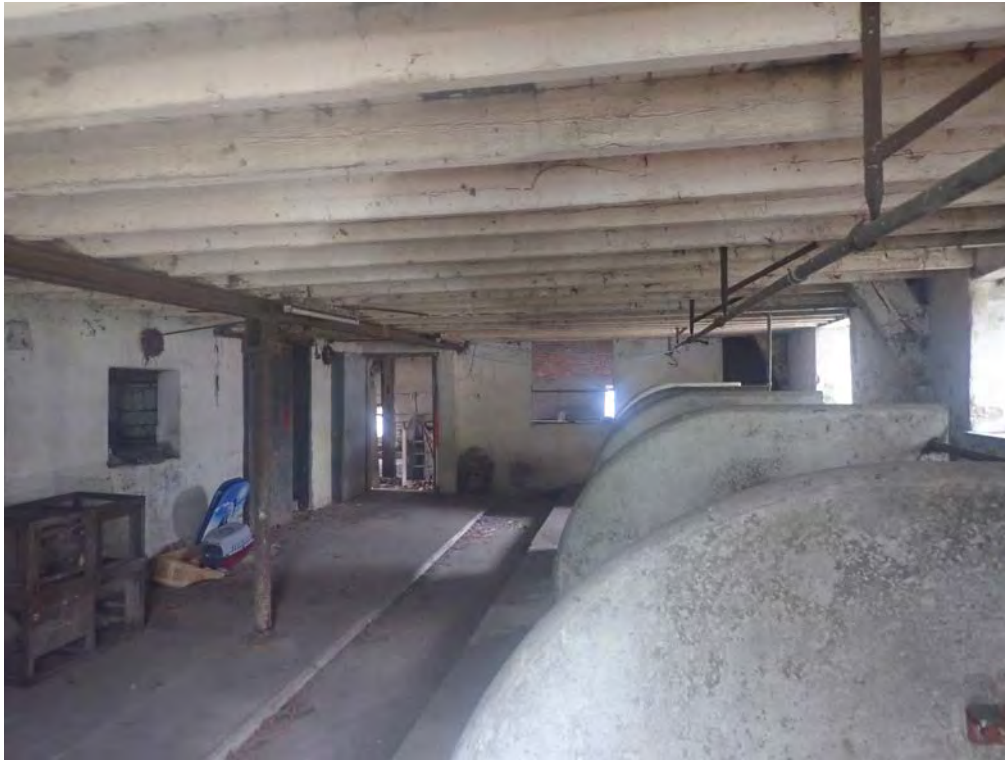
Photograph:55 Direction: SW  
Digital Ref: NEMB2\_0086

The walls were comprised of white rendered stone at the NW and NE and white rendered brick at the SW and SE. The NW wall supported the cruck bases of Truss 2 and Truss 3 (Photographs 28 and 55). The loft was supported by NW-SE oriented machine-cut timber floor joists spaced approximately 0.5m to 0.6m apart and inserted directly into the walls (Photograph 56).

Description: General SW view of space under lof (Area C) with doors and open window to Bay 2 (Area A) in background. Truss 2 and Truss 3 NW cruck blades in wall (right) with rail mortices in NE face.

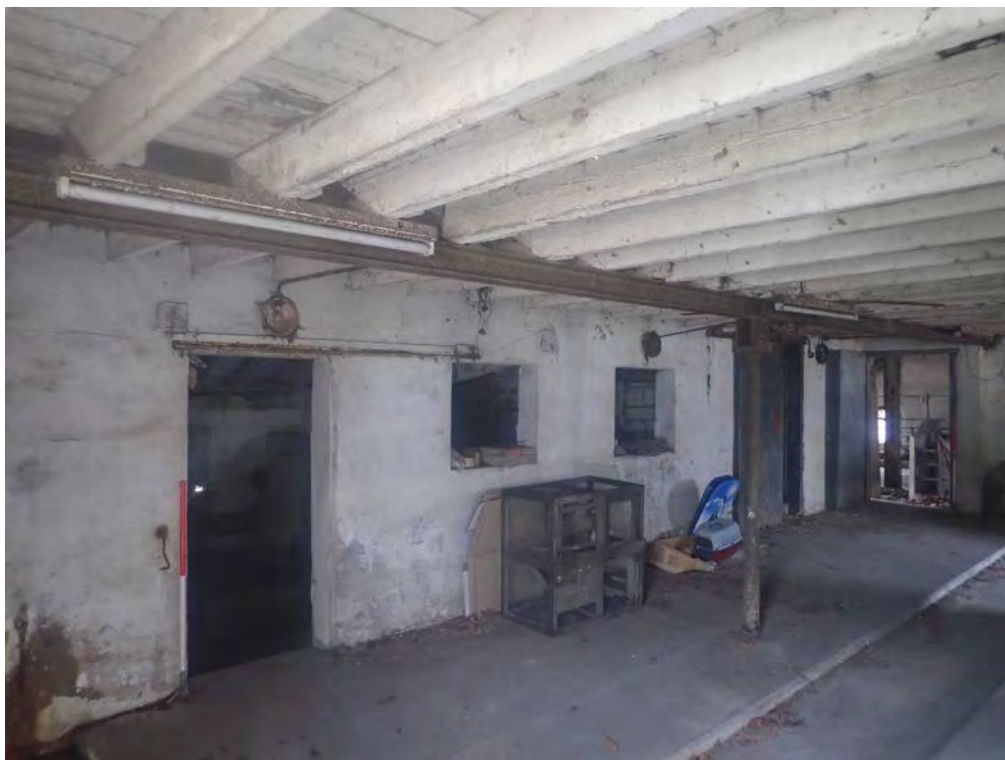
Photograph:56 Direction: S  
Digital Ref: NEMB2\_0087

Description: General southern view of internal dividing wall between Area C and Area D with open windows and two doors. Floor joists inserted directly into wall. Floor joists overlap above steel I-beam.

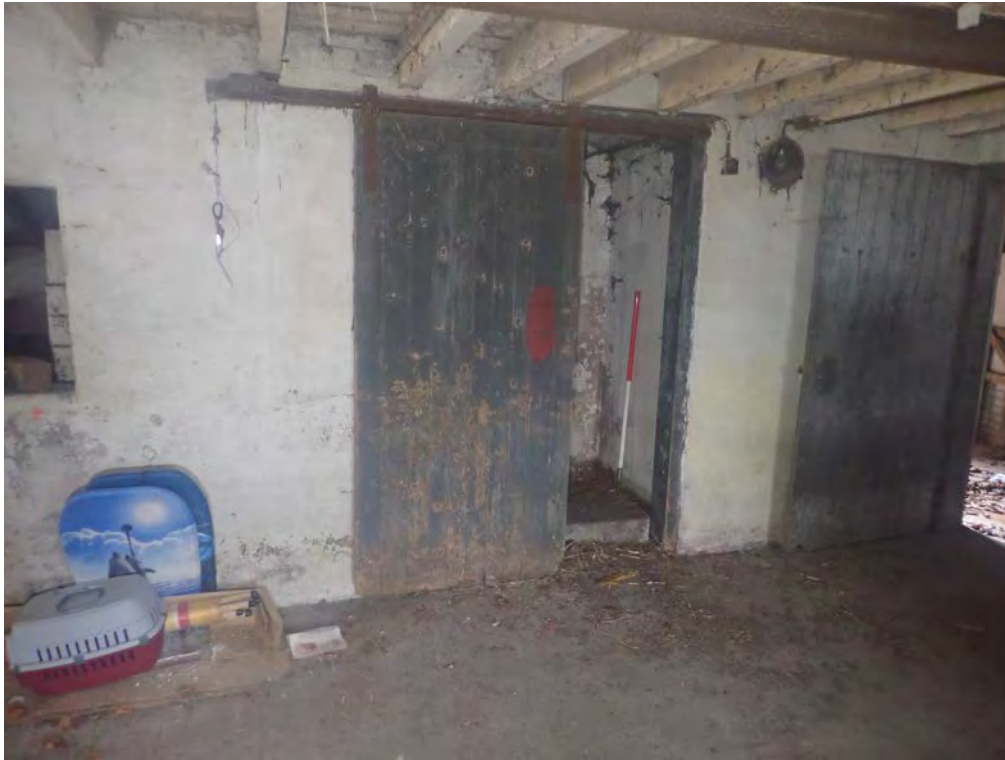
Photograph:57 Direction: S  
Digital Ref: NEMB2\_0088

Description: Detail of SW sliding door in internal dividing wall between Area C and Area D into passageway area.

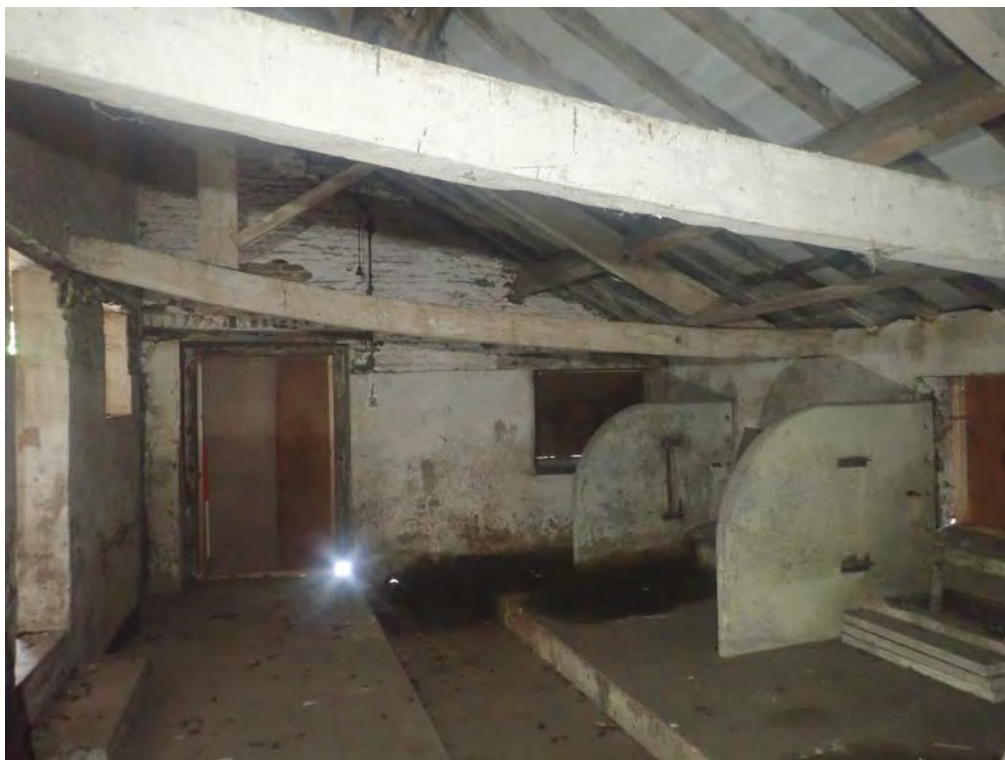
Photograph:58 Direction: NW  
Digital Ref: NEMB2\_0091

Description: General internal NE view of NW outshut (Area D) with doorway and partially blocked doorway window in NE wall. Bend in softwood trusses.

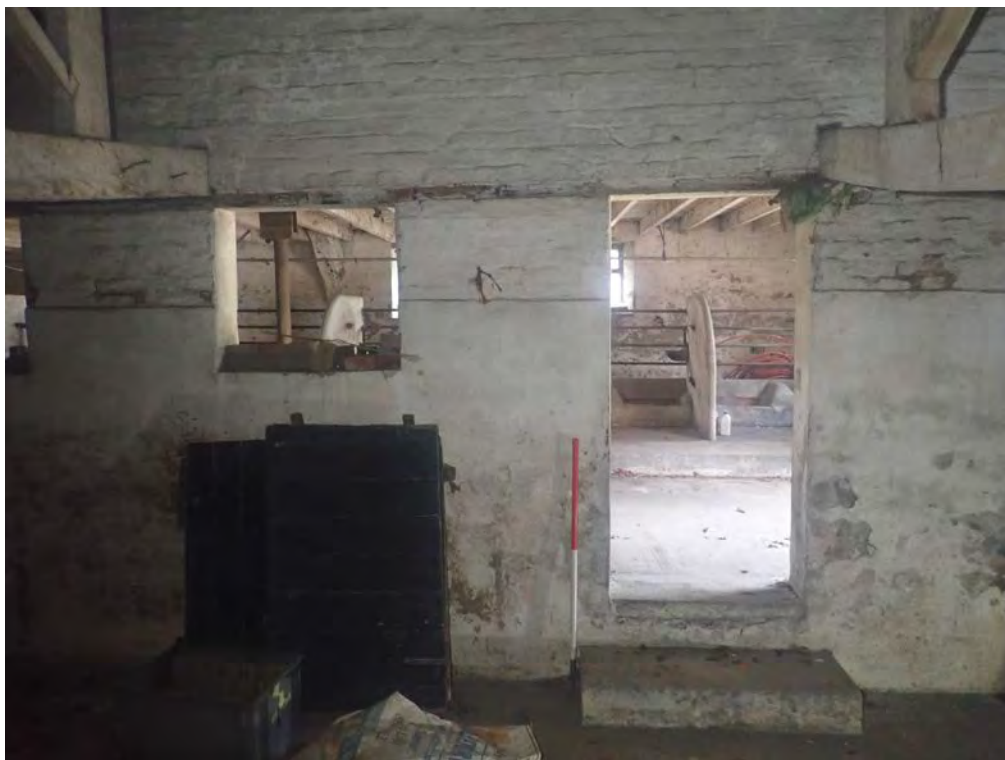
Photograph:60 Direction: NW  
Digital Ref: NEMB2\_0102

Description: Door and window of Area C and Area D dividing wall with level change. Both openings utilise single timber as lintel which NW outshut trusses are set on.

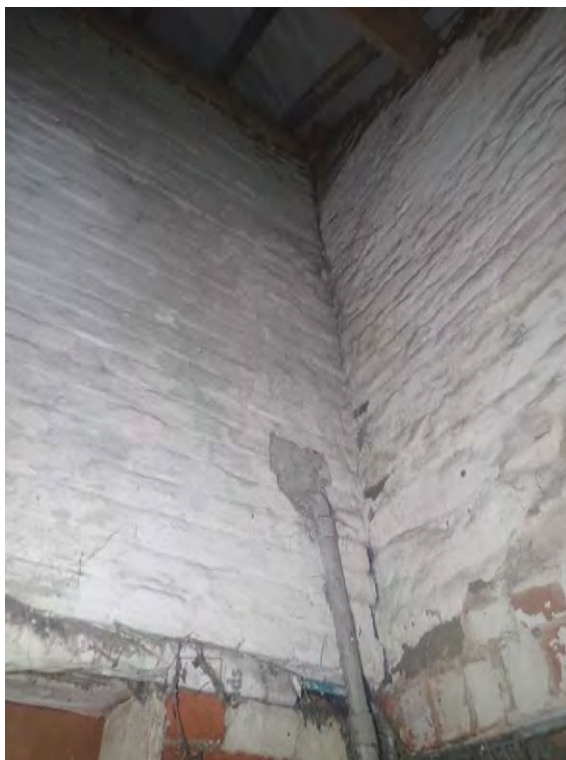
Photograph:61 Direction: N

Description: Internal brick wall (left) appears to abut external NE wall (right) with no clear tie ins.

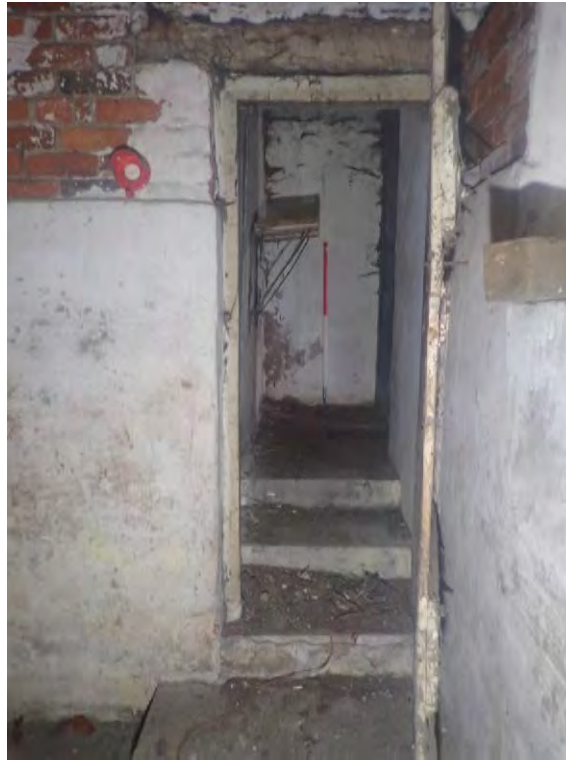
Photograph:63 Direction: SW  
Digital Ref: NEMB2\_0104

The NW extent of the SW wall had a door with a timber lintel which accessed a narrow passageway to **Area C** (Photographs 62 and 63). The passageway footprint measured 2.25m by 0.73m and had steps that descended approximately 0.2m from **Area C**. There was a second doorway from **Area C** towards the NE of the NW wall (Photograph 60). There was an external door in the NW extent of NE wall with had a timber lintel below a row lock brick course (Photograph 58).

Description: Doorway in SW wall of NW outshut (Area D) with timber lintel with steps up to level change.
