**Nether Mill Barn  
Penistone  
South Yorkshire**

Level 3 Historic Building Recording  
Report No. Y582/22

**Report No. Y582/22**

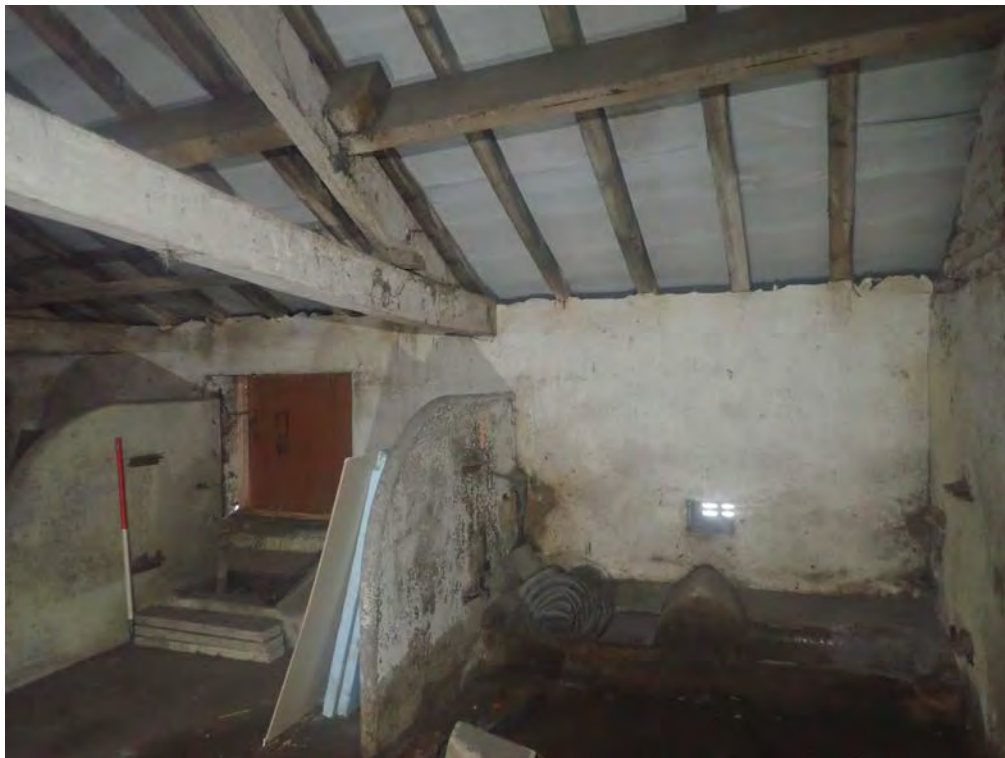
Photograph:64 Direction: W  
Digital Ref: NEMB2\_0092

There was a single window in the centre of the SE wall (Photograph 64). A partially blocked doorway which functioned as a window was located in the SE extent of the NE wall (Photograph 65). The former doorway was headed by timber lintel and had a heavy chamfer on the NW surround.

Description: General internal view of SW side of NW outshut (Area D) with central window (left) and truss tie directly on top course in SE wall.

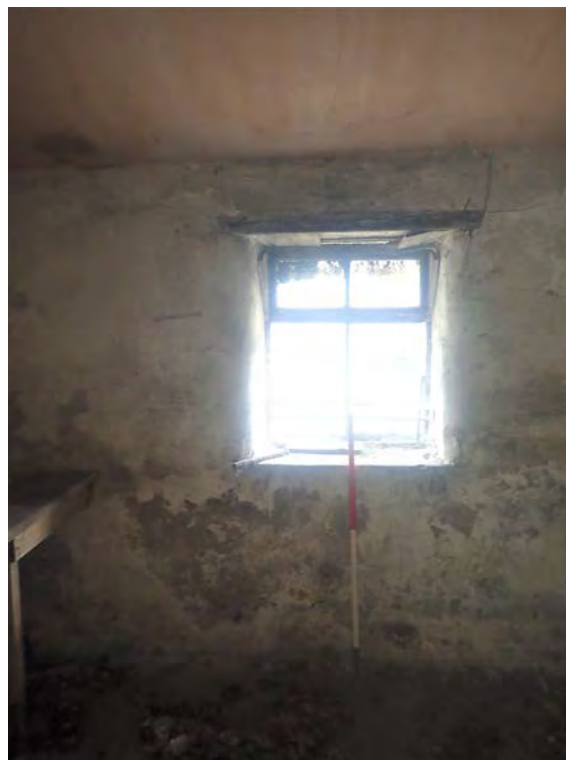
Photograph:70 Direction: SE  
 Digital Ref: NEMB2\_0121  
 Description: Window in centre of SE wall of Area E within NE outshut.

The NW and NE walls were heavily rendered with brick exposed above the false ceiling. There was a single central window in the SE wall with a timber plank lintel and chamfered surrounds (Photograph 70). The Bay 3 SE wall-plate was to the immediate SE of the NW wall (Photograph 71). The wall-plate soffit had identical mortices as the Bay 1 and Bay 2 wall-plates (Section 5.3.2).

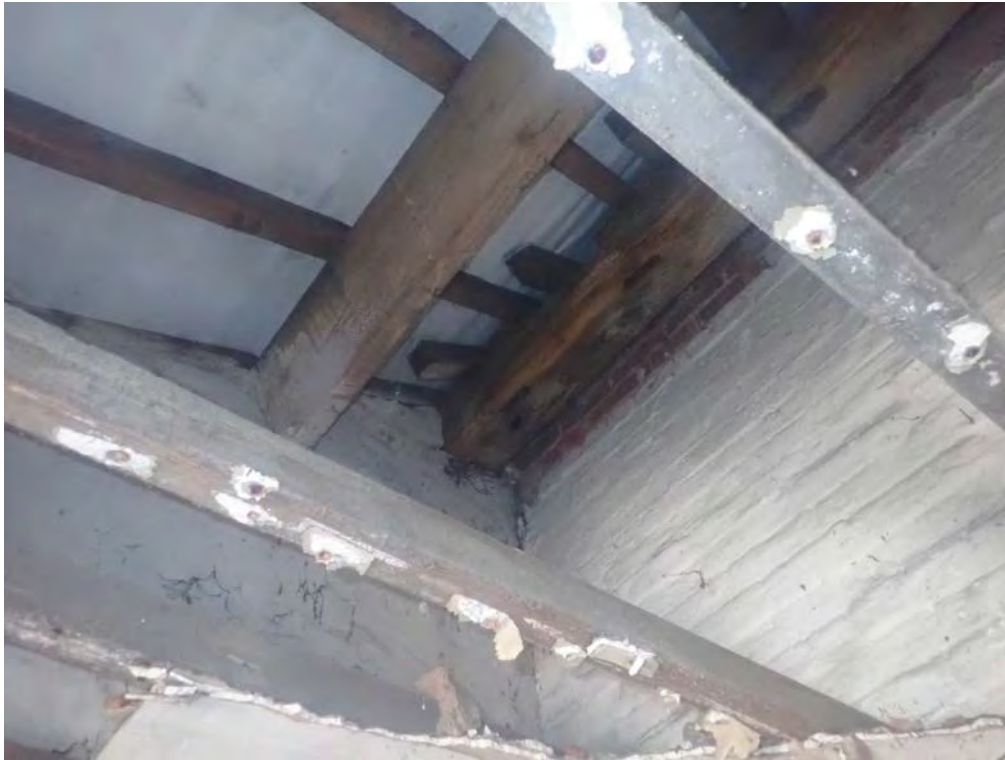
Photograph:71 Direction: W  
Digital Ref: NEMB2\_0117

Description: Bay 3 SE wall-plate to immediate SE of NW wall of Area D in NE outshut. Wall-plate has mortices in soffit.

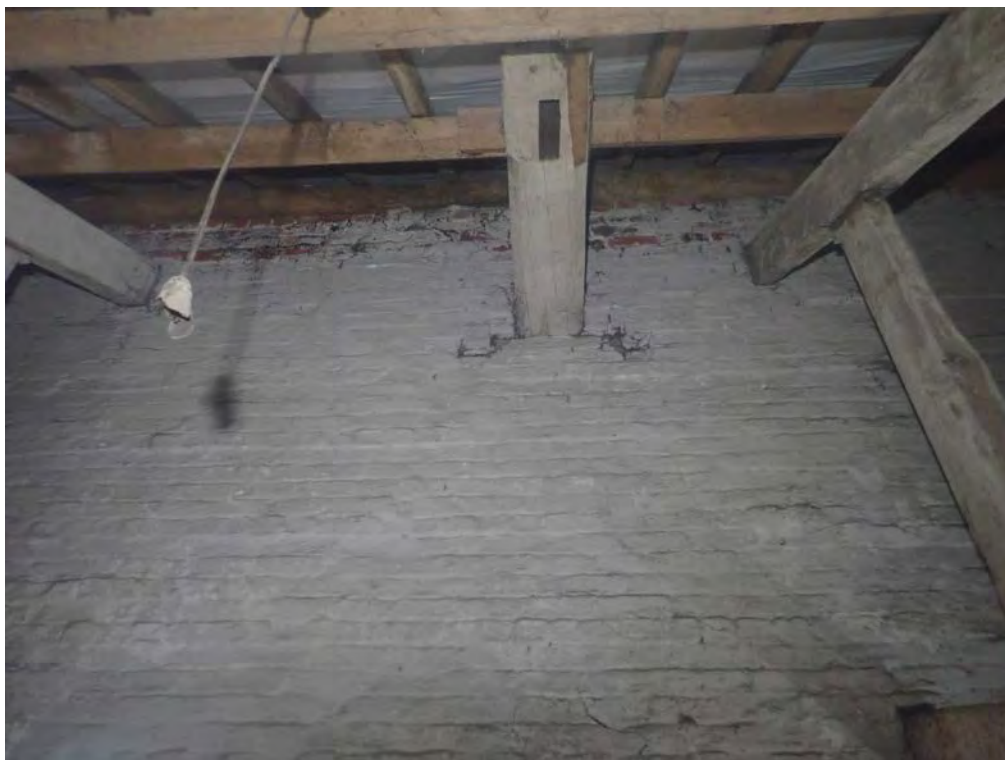
Photograph:72 Direction: NW  
Digital Ref: NEMB2\_0101

The Barn may have been extended to the NE around the same time or shortly after the construction of the SW outshut within the *second* or *third* construction *phase*. This was likely contemporary to the partial reconstruction of Truss 3 (figs. 3i and 4i; Section 5.3.3). The length of the Truss 4 tie beam aligns with the SE wall-plates and SE soffit mortice suggest the beam was formerly supported by a post to suggest it aligned with the former bays and may have contained a continued wall (figs. 3b and 4b; Photograph 72).

Description: SE extent of Truss 4 tie beam with single mortice in soffit extent indicating former post.
