Belle Green Court Care Home, Cudworth

Bat Survey Report

24th January 2024

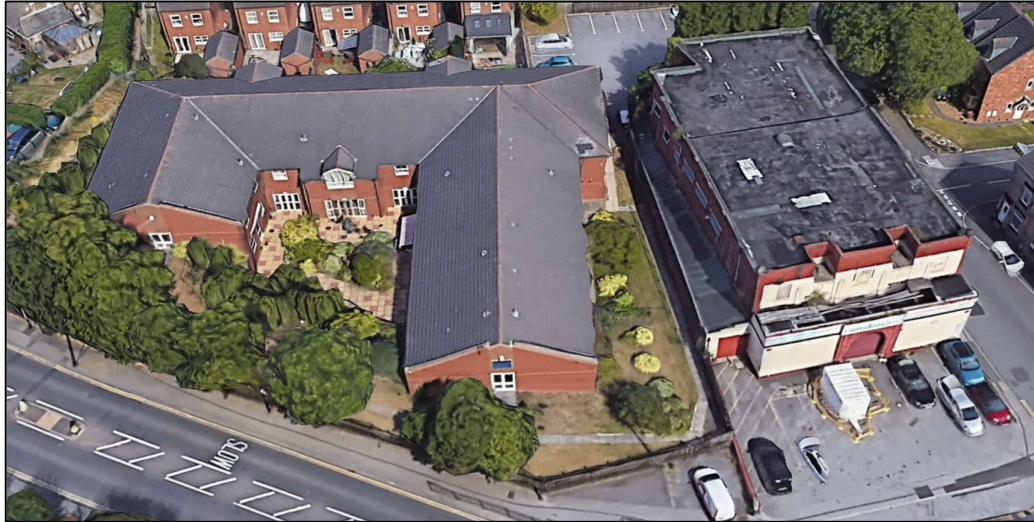
- 5.2.6 The care home was a brick-built building with a multi-pitched roof. The building was built in a 'J' shape with a hipped roof at the southeast, and northeast corners and gables present at the two western ends (Plate 1). The gables had a small parapet covering most of the end of the roof with a gap at the apex where the mortared verge could be seen (Plate 2). The roof was covered with interlocking concrete tiles. Valleys were lined with lead. Soffit boxes were present, they included a ventilation strip along the outer edge of the base which was lined with insect mesh.

Plate 1. Google Earth birds eye view of the care home (left) and cinema (right) viewed from the west

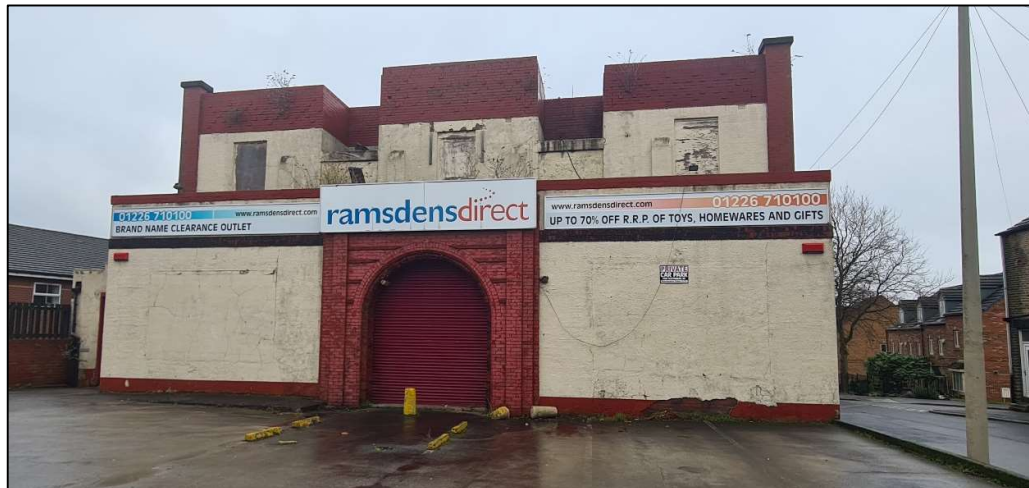
roofing felt. Parapet walls surrounded the roof. A single storey foyer was present on the front of the building. This section also had a flat roof (Plate 5).

Plate 5. The façade of the former cinema (viewed from the west)

5.2.14 The windows were framed with wood and mostly boarded up. The doors had metal roller door shutters with the original wooden doors behind.

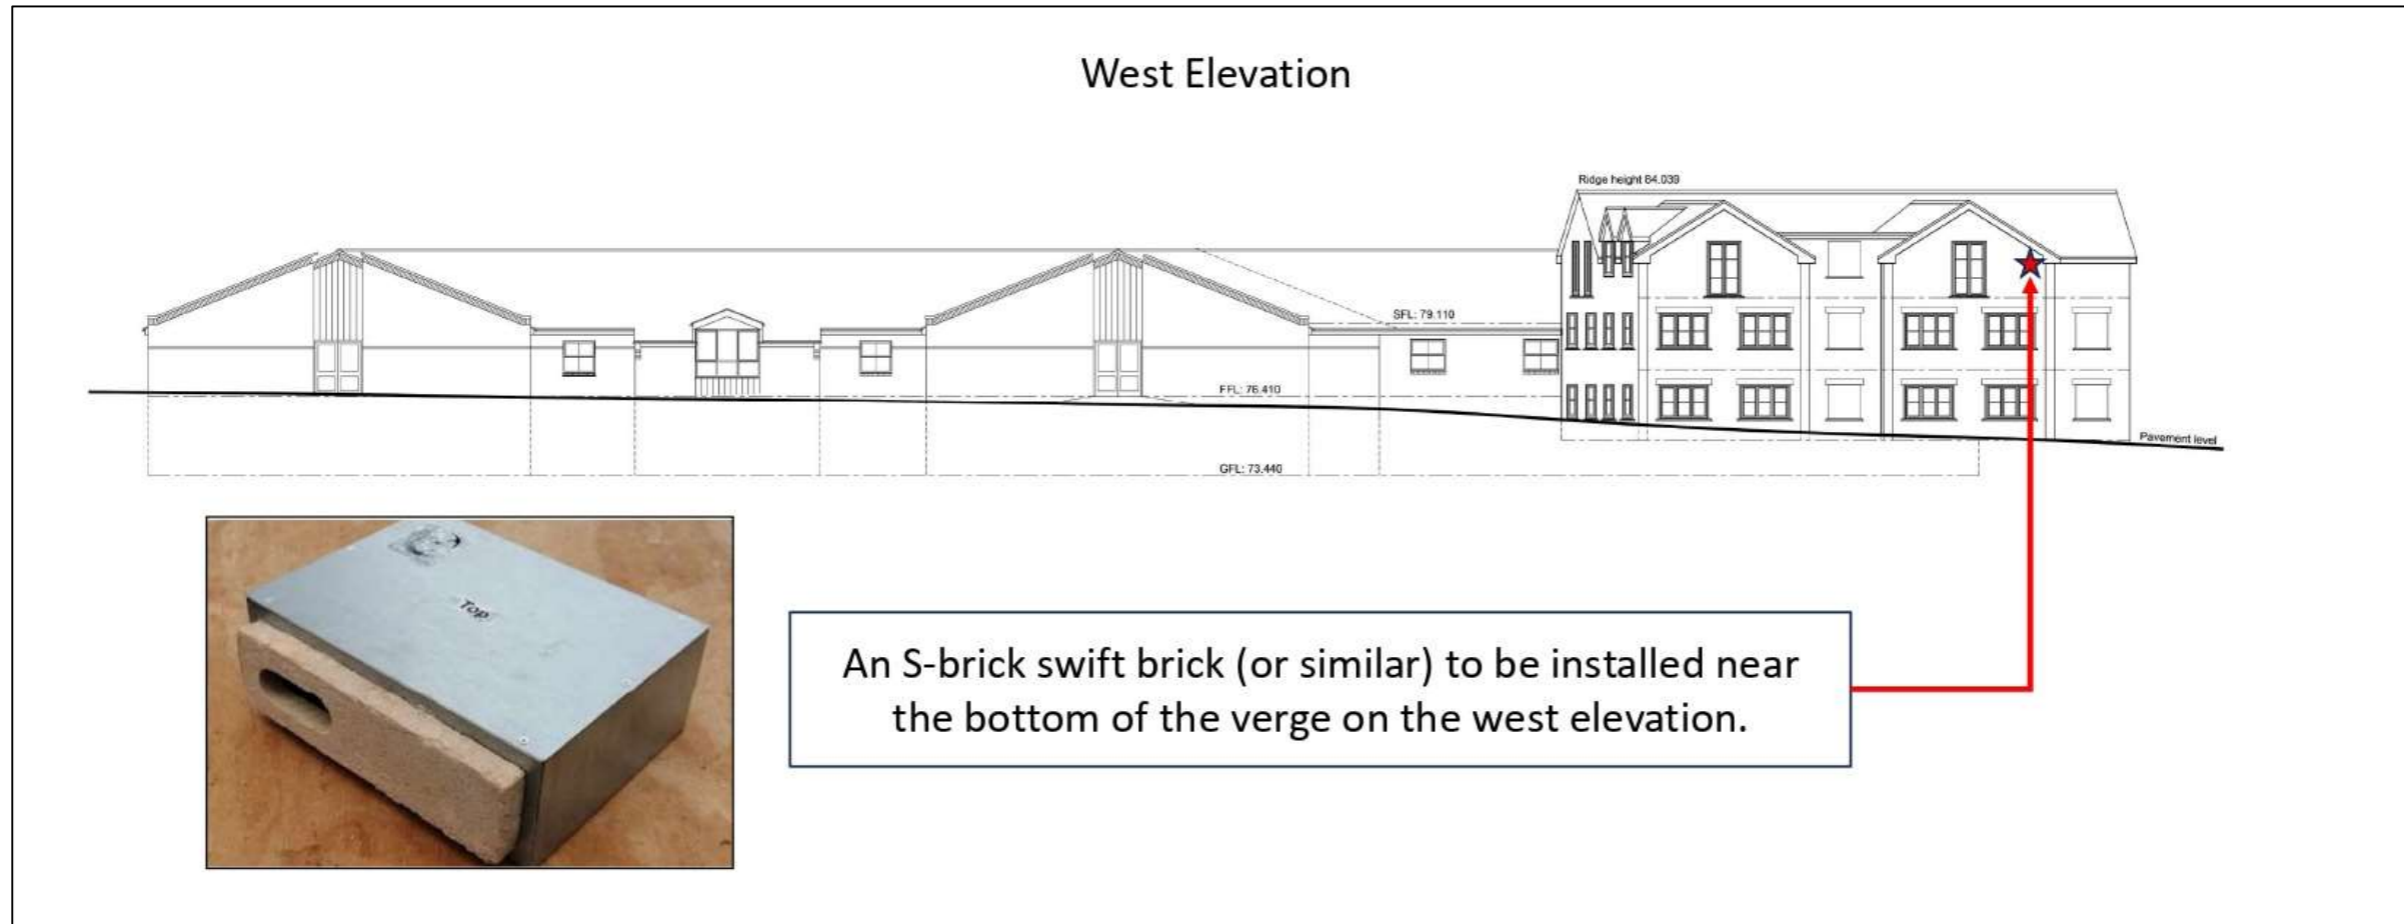
Plate A2.2 Swift box location on the west of the new building

A solitary bee brick to be installed on the south elevation at a height of at least 1m, in a sunny location.
