Wakefield Road, Mapplewell Highway Condition Survey 1

June 2026 (Initial Issue)

Prepared on behalf of
Vistry West Yorkshire

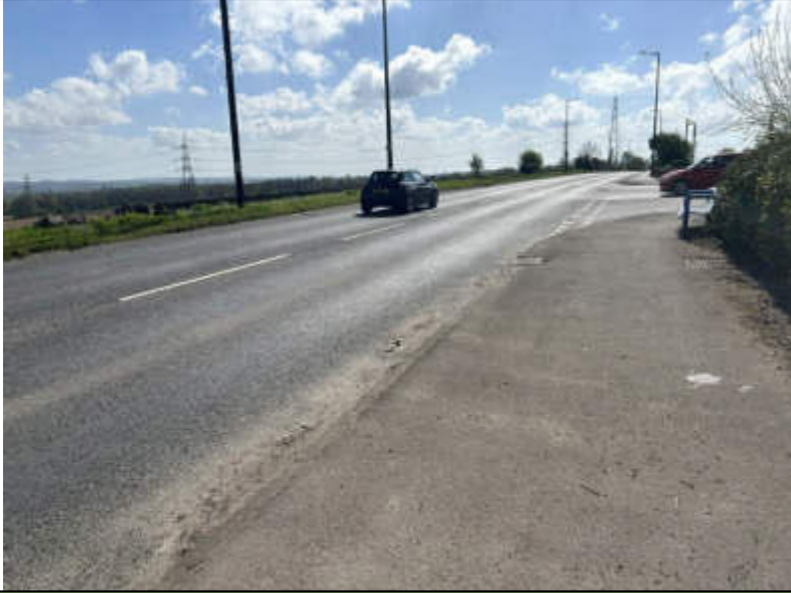
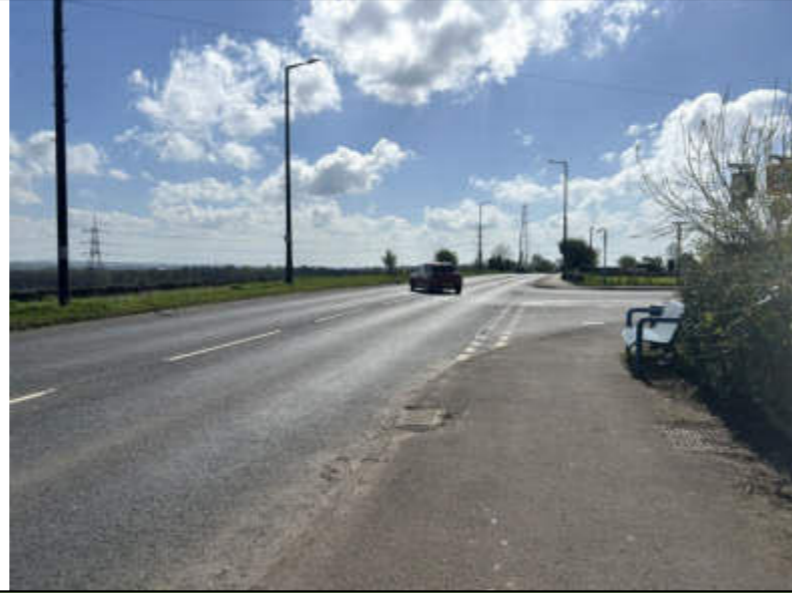
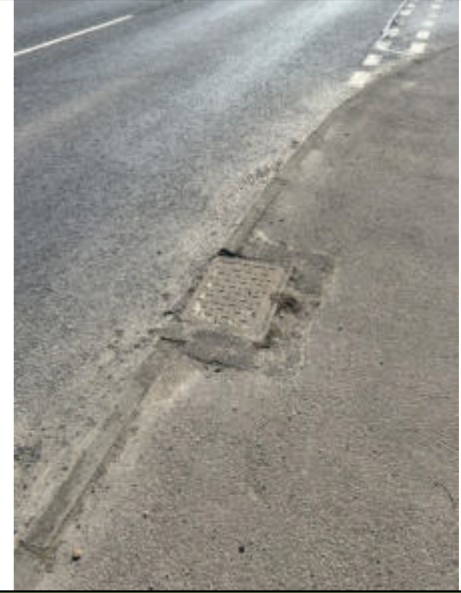
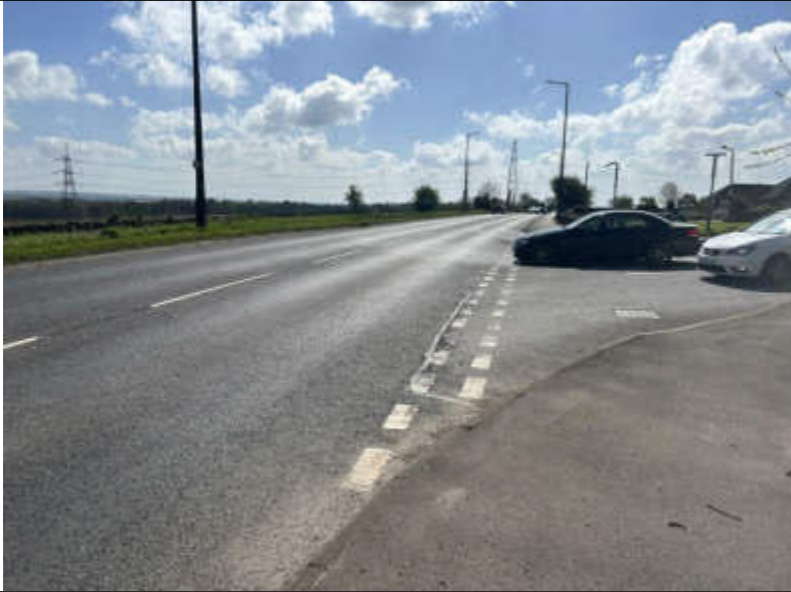
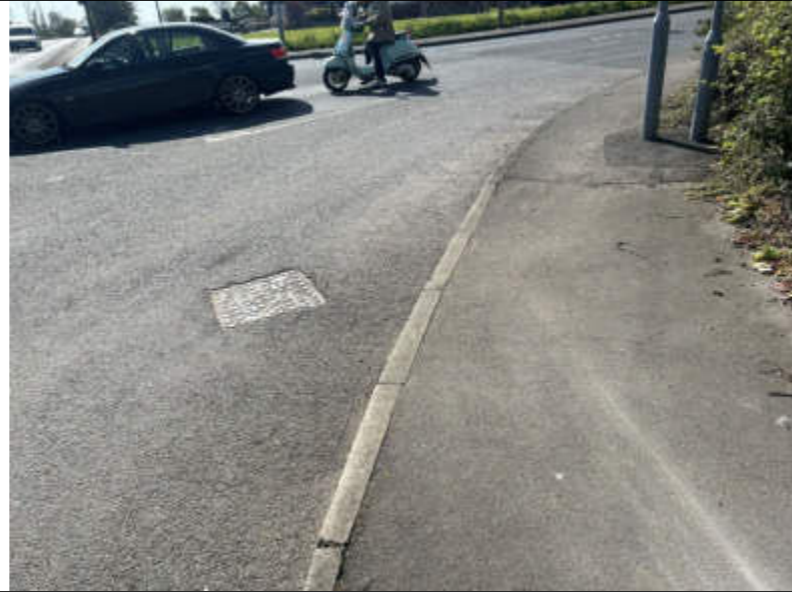
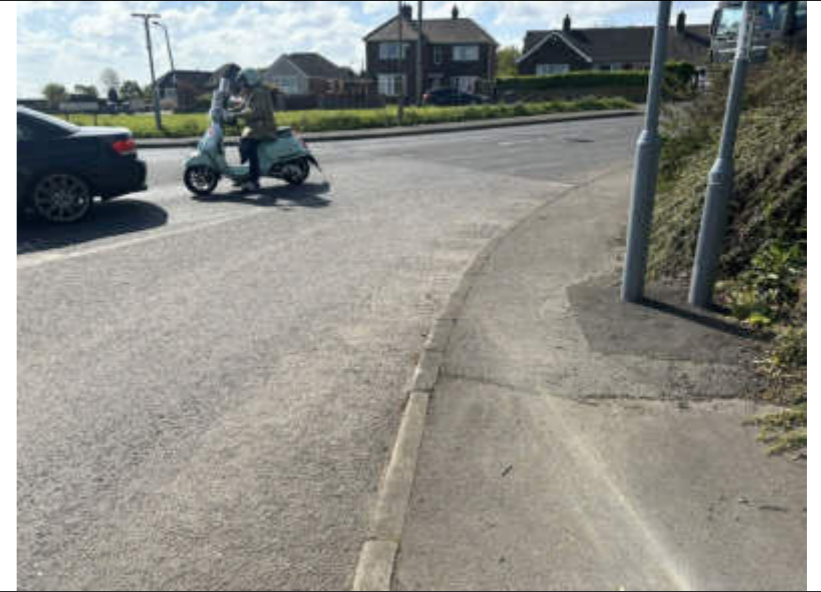
Table 2.1 Defect 1 (Images 1-6)

DEFECT	
Location	A61 Wakefield Road
Summary	<ul style="list-style-type: none">• Kerb damage• Slightly sunken ironworks

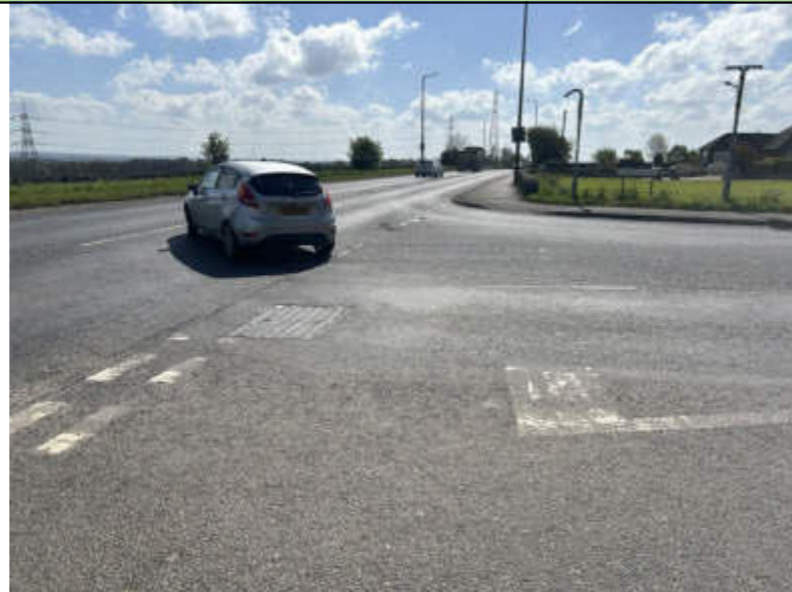
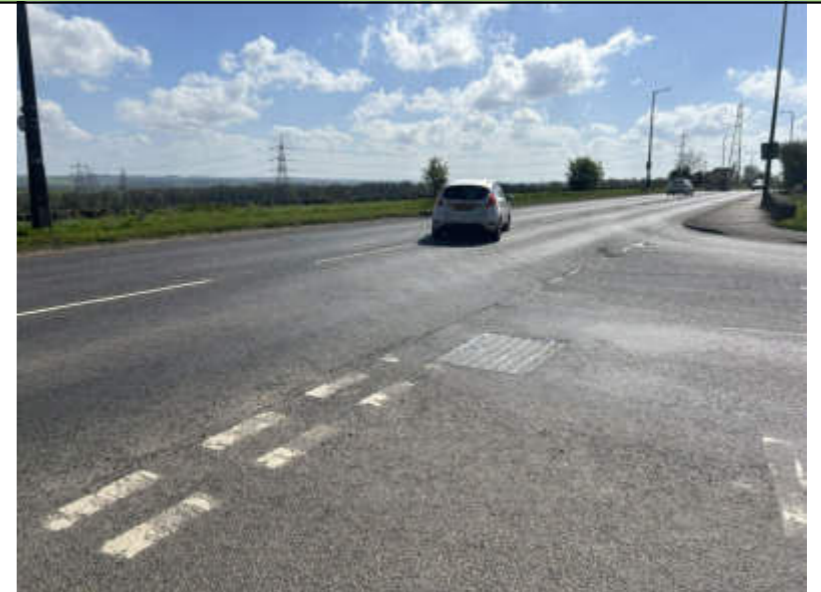
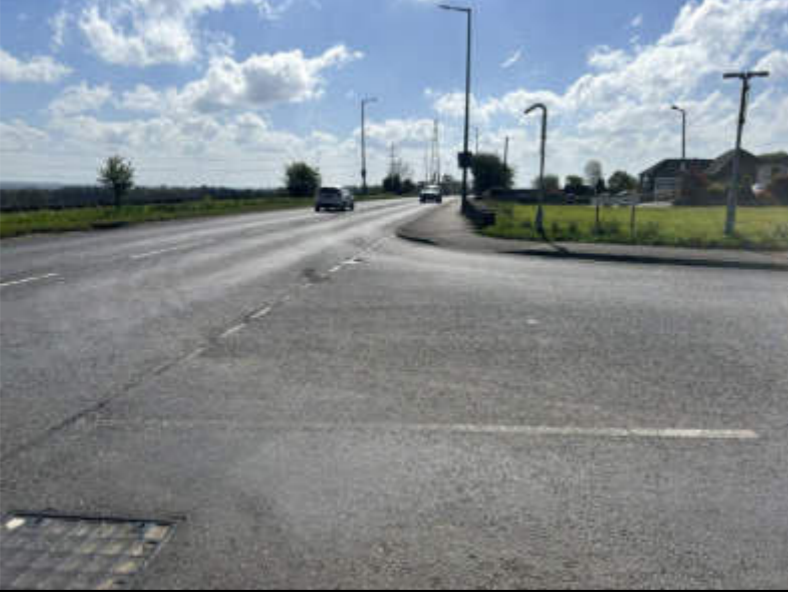
Table 2.2 Defect 2 (Image 8-10)

DEFECT	
Location	A61 Wakefield Road/Paddock Road junction
Summary	<ul style="list-style-type: none">• Worn road markings

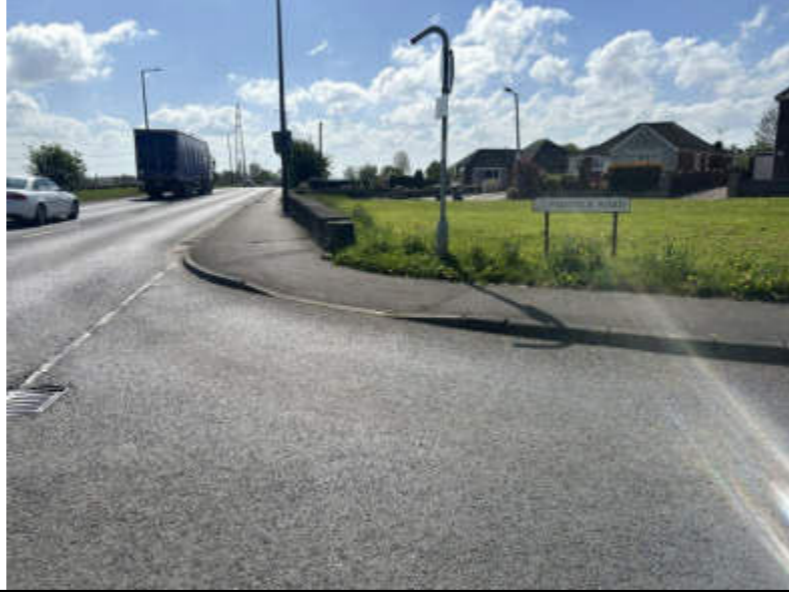
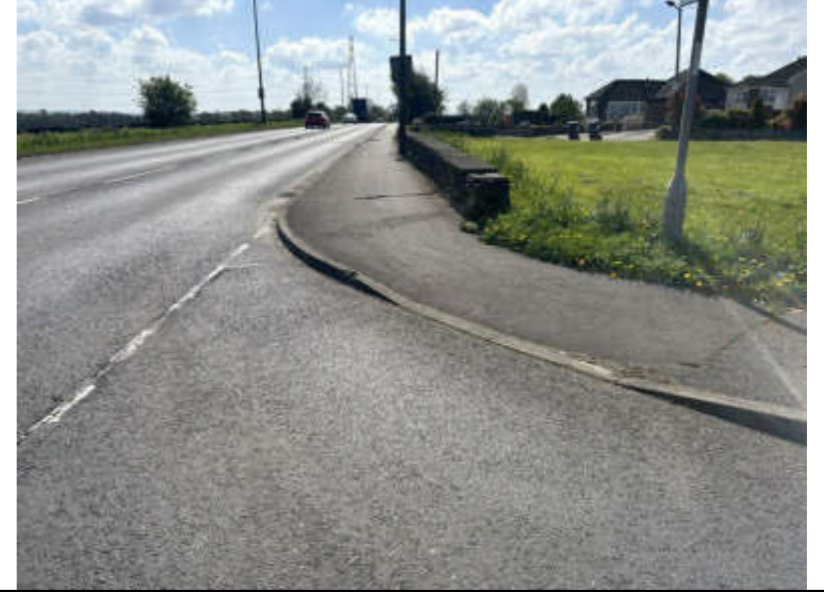
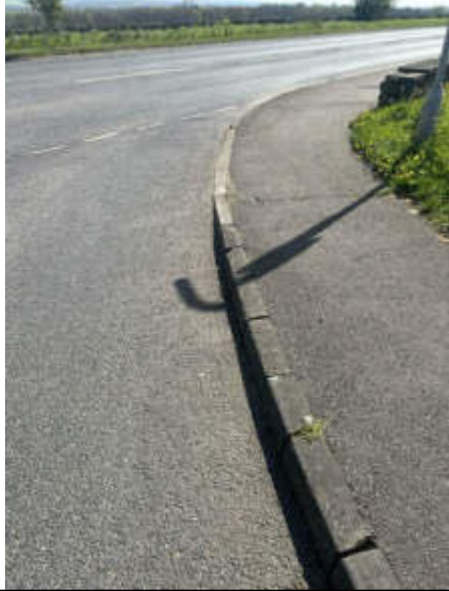
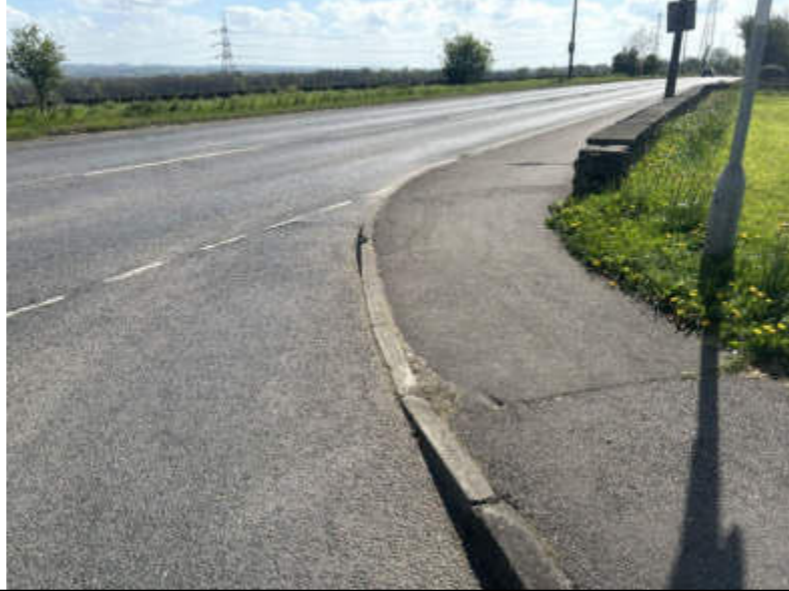
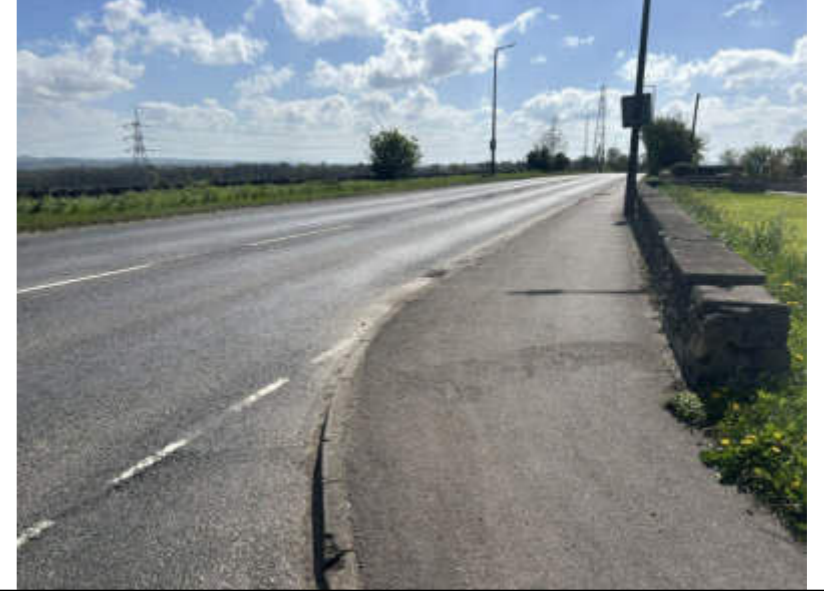
Table 2.3 Defect 3 (Images 11-15)

DEFECT	
Location	A61 Wakefield Road/Paddock Road junction
Summary	<ul style="list-style-type: none">• Kerb damage

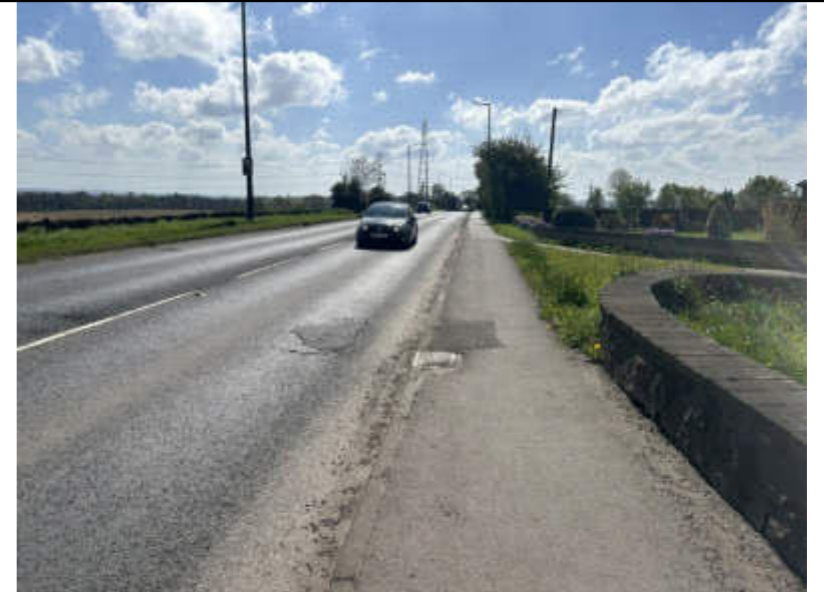
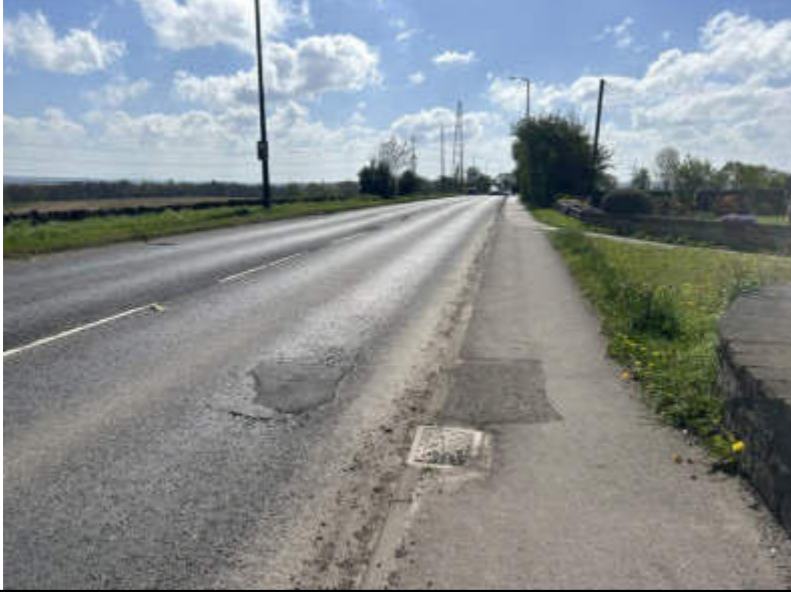
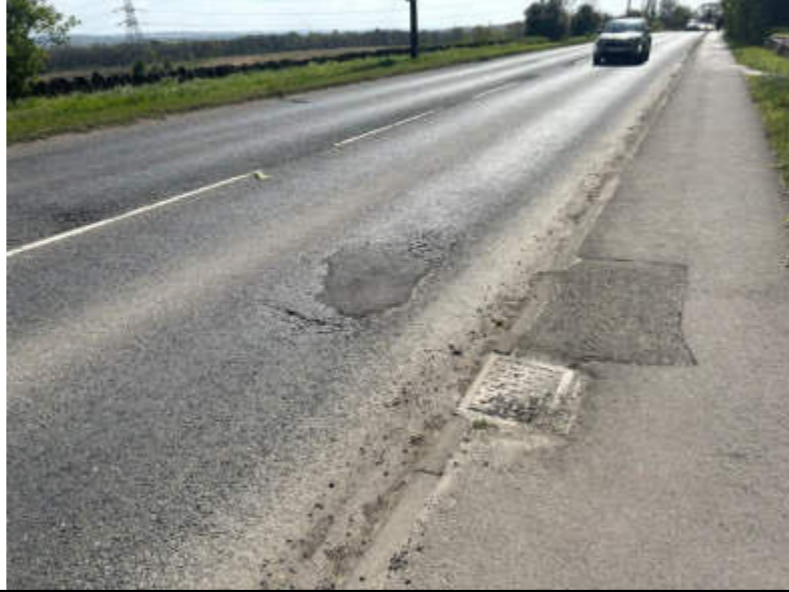
Table 2.4 Defect 4 (Images 18-20)

DEFECT	
Location	A61 Wakefield Road
Summary	<ul style="list-style-type: none">• Fretting• Kerb Damage• Damaged Ironworks• Fattening

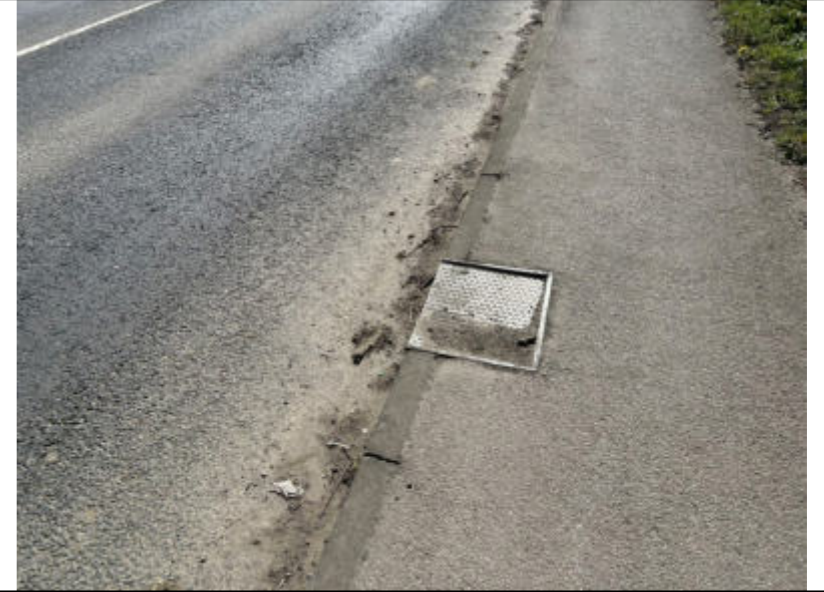
27

Table 2.5 Defect 5 (Image 27)

DEFECT	
Location	A61 Wakefield Road
Summary	<ul style="list-style-type: none">Damaged Ironworks

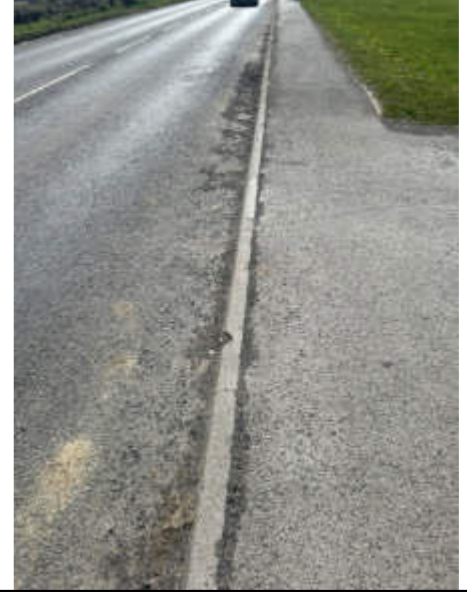
30

Table 2.6 Defect 6 (Image 30)

DEFECT	
Location	A61 Wakefield Road
Summary	<ul style="list-style-type: none">• Kerb Damage

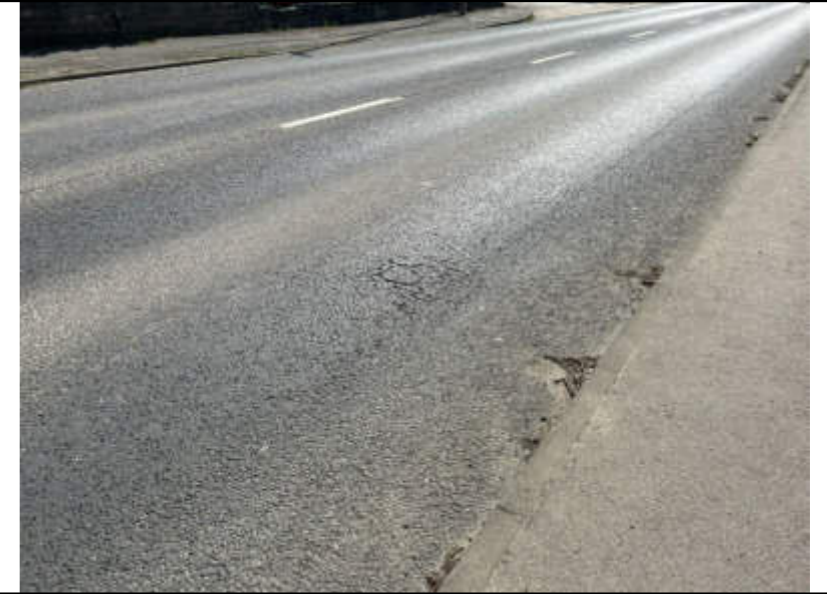
54

Table 2.7 Defect 7 (Image 54)

DEFECT	
Location	A61 Wakefield Road
Summary	<ul style="list-style-type: none">Fretting

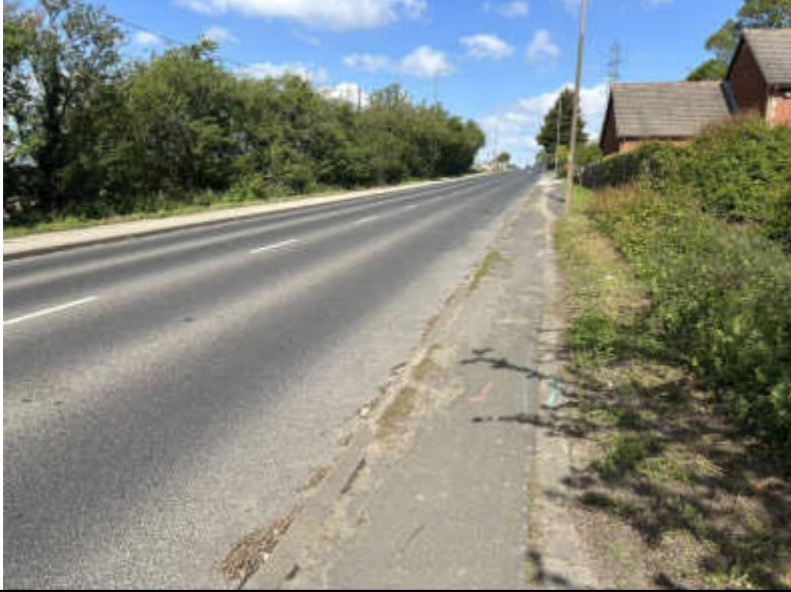
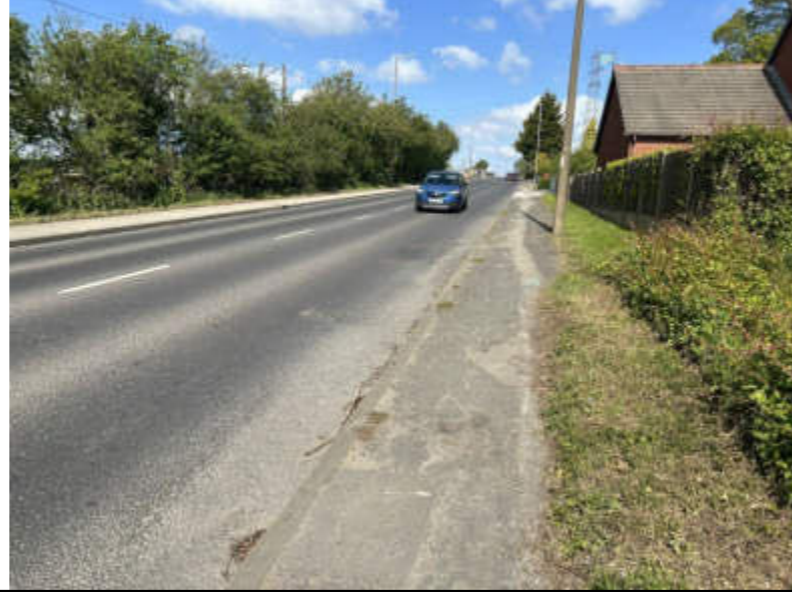
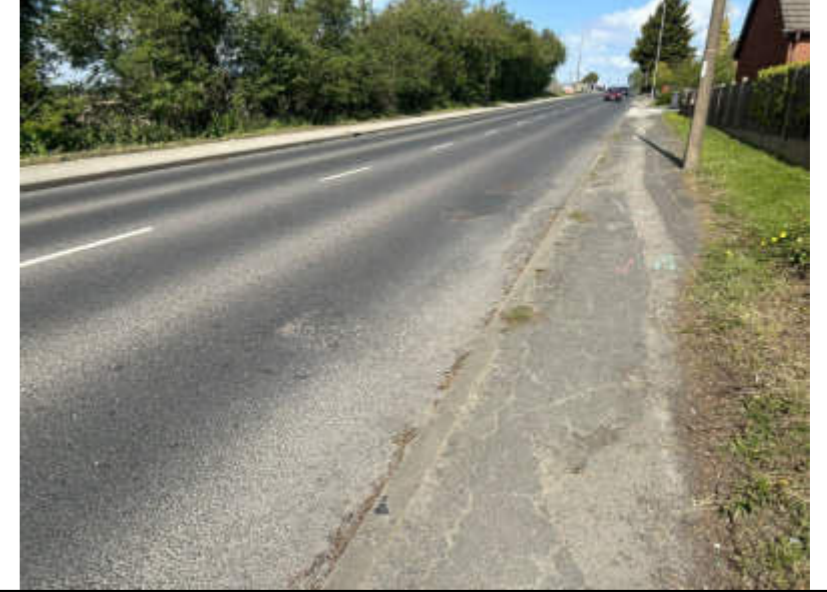
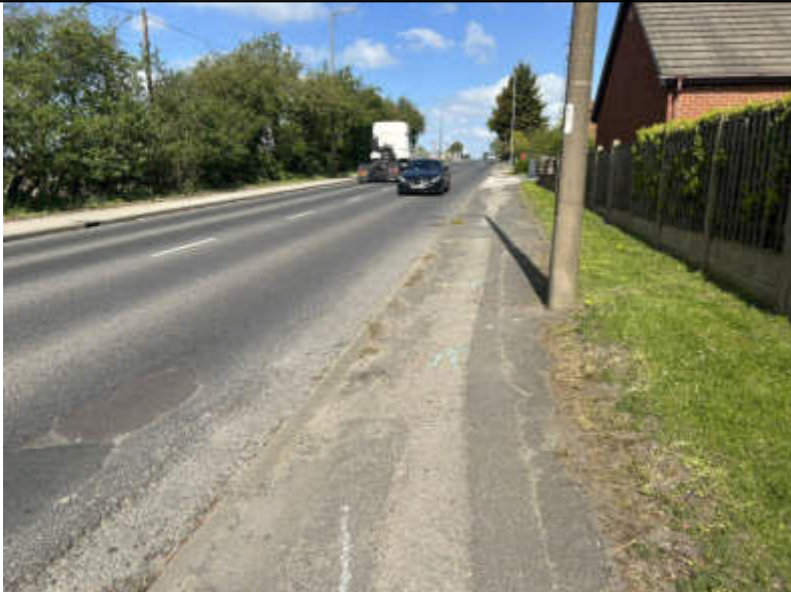
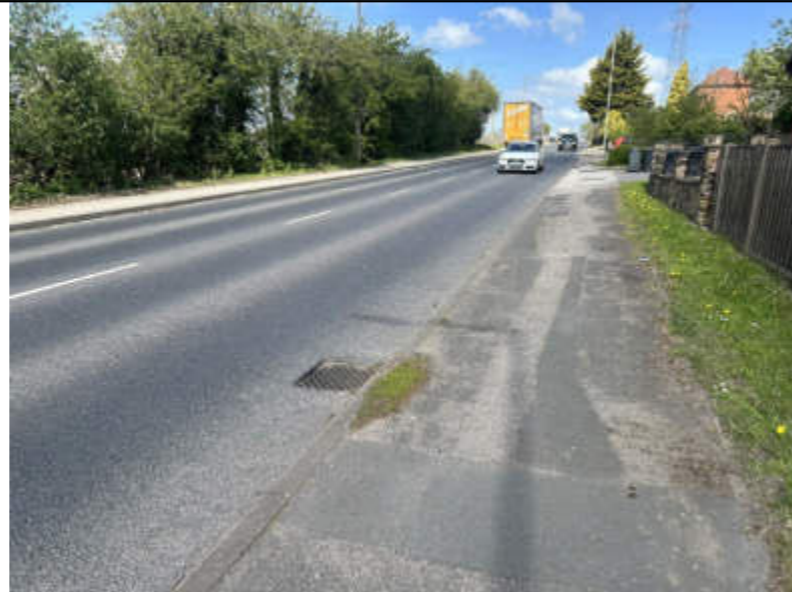
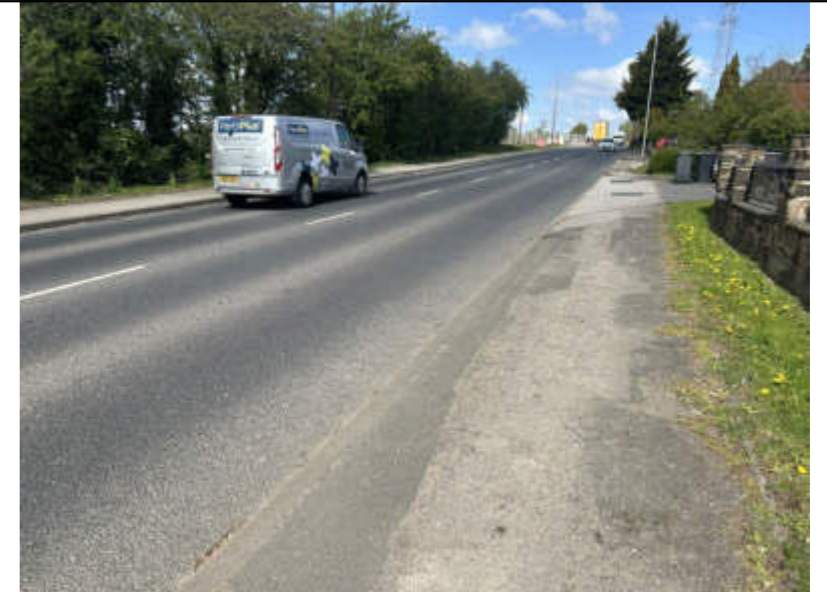
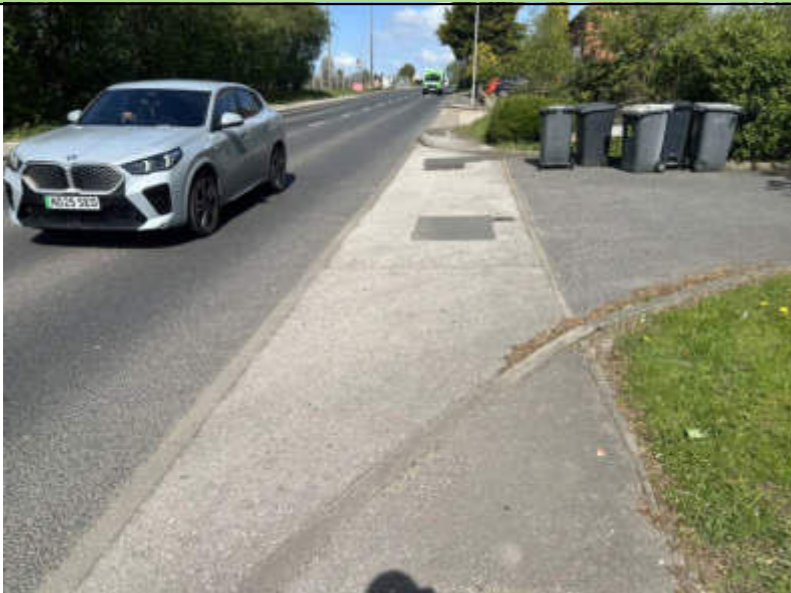
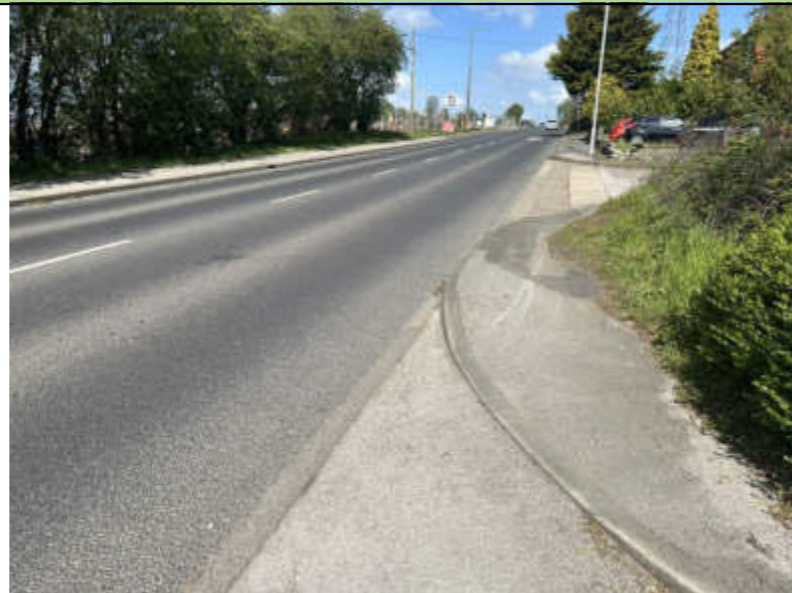
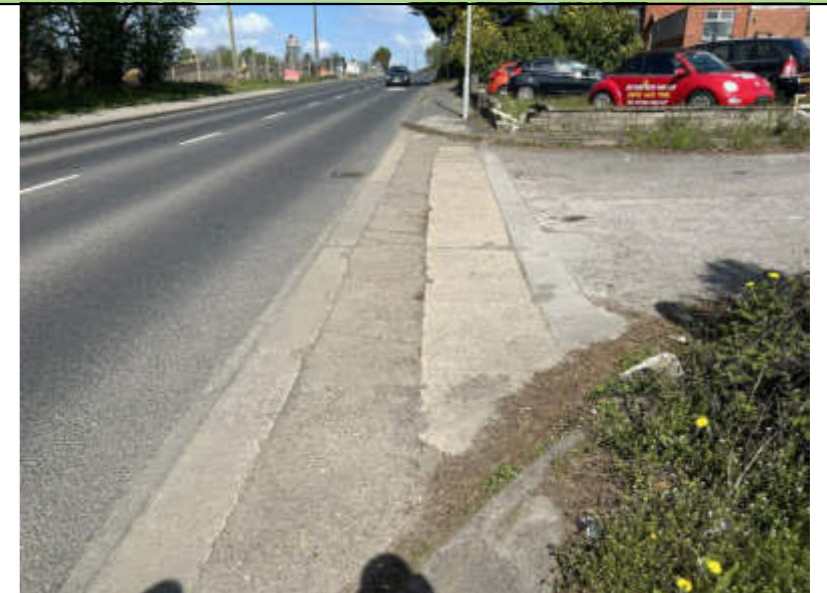
Table 2.8 Defect 8 (Image 64-72)

DEFECT	
Location	A61 Wakefield Road
Summary	<ul style="list-style-type: none">• Footway fretting• Footway cracking

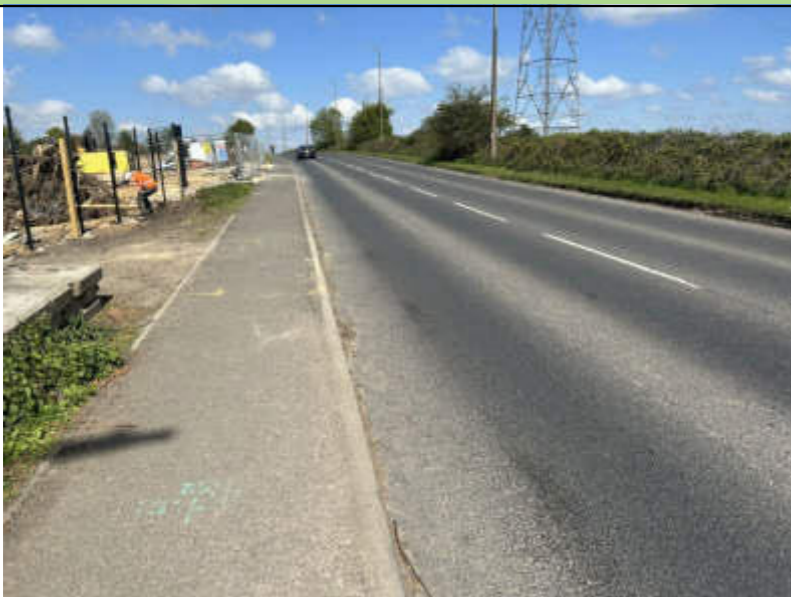
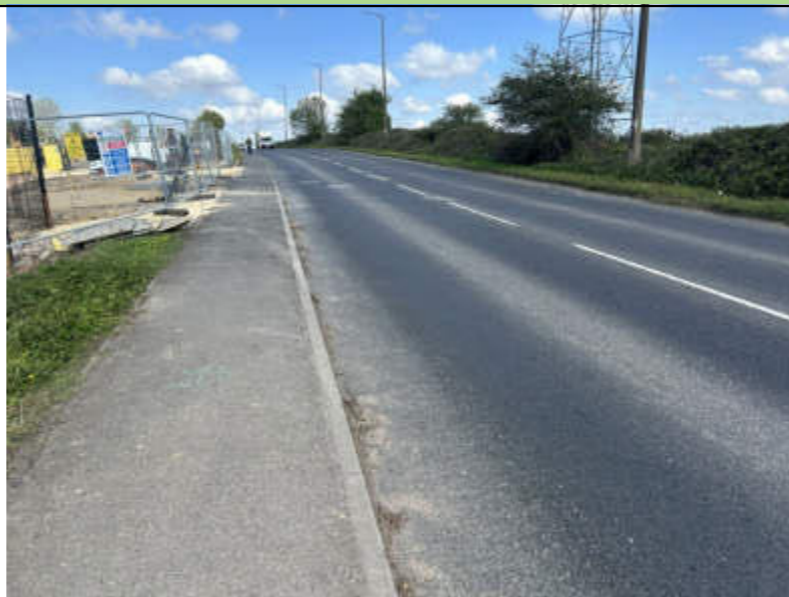
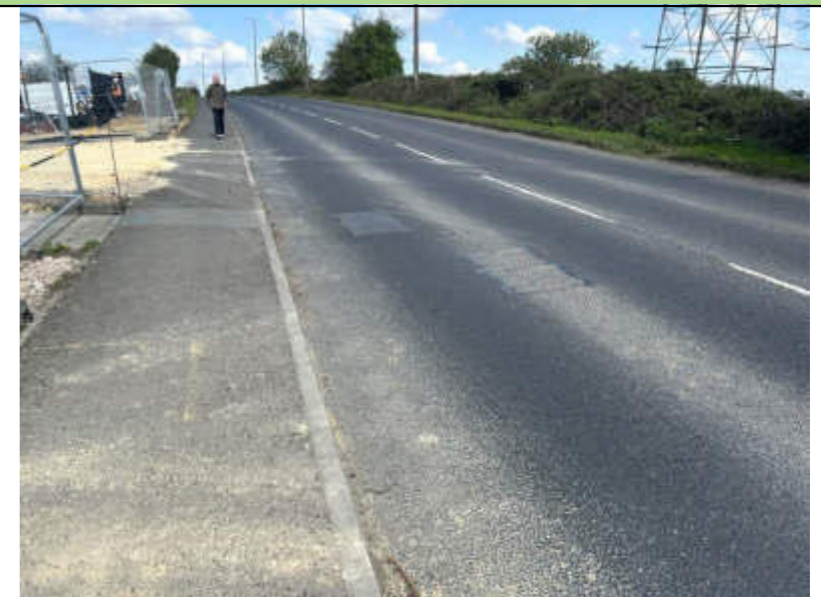
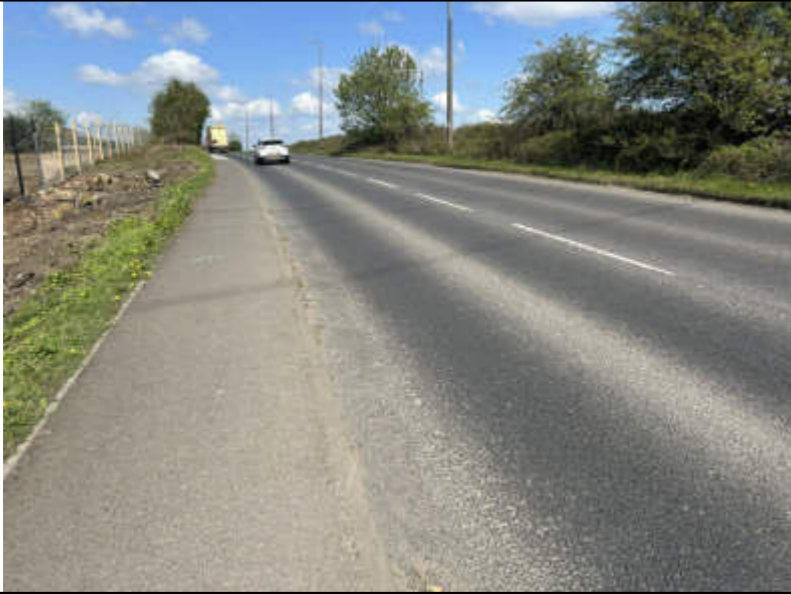
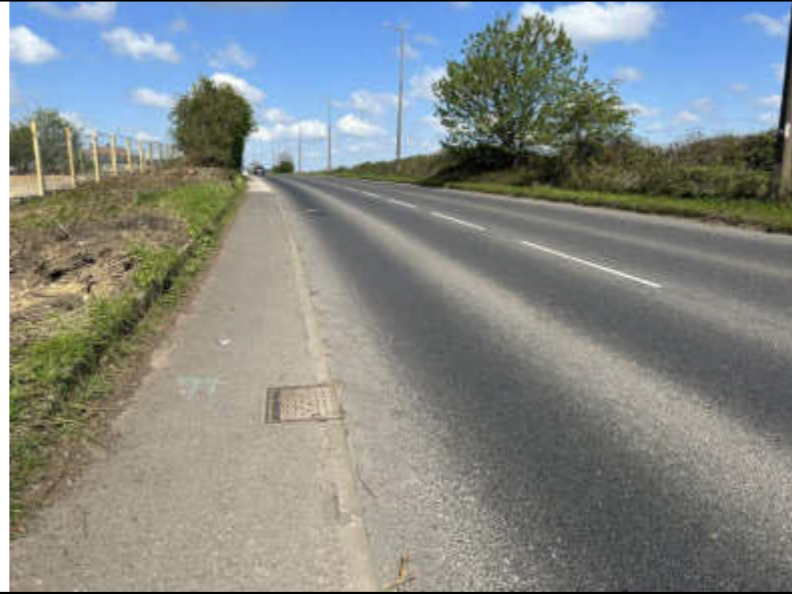
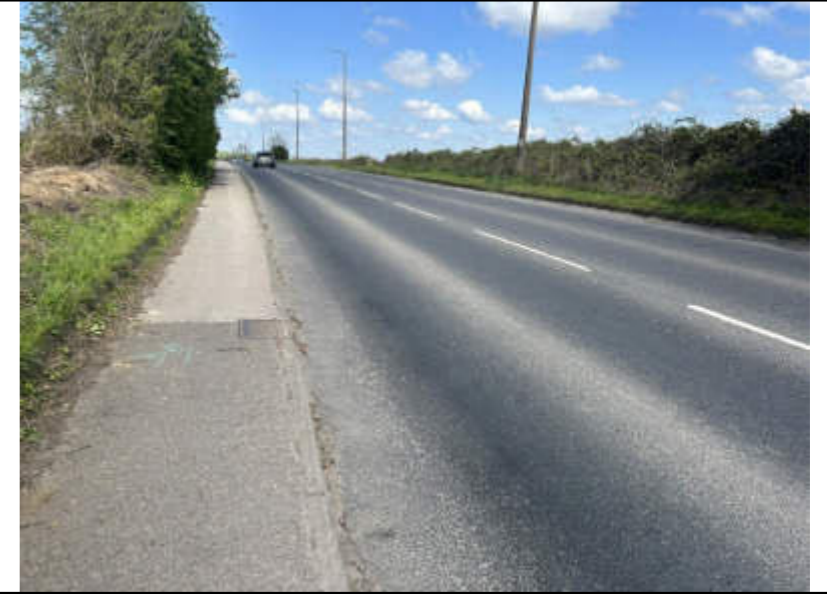
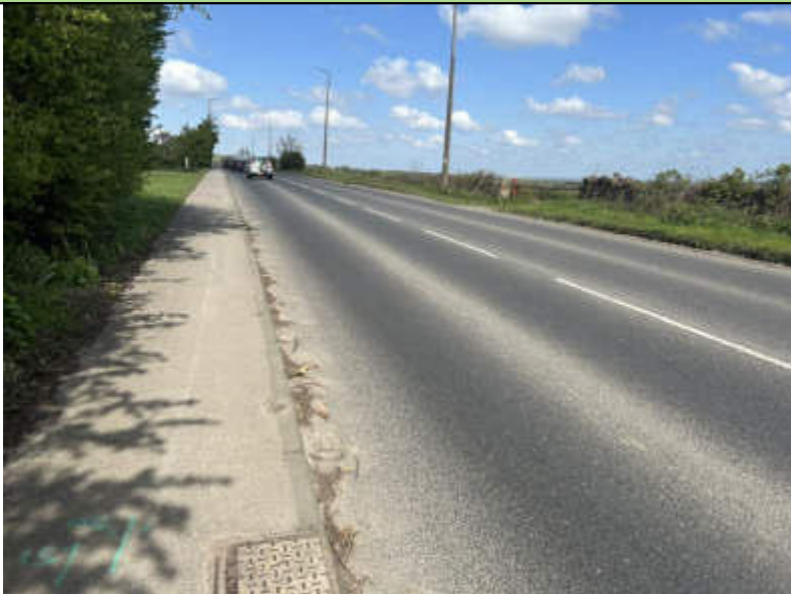
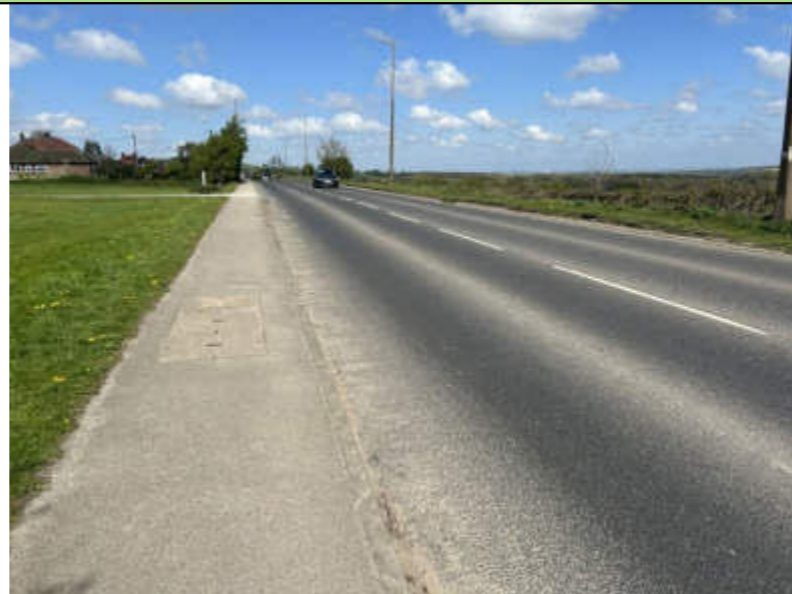
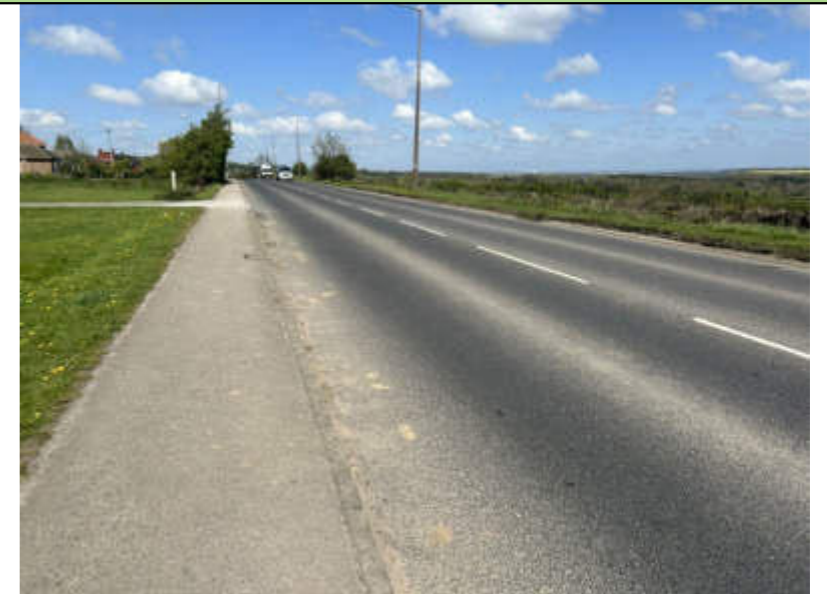
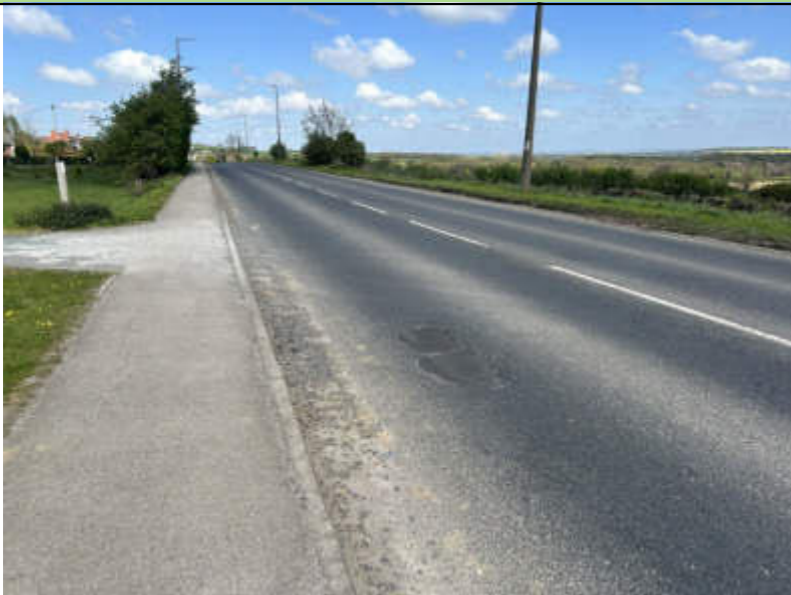
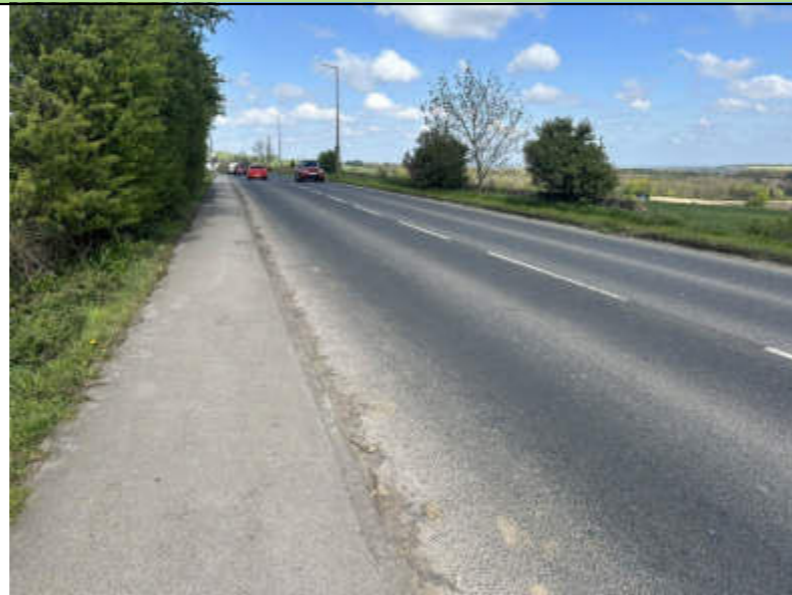
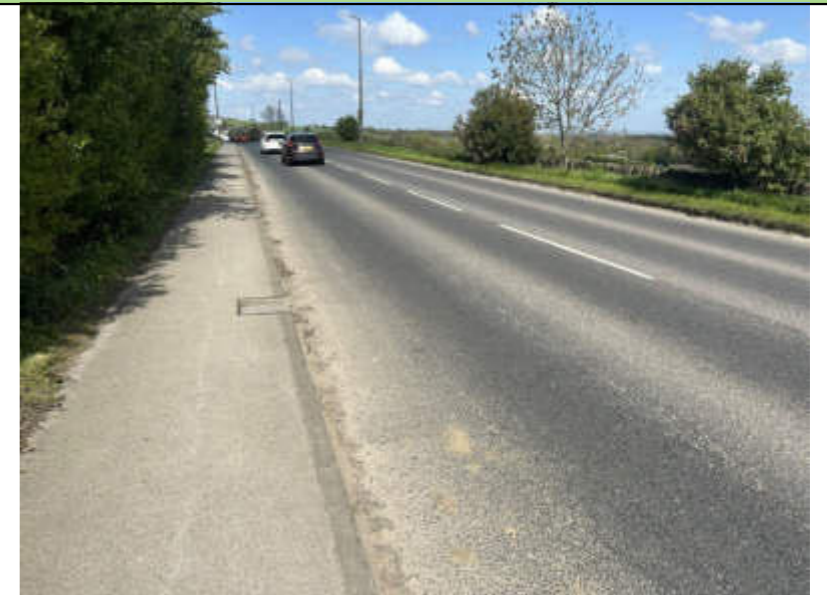
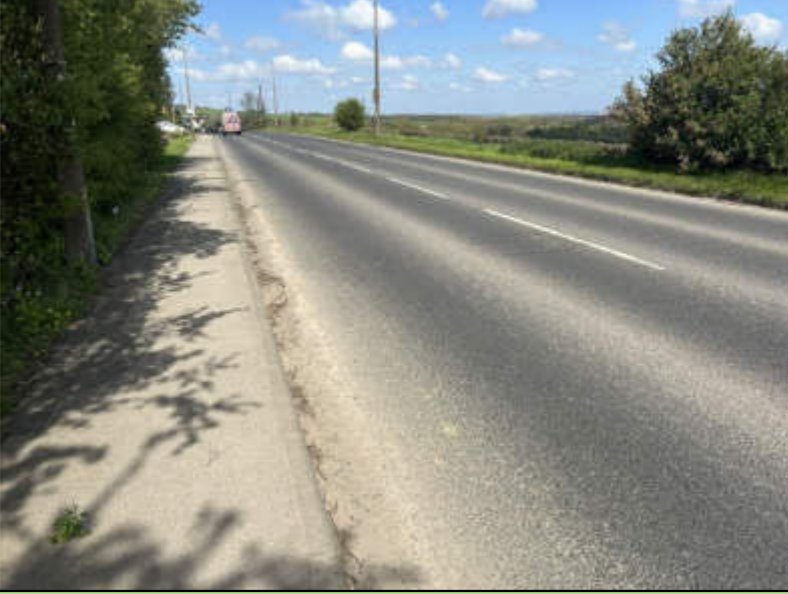
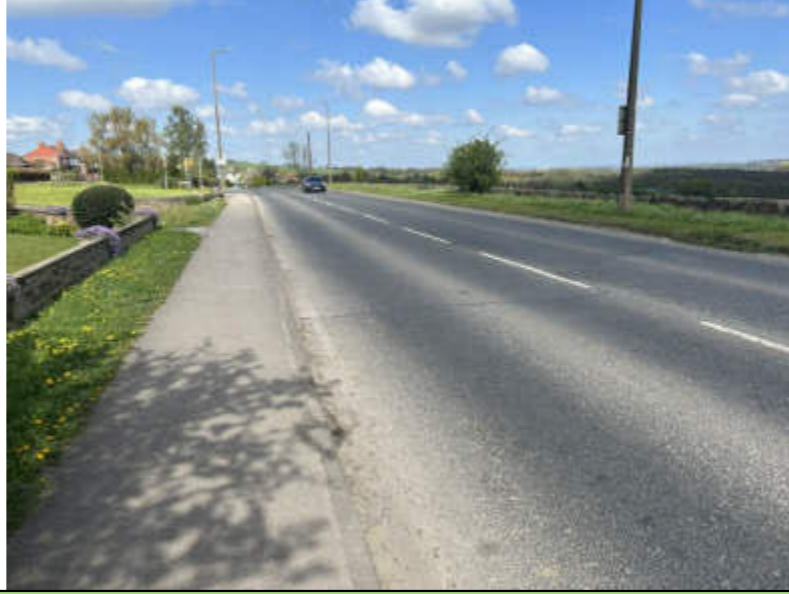
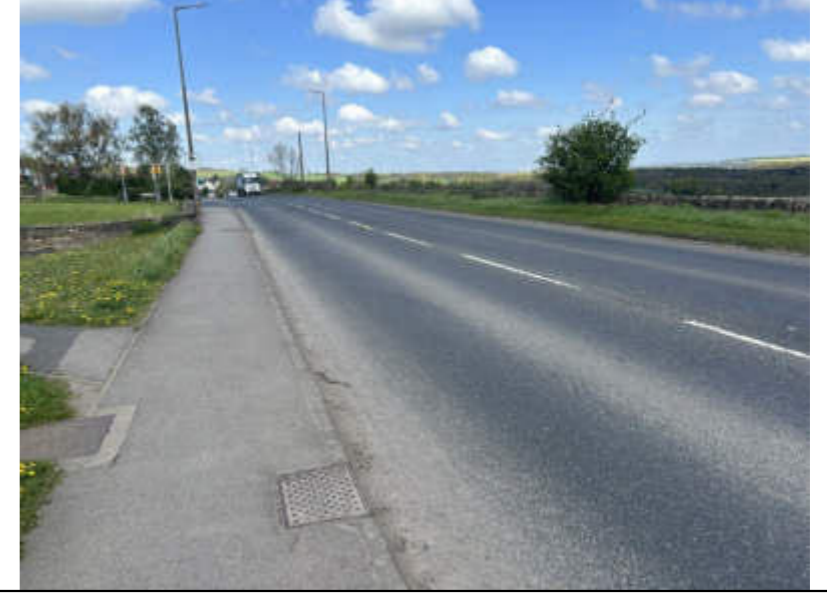
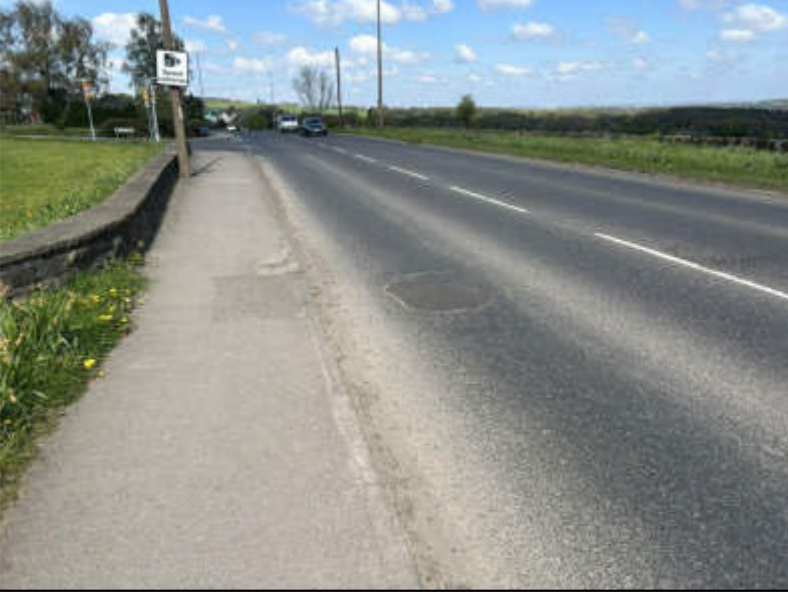
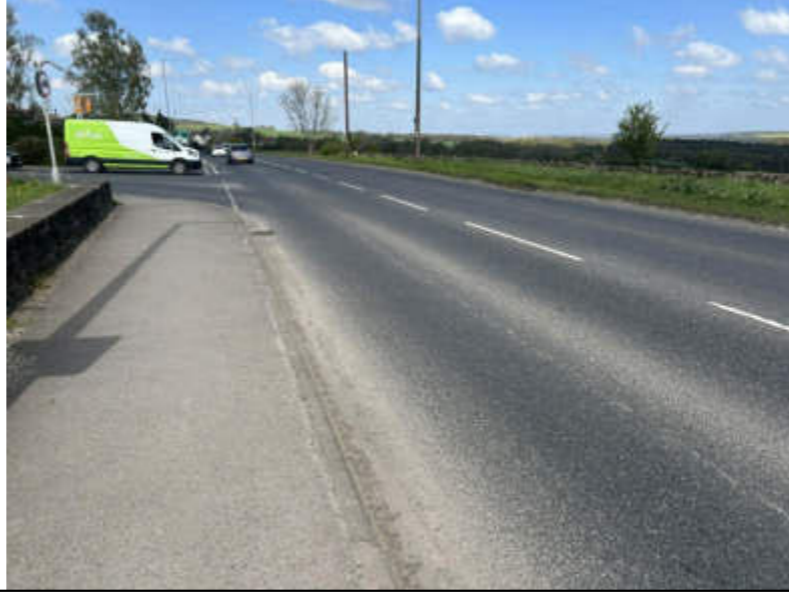
Table 2.9 Defect 9 (Image 79-95)

DEFECT	
Location	A61 Wakefield Road
Summary	<ul style="list-style-type: none">Fatting

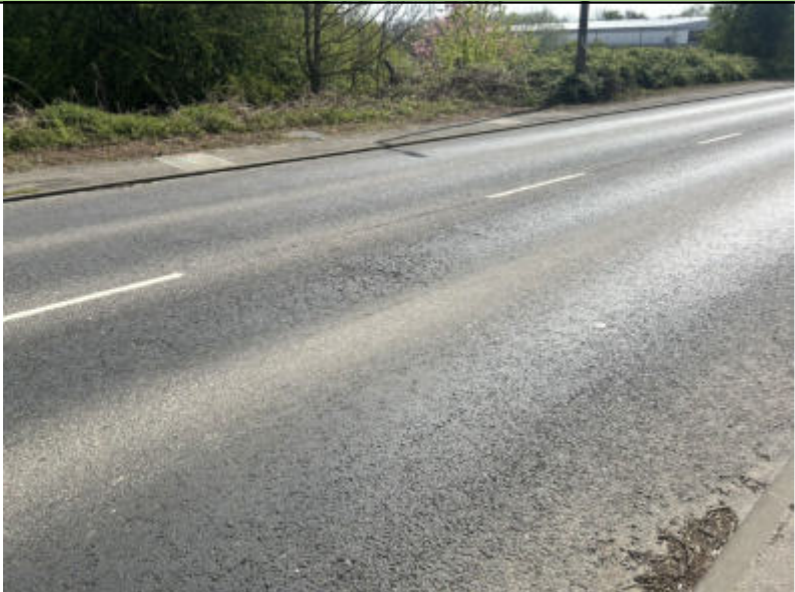
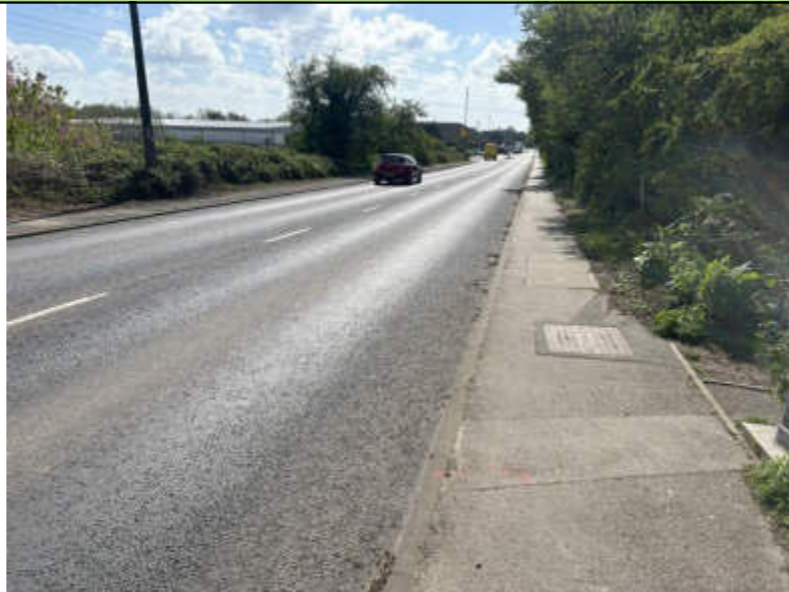
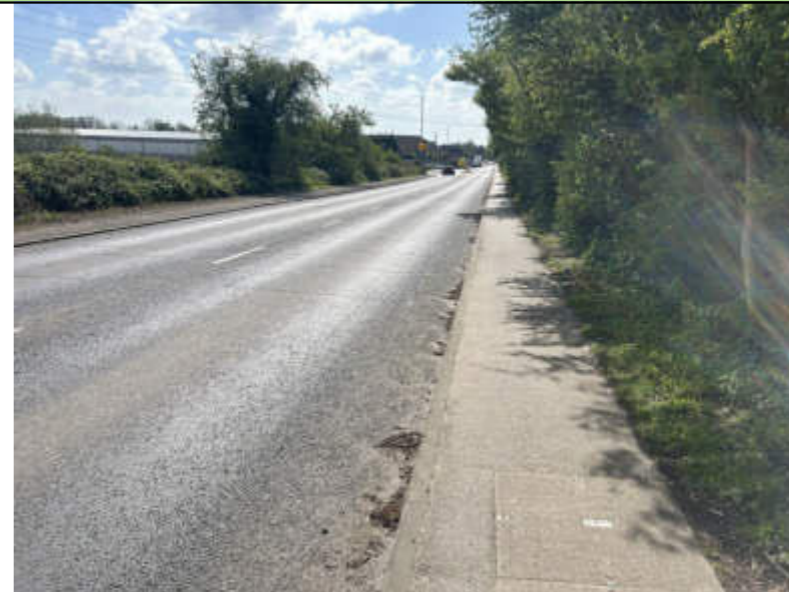
Table 2.10 Defect 1 (Images 7-9)

DEFECT	
Location	A61 Wakefield Road
Summary	<ul style="list-style-type: none">• Fretting• Fatting

DEFECT 1 (IMAGE 7-9):
• FRETTING
• FATTING
