Wakefield Road, Mapplewell Highway Condition Survey 1

June 2026 (Initial Issue)

Prepared on behalf of
Vistry West Yorkshire

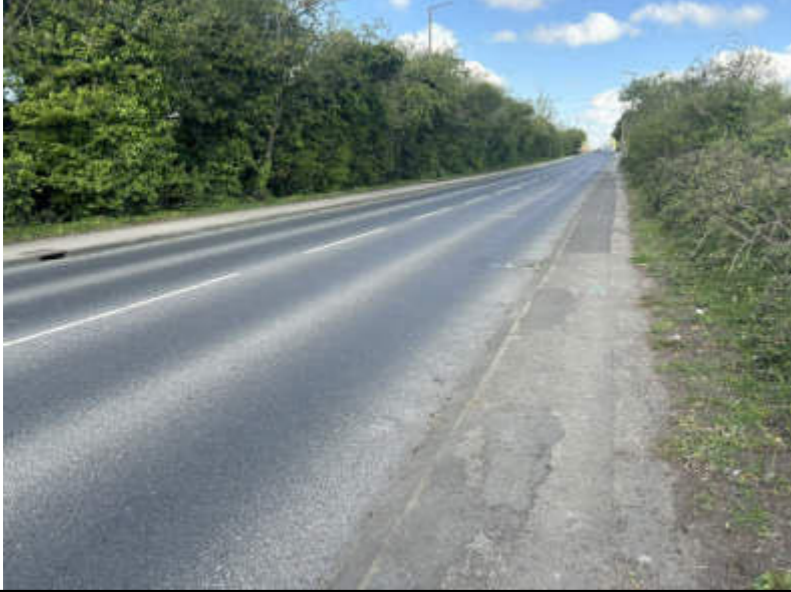
91

Table 2.13 Defect 4 (Images 91)

DEFECT	
Location	A61 Wakefield Road
Summary	<ul style="list-style-type: none">• Footway fretting

DEFECT 4 (IMAGE 91):
• FOOTWAY FRETTING

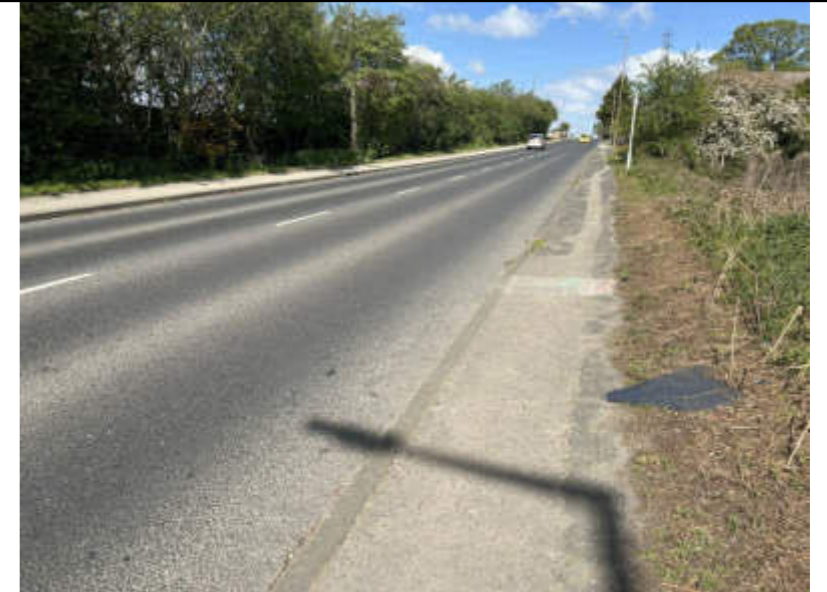
99

Table 2.14 Defect 5 (Images 99)

DEFECT	
Location	A61 Wakefield Road
Summary	<ul style="list-style-type: none">Fatting

DEFECT 4 (IMAGE 99):
• FATTING
