# Bank End Youth Club, Worsbrough

## Bat Survey Report

29<sup>th</sup> November 2022

| Document ref: MBE/BAT/2022/103/03 | | | | |

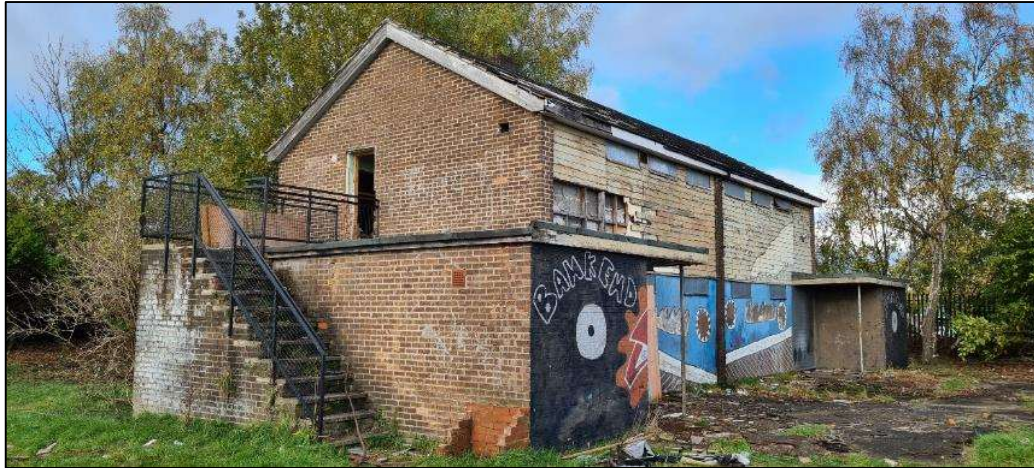
- 5.2.2 The building comprised a two-storey youth club with single storey sections and covered porches (Plate 1). The ground floor of the building was constructed from concrete block, brick, and render. The first floor also incorporated substantial sections of wooden cladding. The two storey section of the building had a two-pitched roof covered with interlocking concrete tiles. The ground floor had additional flat roof sections covered with bitumen felt. Soffit boxes were present at the eaves and barge boards were present below the tiles on the verges. The windows were relatively small, framed in wood, and boarded over.

**Plate 1. The southern and eastern aspects of the building**

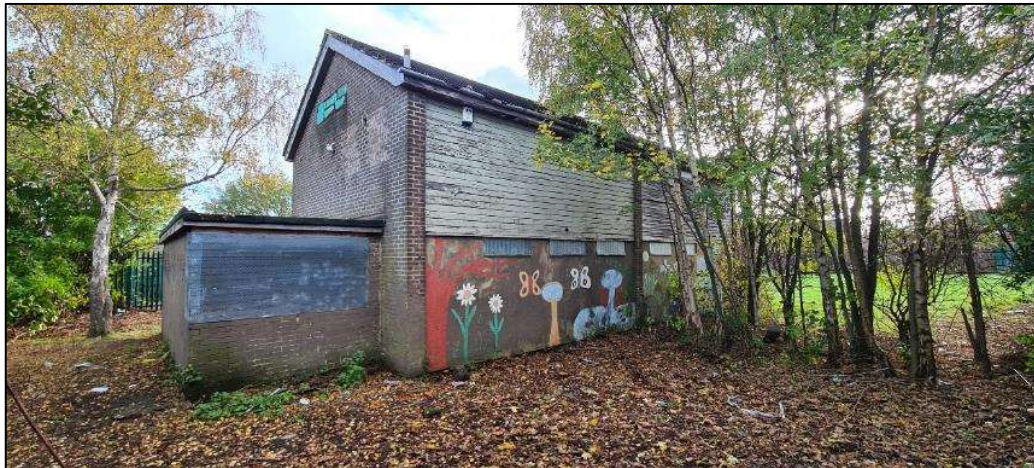
**Plate 2. The northern and western aspects of the building**

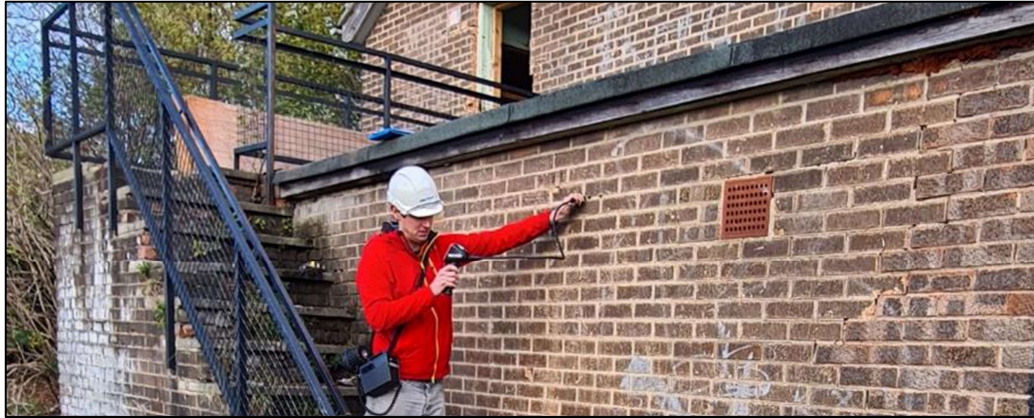
5.2.4 All external features below the eaves were inspected using an endoscope and or torch (Plate 3) with no bats or signs of bats recorded.

**Plate 3. Inspection of a potential roost feature on the southern end of the building using an endoscope**

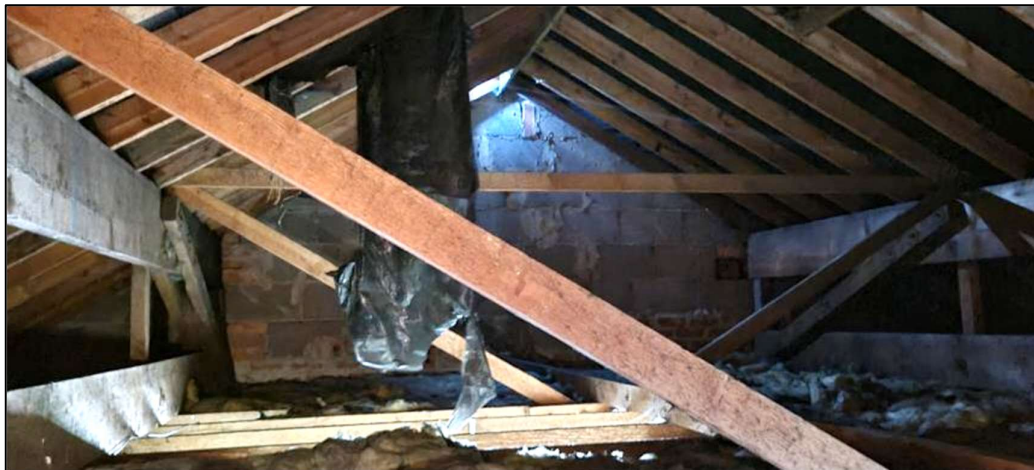
- 5.2.5 The pitched roof in the two storey section of the building was constructed using large purlins, tie beams and struts creating an inverted triangular roof truss design within the loft space (Plate 4). The first floor ceiling was intact in the northern half of the building but in the southern half the ceiling had been removed exposing the loft void above (Plate 5).

**Plate 4. The loft space at the northern end of the building**

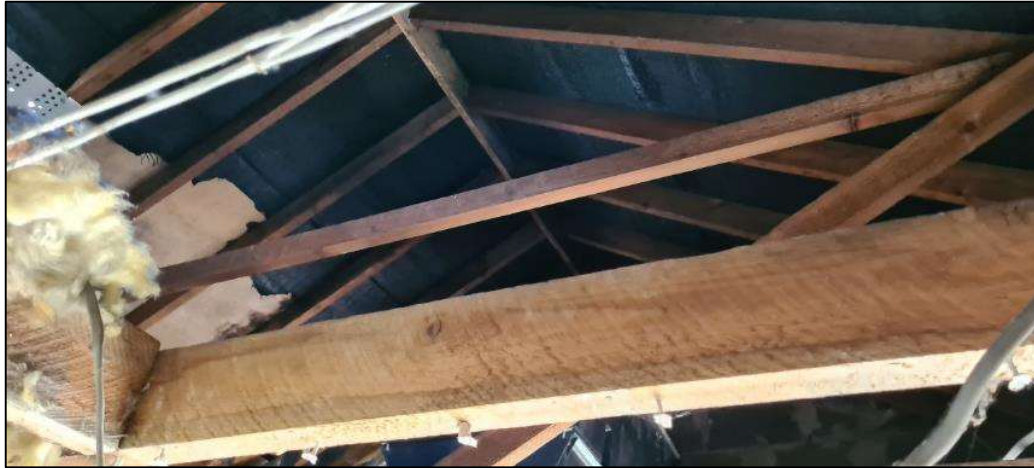
**Plate 5. The loft space at the southern end of the building (looking up from the first floor)**

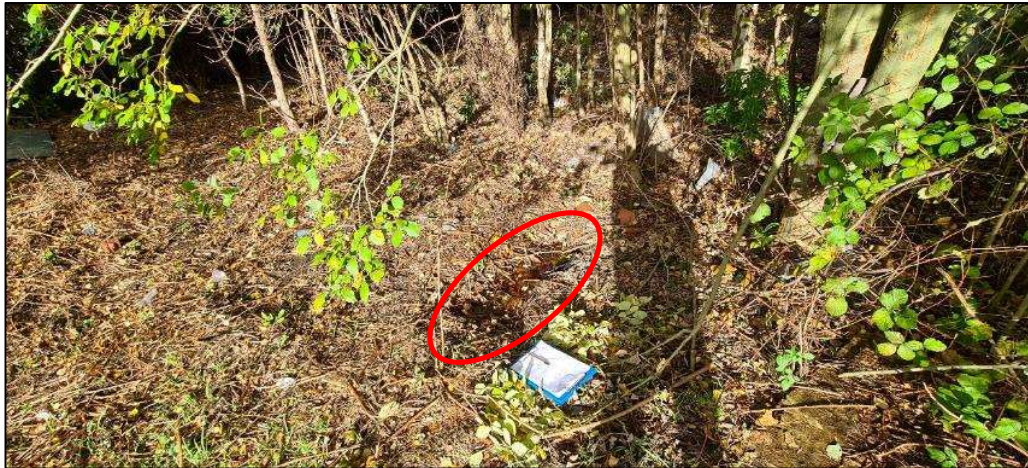
**Plate A2.1 Small pool of water (circled red) in a preformed pond liner.**

The potential for the pool to support great crested newts *Triturus cristatus* was assessed using the great crested newt habitat suitability index. The overall suitability for great crested newts was identified as "Poor". Coupled with the lack of nearby ponds no further precautions are anticipated to be necessary to ensure the safety of amphibian populations which may be present.

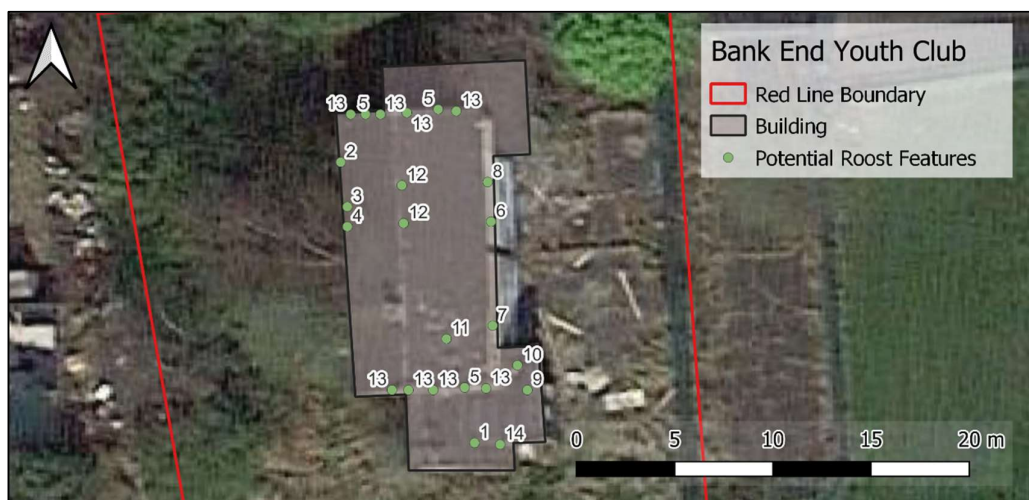
**Figure A3.1 – PRF locations**

This work will be undertaken outside of a licence as no bat roosts have been recorded within the building and the check of the PRFs is considered to be the equivalent of a further nocturnal survey, as any bats present would be expected to be observed during the close visual inspection. Moreover any signs of historical use (such as the presence of bat droppings) could also be observed during the inspection. PRF locations are shown on Figure A3.1

The PRFs will need to be directly inspected with elevated PRFs accessed from a cherry picker / Mobile Elevated Working Platform (MEWP). This will allow the direct inspection of all PRFs with the feature taken apart if there is any remaining doubt.
