## Proposed Drainage Strategy

PERSEVERANCE STREET, BARNSELEY

CAIRNWELL DEVELOPMENTS LTD

**48063-ECE-XX-XX-RP-C-0005**

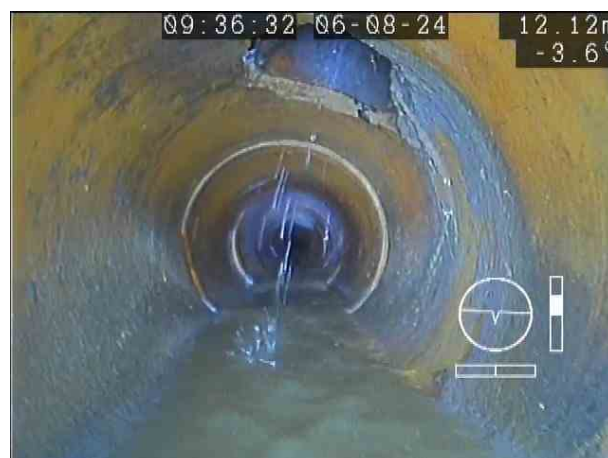
MH1X\_c03737ab-b56c-44e3-8d3f-9695d96e3ca8\_20240812\_111333\_891.jpg, 00:01:13, 12.12 m  
 Connection other than junction at 01 o'clock, 100mm dia

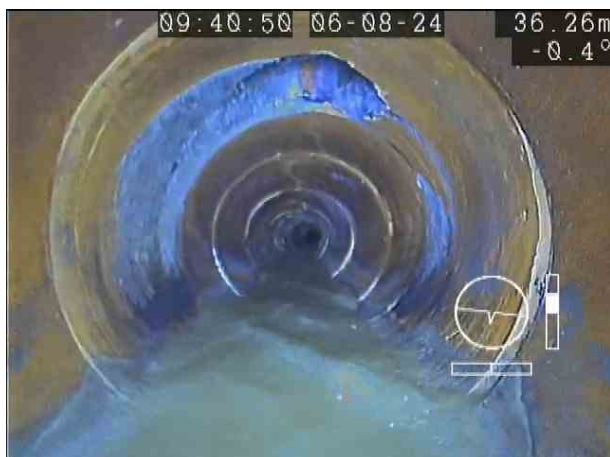
MH1X\_0d9a47b8-c179-421c-9966-5658da730b5a\_20240812\_111402\_502.jpg, 00:02:41, 36.26 m  
 Connection other than junction at 12 o'clock, 100mm dia

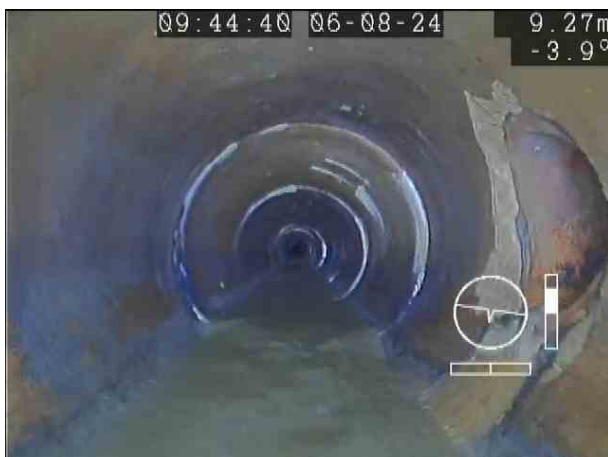
MH2X\_cc252805-bd3a-4993-b611-59dcfd49c579\_20240812\_111721\_045.jpg, 00:00:48, 9.27 m  
 Connection other than junction at 03 o'clock, 150mm dia

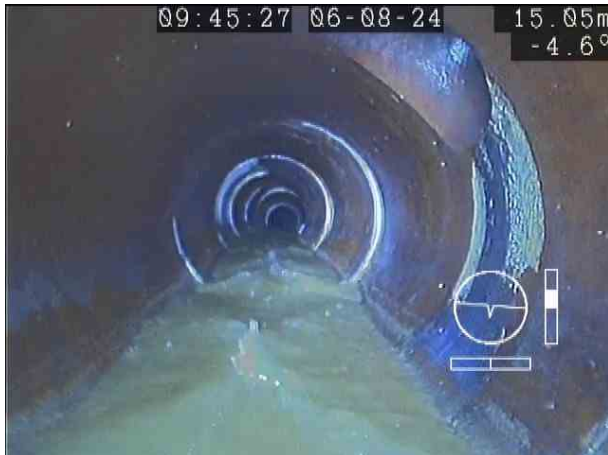
MH2X\_a38a3649-f45a-43d8-9154-86ef85ffa054\_20240812\_111802\_344.jpg, 00:01:35, 15.05 m  
 Junction at 01 o'clock, 100mm dia

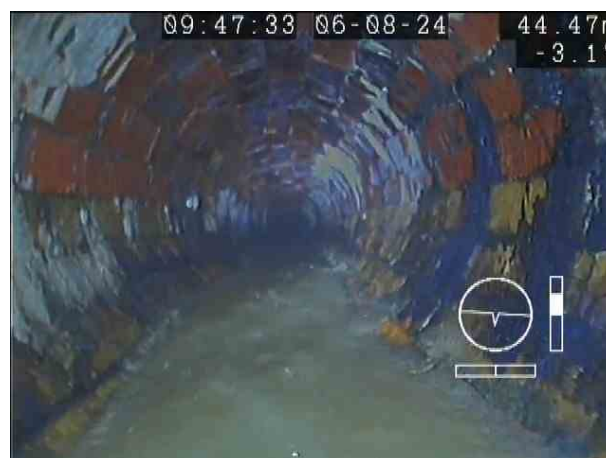
MH2X\_ab00335a-4fe4-4e54-8d0e-c2fd4113e1cd\_20240812\_112037\_954.jpg, 00:03:40, 44.47 m  
 Pipe material changes to brick at this point

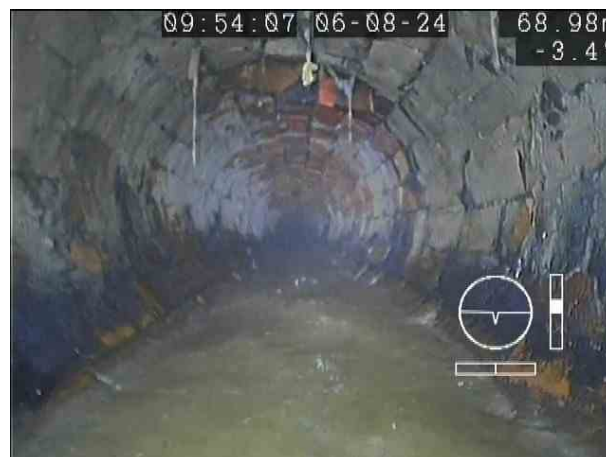
MH2X\_17d61786-185a-4e1b-82ea-5b547061bb71\_20240812\_112324\_575.jpg, 00:06:47, 68.98 m  
 Connection other than junction at 12 o'clock, 150mm dia

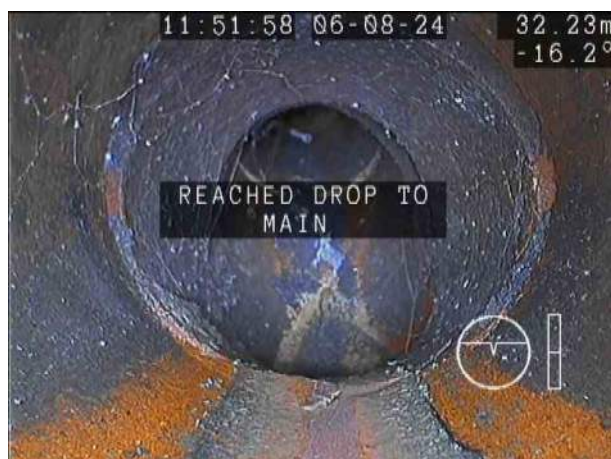
Exc  
 Pipe1X\_6996a05f-2b40-46db-a197-b5ac073126dd\_20240812\_113859\_811.jpg, 00:03:19, 32.23 m  
 Finish node, other special chamber, reference: Downstream,  
 Reached drop to main
