National
Trust

Wentworth Castle Gardens Gun Room Roof Condition Survey

Prepared by: David Rankine
Date : 28th March 2025

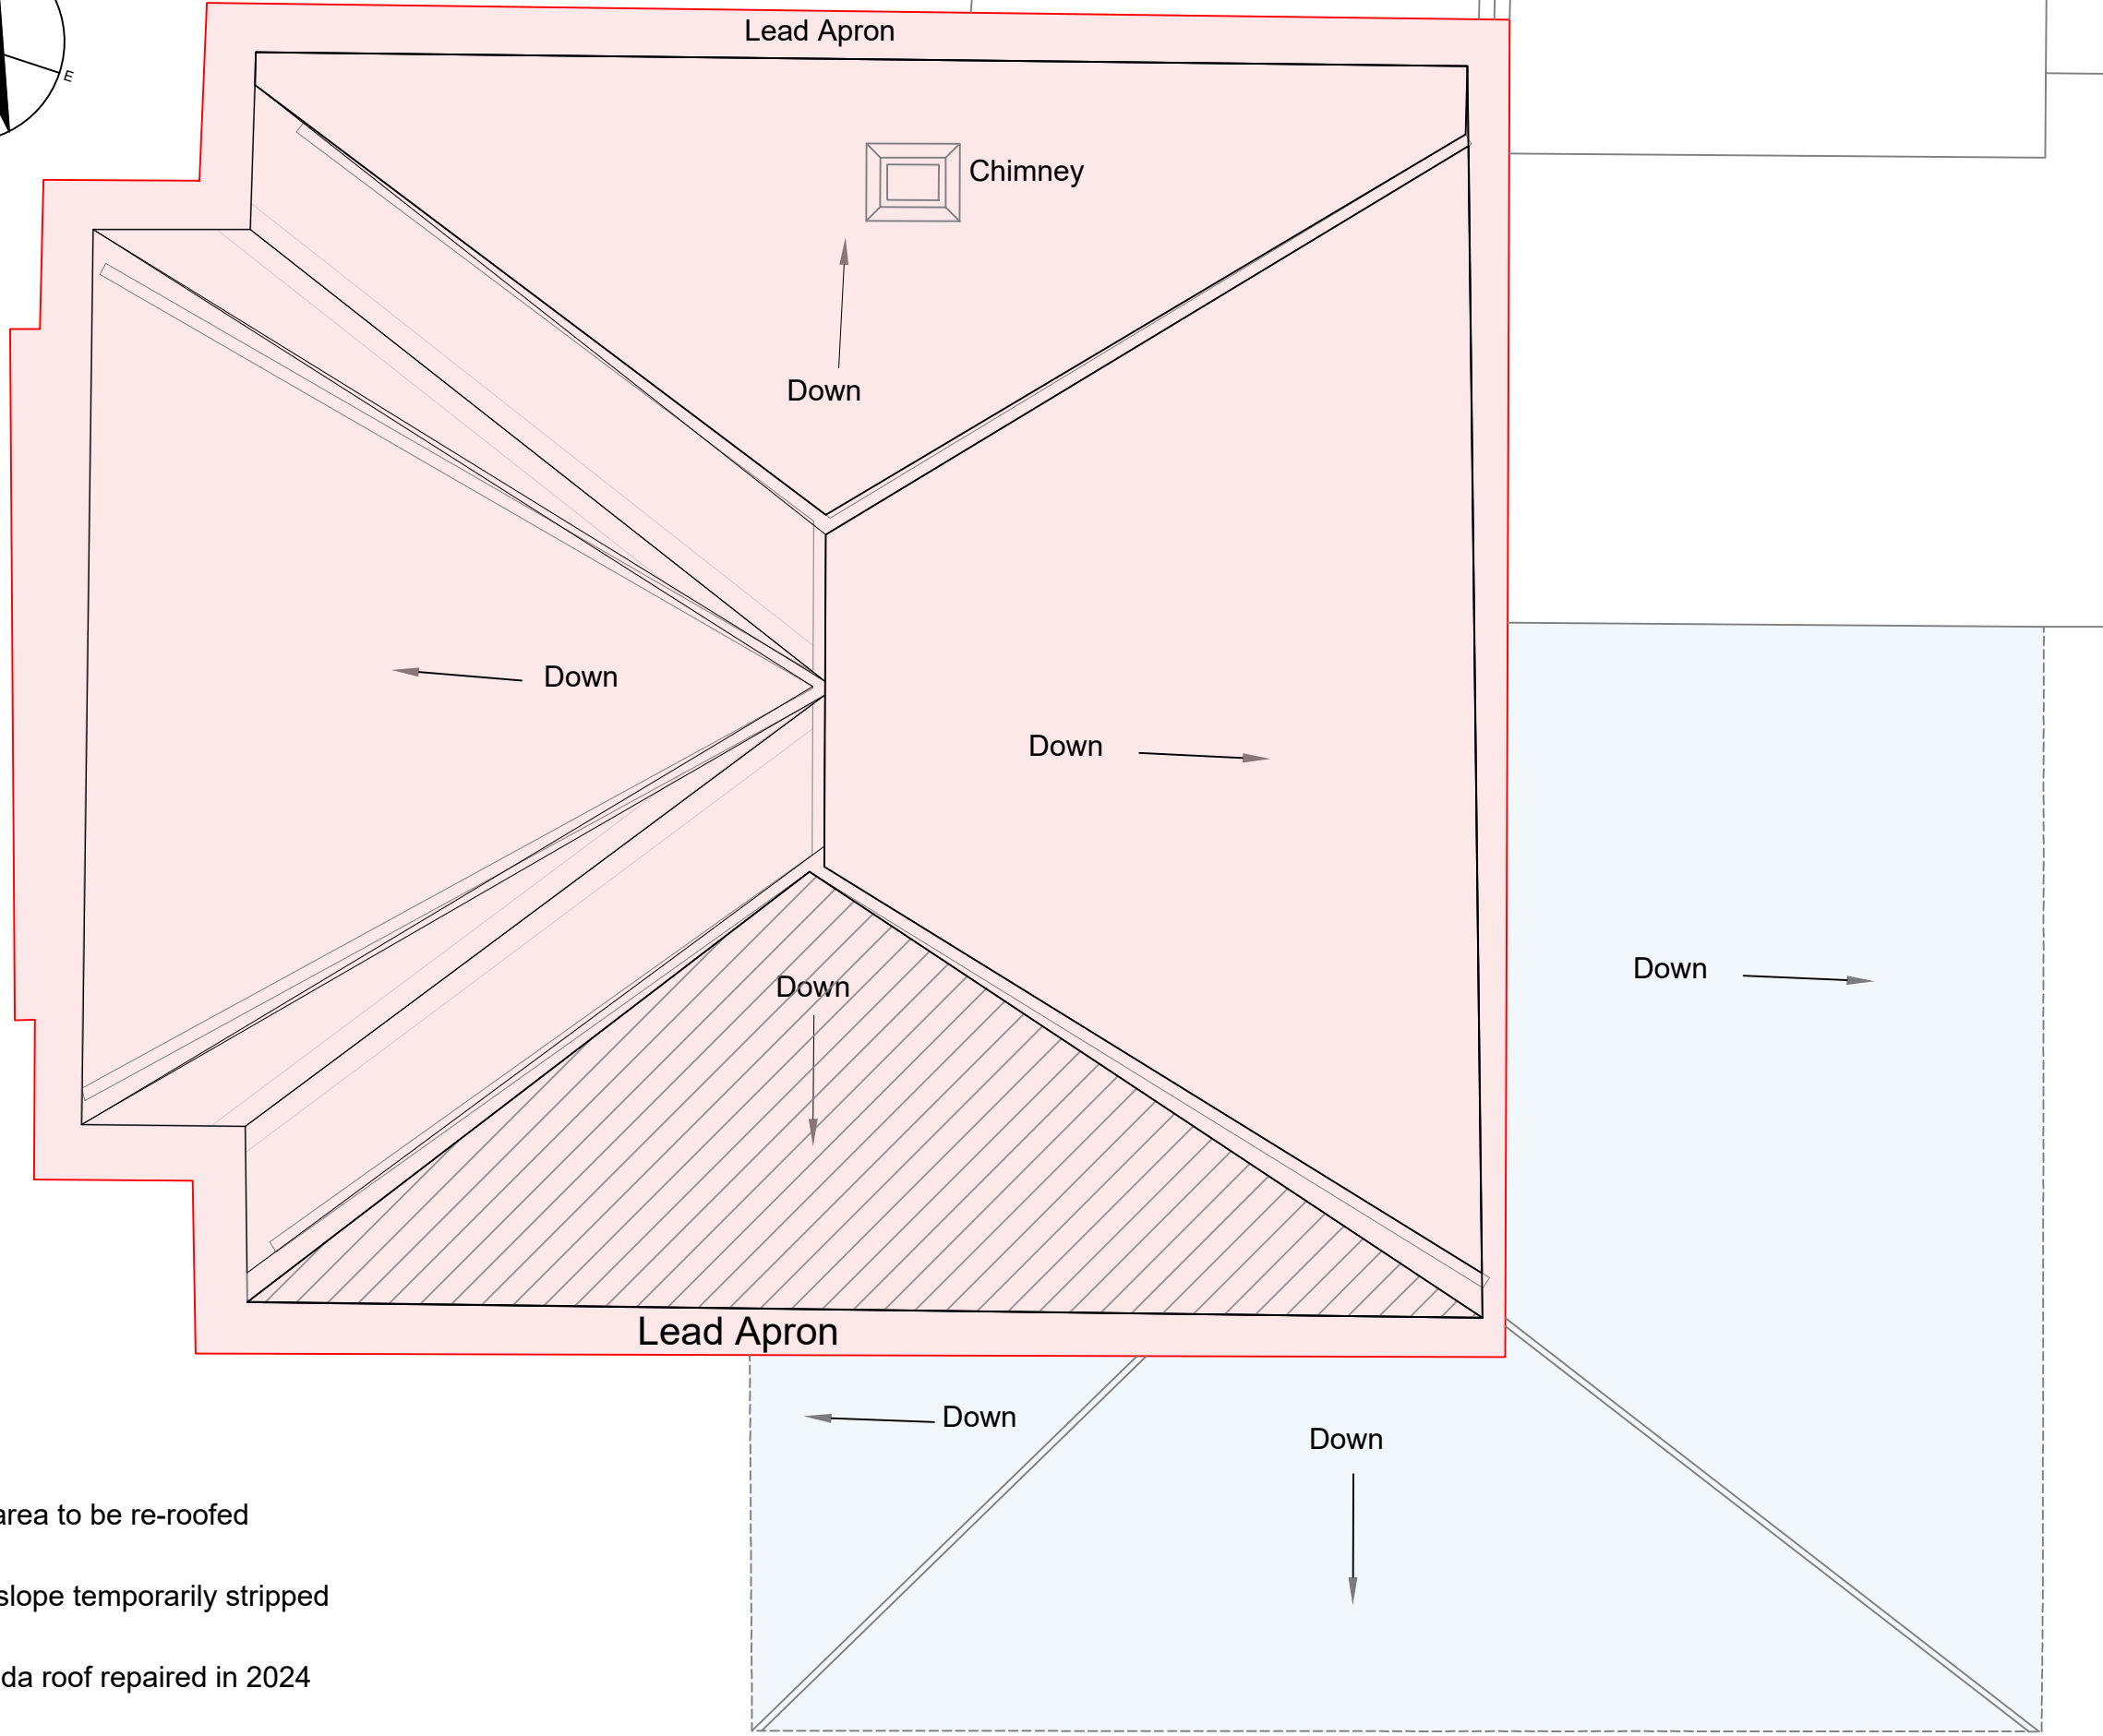
Project Title Gun Room Roof & Ceiling Survey	Drawing Title Roof Plan
Drawn By David Rankine	Date 24 March 2025
Scale @ A3 1:50	Property Reference -
Drawing No WCG_GRR Surv_01	Revision 0

- Roof area to be re-roofed
- Roof slope temporarily stripped
- Veranda roof repaired in 2024

It is recommended that the roof coverings are removed and replaced with improved detailing. The higher quality Welsh slate roof coverings should be retained for reuse where possible. The new detailing should include counter battening to provide ventilation to the roof void and larger head laps to the slates. All leadwork should be replaced with new, appropriately sized sheets jointed and secured to LSTA approved details.

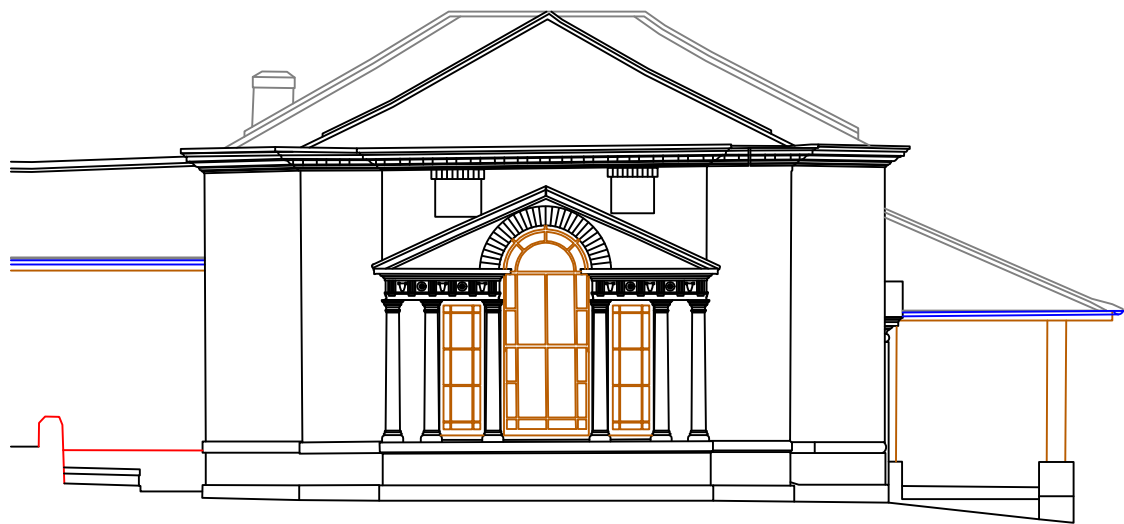
West Elevation

Loss of detail observed on the west elevation

Water staining and vegetation growth on the west elevation

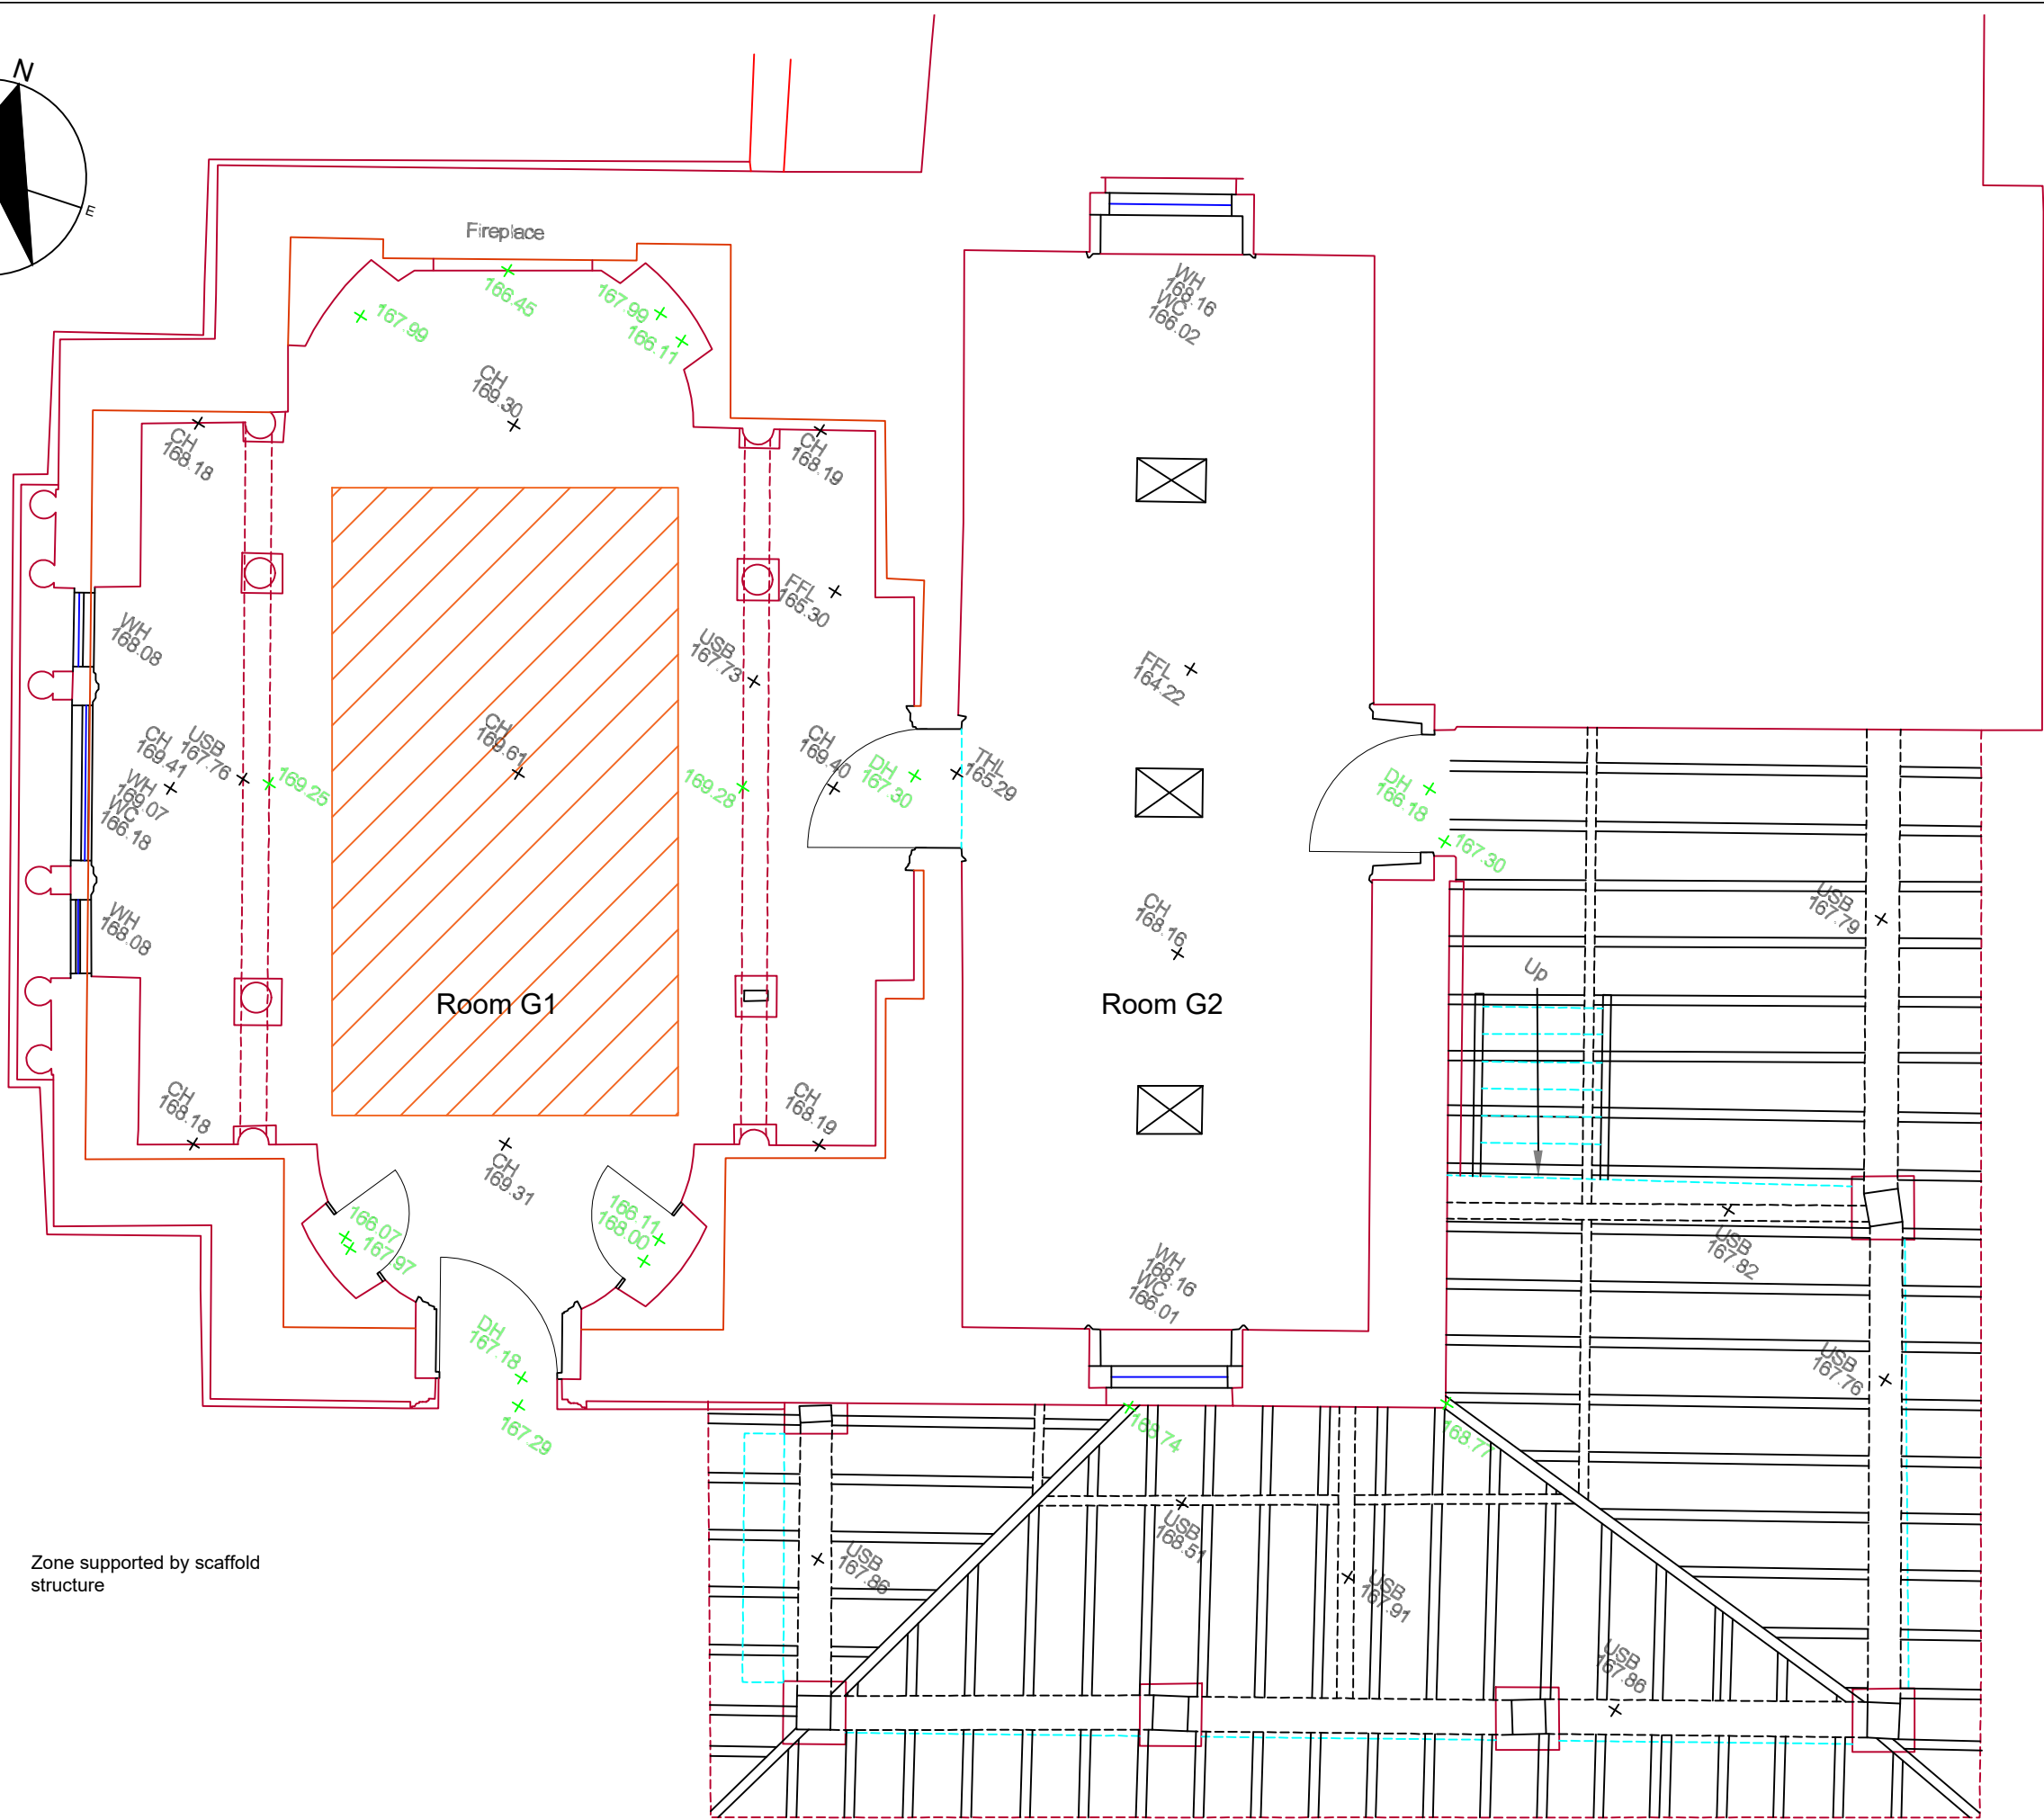
Project Title Gun Room Roof & Ceiling Survey	Drawing Title Existing Floor Plan
Drawn By David Rankine	Date 24 March 2025
Scale @ A3 1:50	Property Reference -
Drawing No WCG_GRR Surv_04	Revision 0

Zone supported by scaffold structure

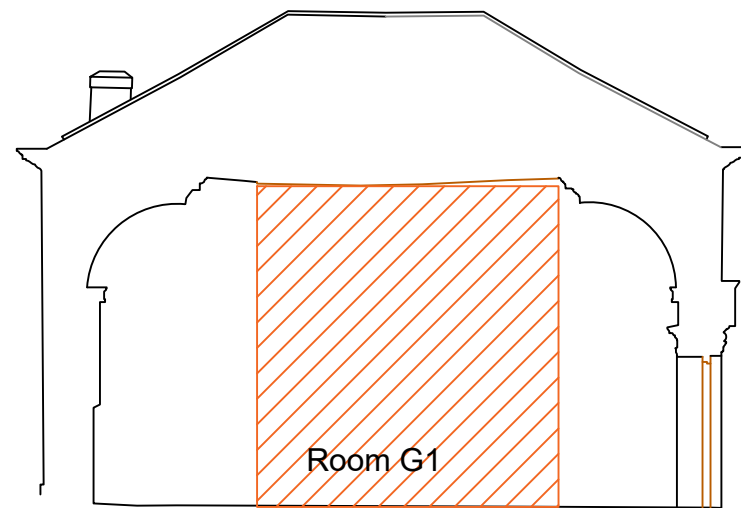
Internal Section A

Approximate line of original ceiling observed from above.
