Project Name: 10008578 - To Your Home Ltd, Manchester Road S36 9LQ
Project Date: 19/05/2021
Inspection Standard: MSCC5 Sewers & Drainage GB (SRM5 Scoring)

CCTV Survey Report

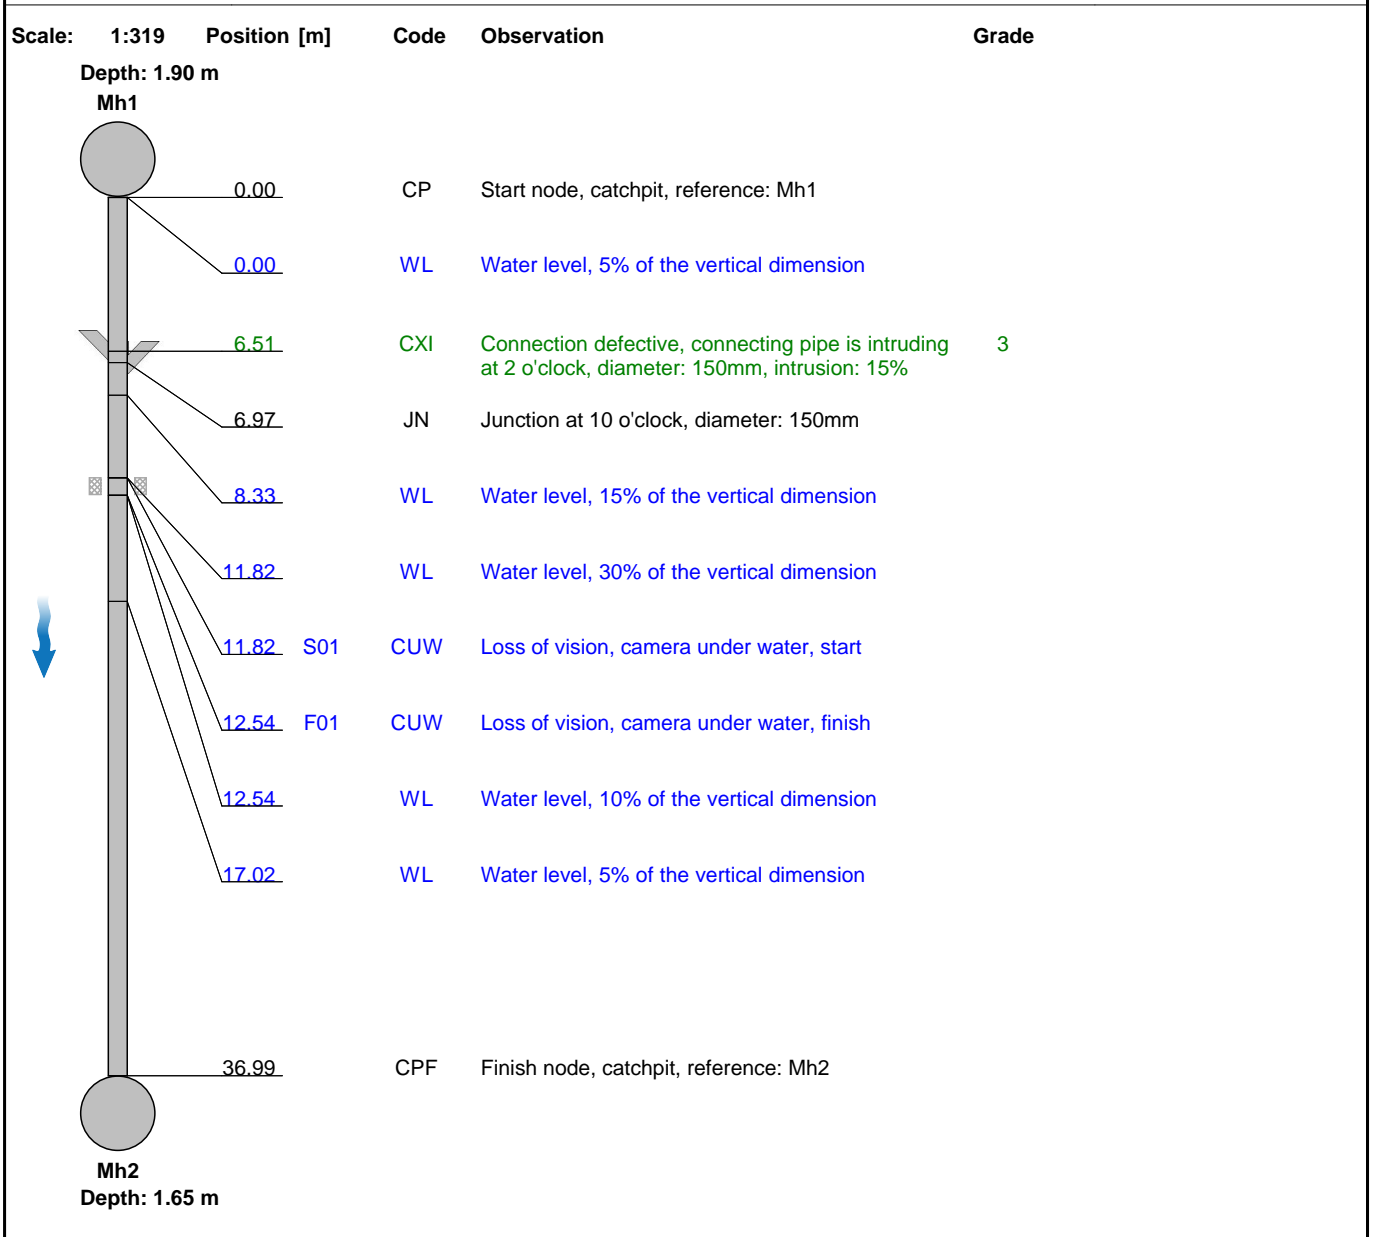
Section Inspection - 19/05/2021 - Mh1X

Section	PLR	Grade	Description
2	Mh1X	3	Connection defective, connecting pipe is intruding at 2 o'clock, diameter: 150mm, intrusion: 15%
5	Mh4X	5	Roots, mass at joint, 30% cross-sectional area loss
6	Mh3X	3	Settled deposits, fine, 10% cross-sectional area loss, finish
8	GullyX	4	Joint displaced, large

Construction Features					Miscellaneous Features				
Structural Defects					Service & Operational Observations				
STR No. Def	STR Peak	STR Mean	STR Total	STR Grade	SER No. Def	SER Peak	SER Mean	SER Total	SER Grade
0	0.0	0.0	0.0	1.0	1	2.0	0.1	2.0	3.0

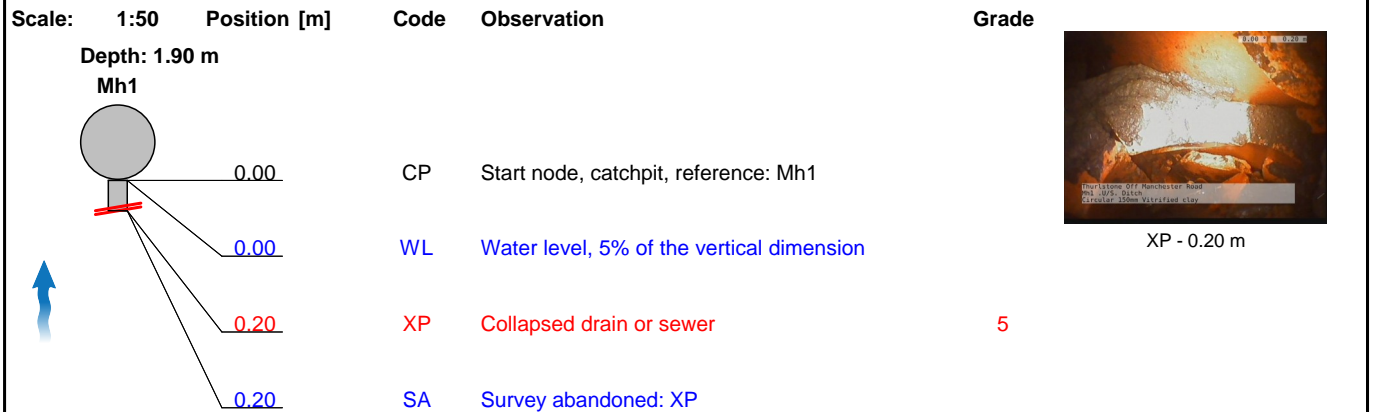
Section Inspection - 19/05/2021 - DitchX

Section	PLR	Grade	Description
3	DitchX	5	Collapsed drain or sewer
5	Mh4X	4	Hole in drain or sewer at joint at 12 o'clock

Section	PLR	Description
3	DitchX	Survey abandoned
4	Mh5X	Survey abandoned
8	GullyX	Survey abandoned

Construction Features					Miscellaneous Features				
Structural Defects					Service & Operational Observations				
STR No. Def	STR Peak	STR Mean	STR Total	STR Grade	SER No. Def	SER Peak	SER Mean	SER Total	SER Grade
1	165.0	825.0	165.0	5.0	0	0.0	0.0	0.0	1.0

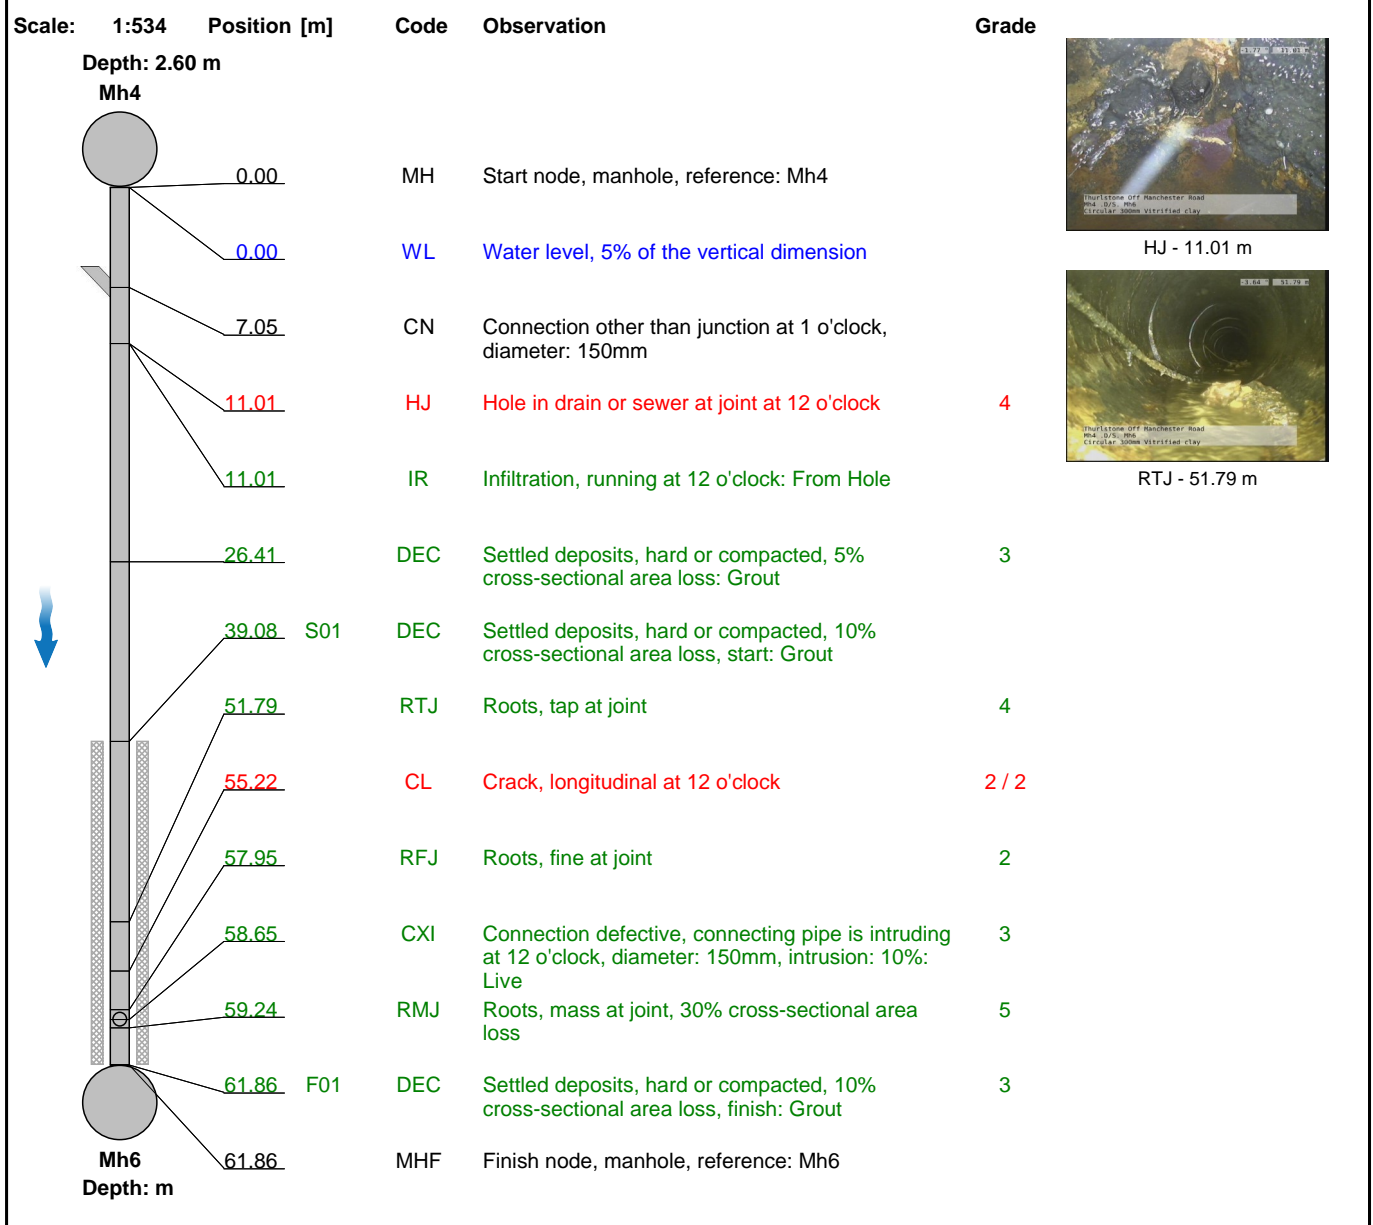
Construction Features					Miscellaneous Features						
Structural Defects					Service & Operational Observations						
STR No.	Def	STR Peak	STR Mean	STR Total	STR Grade	SER No.	Def	SER Peak	SER Mean	SER Total	SER Grade
2		80.0	8.2	90.0	4.0	7		12.0	6.1	67.0	5.0

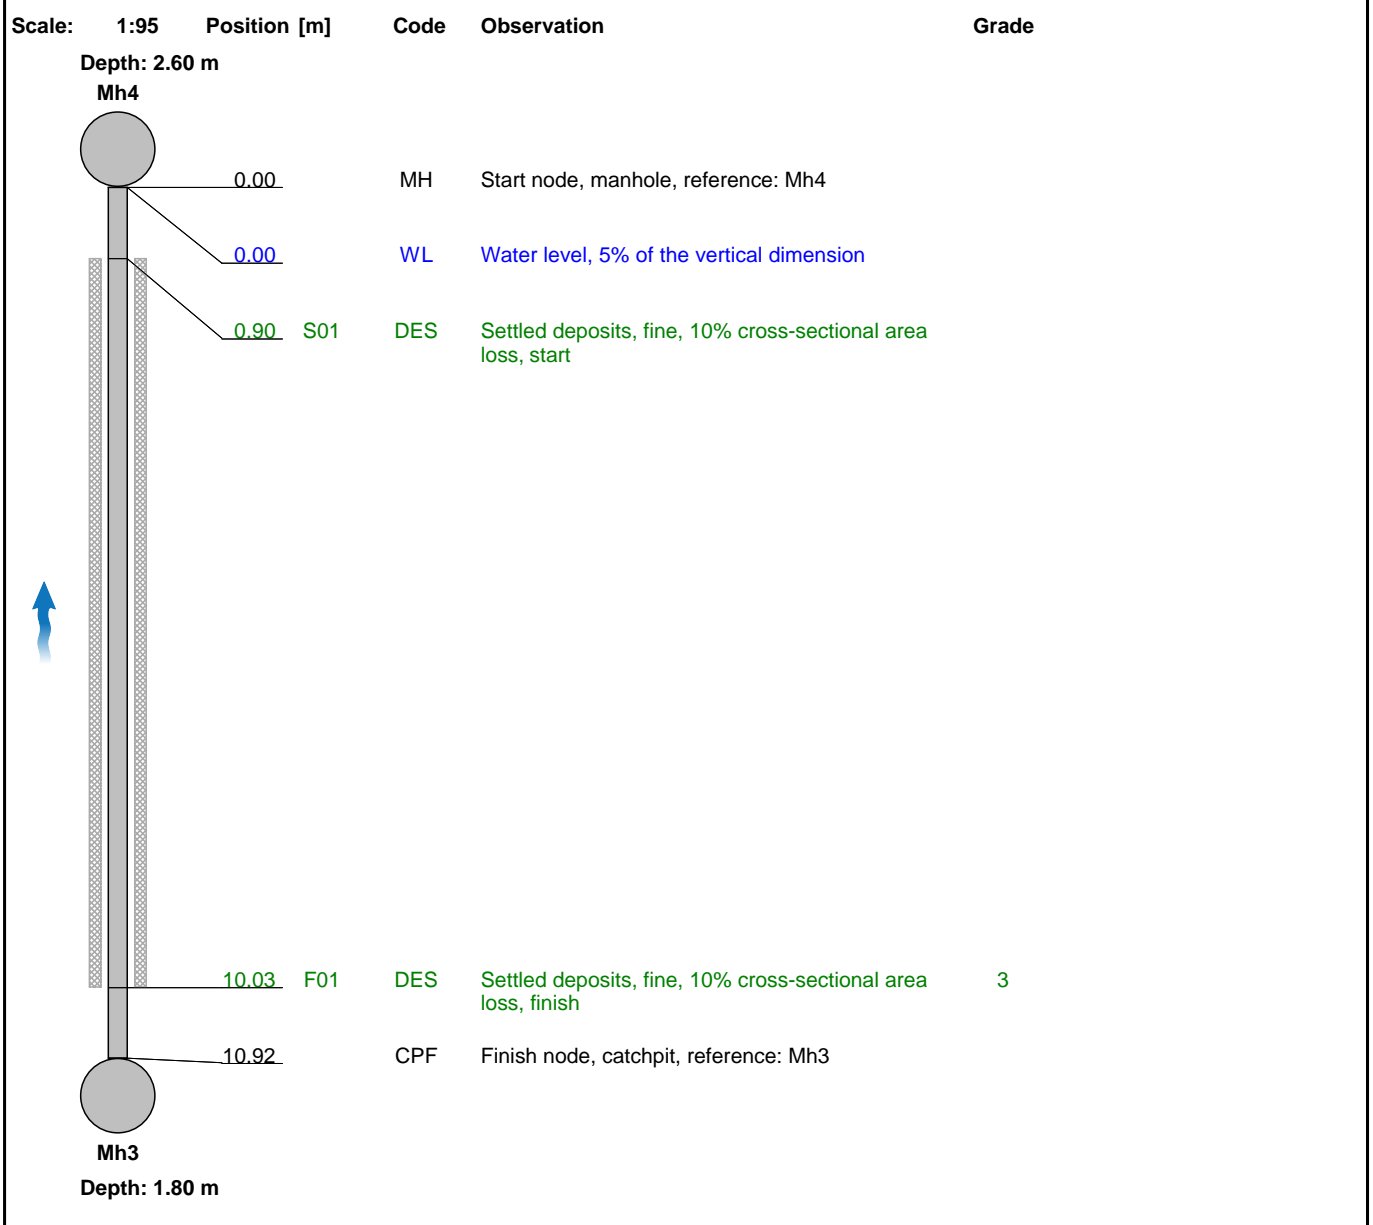
Construction Features					Miscellaneous Features				
Structural Defects					Service & Operational Observations				
STR No. Def	STR Peak	STR Mean	STR Total	STR Grade	SER No. Def	SER Peak	SER Mean	SER Total	SER Grade
0	0.0	0.0	0.0	1.0	1	2.0	1.8	20.0	3.0

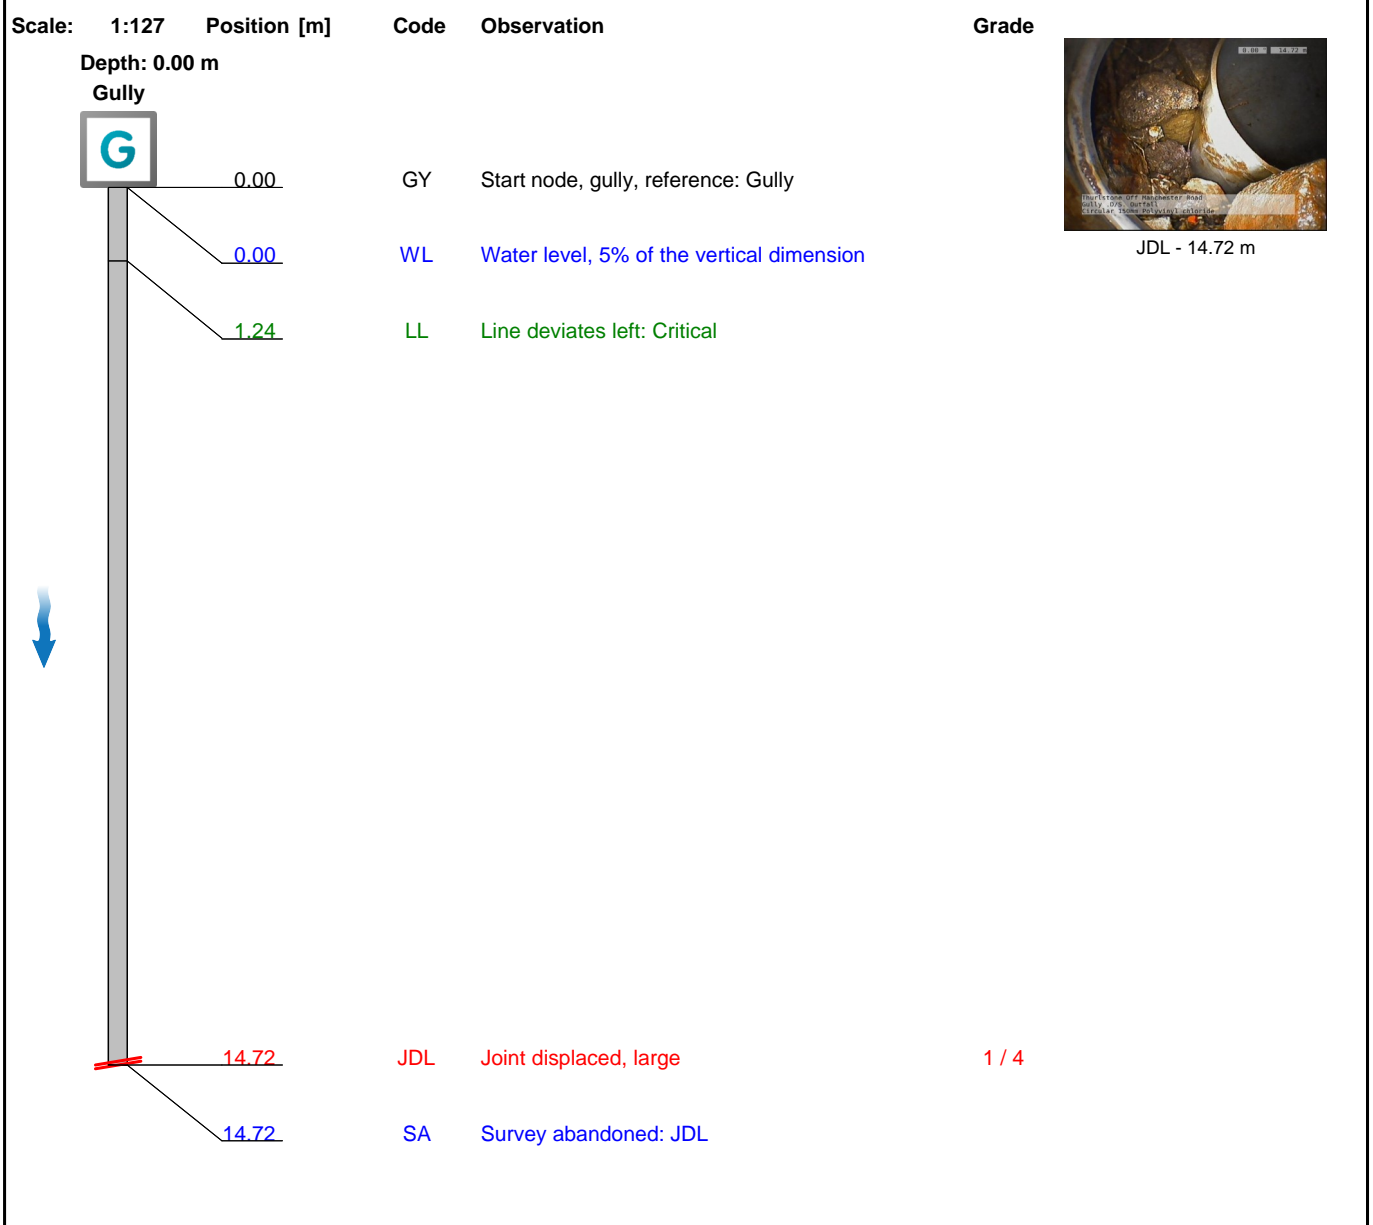
Section Inspection - 19/05/2021 - GullyX

Construction Features					Miscellaneous Features				
Structural Defects					Service & Operational Observations				
STR No. Def	STR Peak	STR Mean	STR Total	STR Grade	SER No. Def	SER Peak	SER Mean	SER Total	SER Grade
1	2.0	0.1	2.0	1.0	1	5.0	0.3	5.0	4.0
