Tree Survey; **Holiday Inn, Dodworth, Barnsley.  
(former Brooklands)**

Client; **Francis Hindle Esq. General Manager.**

Date of Survey; **January 19<sup>th</sup> 20<sup>th</sup>, 2010.**

File reference **new garden area 01**

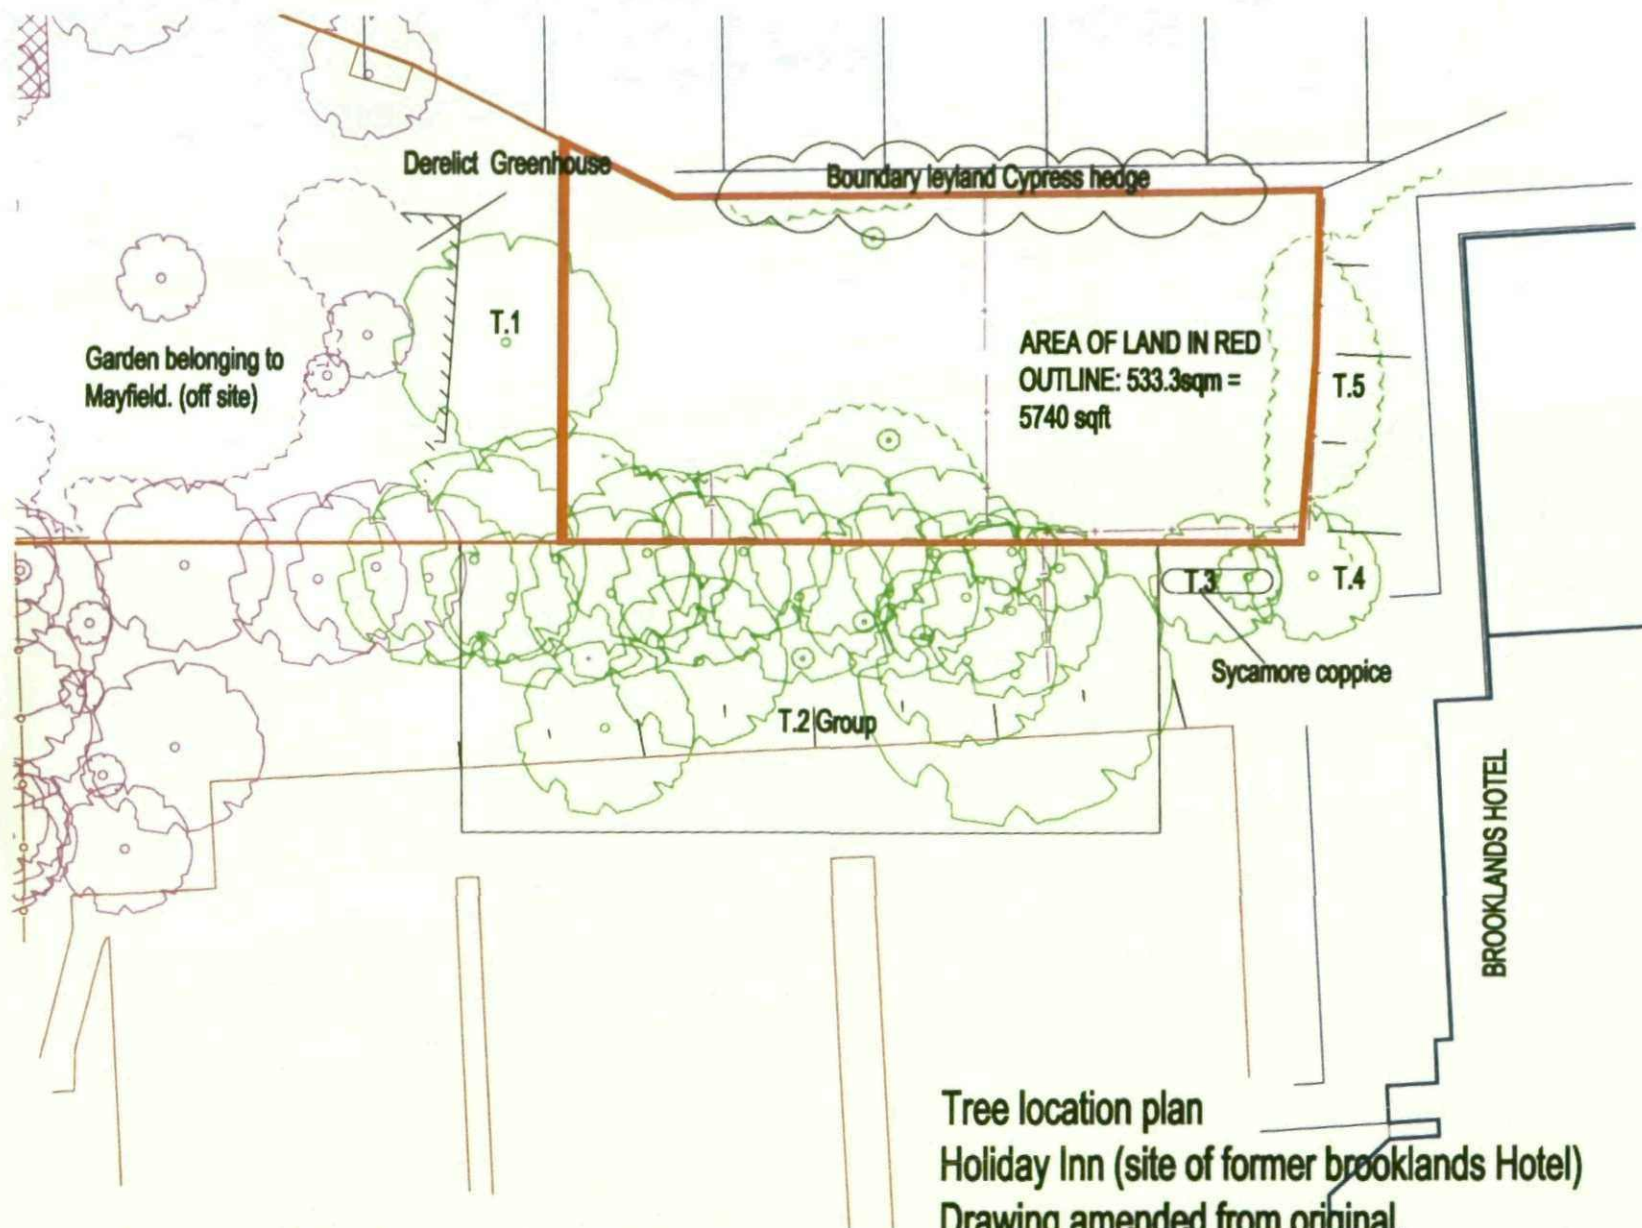
Tree location plan  
 Holiday Inn (site of former Brooklands Hotel)  
 Drawing amended from original.  
 Drawing not to scale  
 January 2010
