RISK ASSESSMENT,  
SSSI, STAIRFOOT  
AT  
PROPOSED CULLET RECYCLING FACILITY  
WOMBWELL LANE, BARNSELY, S70 3NS  
FOR  
POTTERS-BALLOTINI LTD  
REPORT REF: PB 3505/SSSI

REPORT REF: PB 3505/SSSI

November 2022

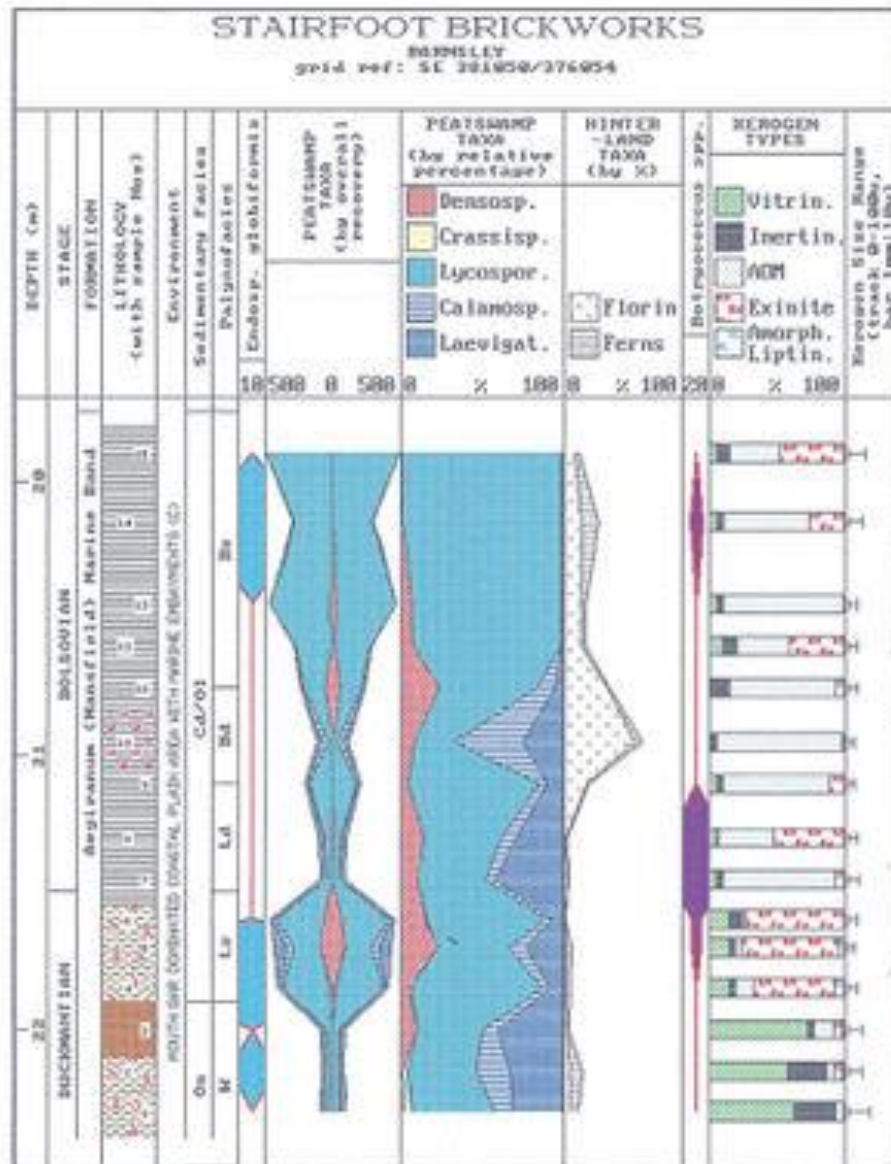
**Figure 8 Fossil Horizon Description**

The Aegiranum (Mansfield) Marine Band marks the base of the Duckmantian-Bolsovian (Westphalian C) Measures and is well documented. The Marine Band comprises a dark grey mudstone and bioturbated siltstone with rare layers of impure limestone or calcareous siltstone, and commonly overlies a thin coal and seatearth.

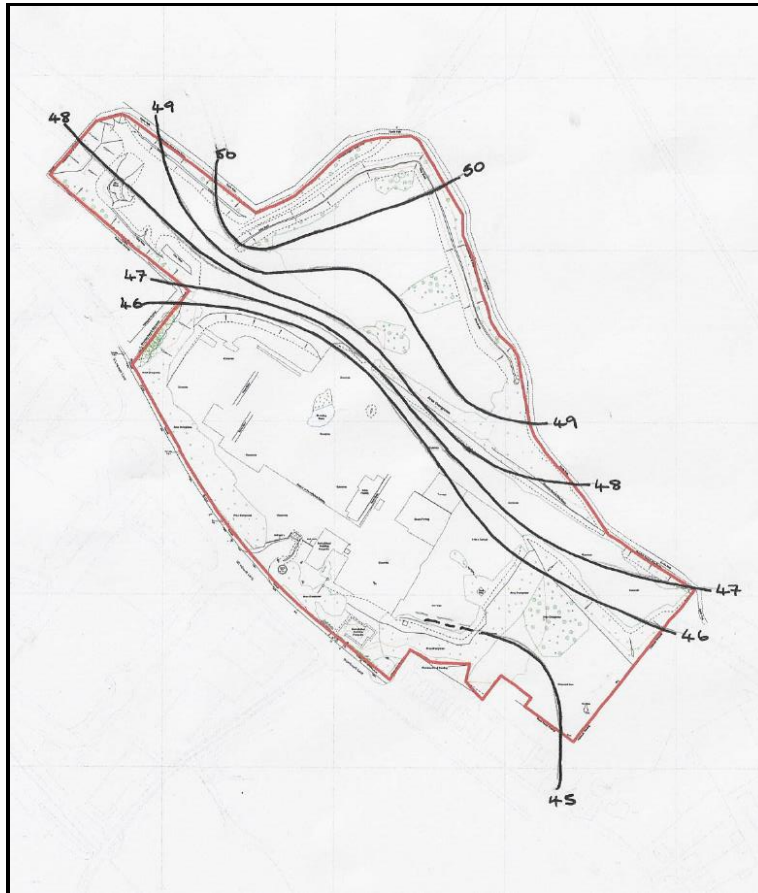
**Figure 9 Contours of Groundwater Levels in m aOD (2021)**

During a ground investigation undertaken on the proposed development site, the groundwater depth in each borehole was monitored and converted into a level above OD and the highest groundwater levels recorded were used to draw groundwater contours across the site as shown in Figure 9. This shows the groundwater at a level of around 50m aOD in the northern extremity of the site reducing to 45m aOD at the front of the site along Wombwell Lane.

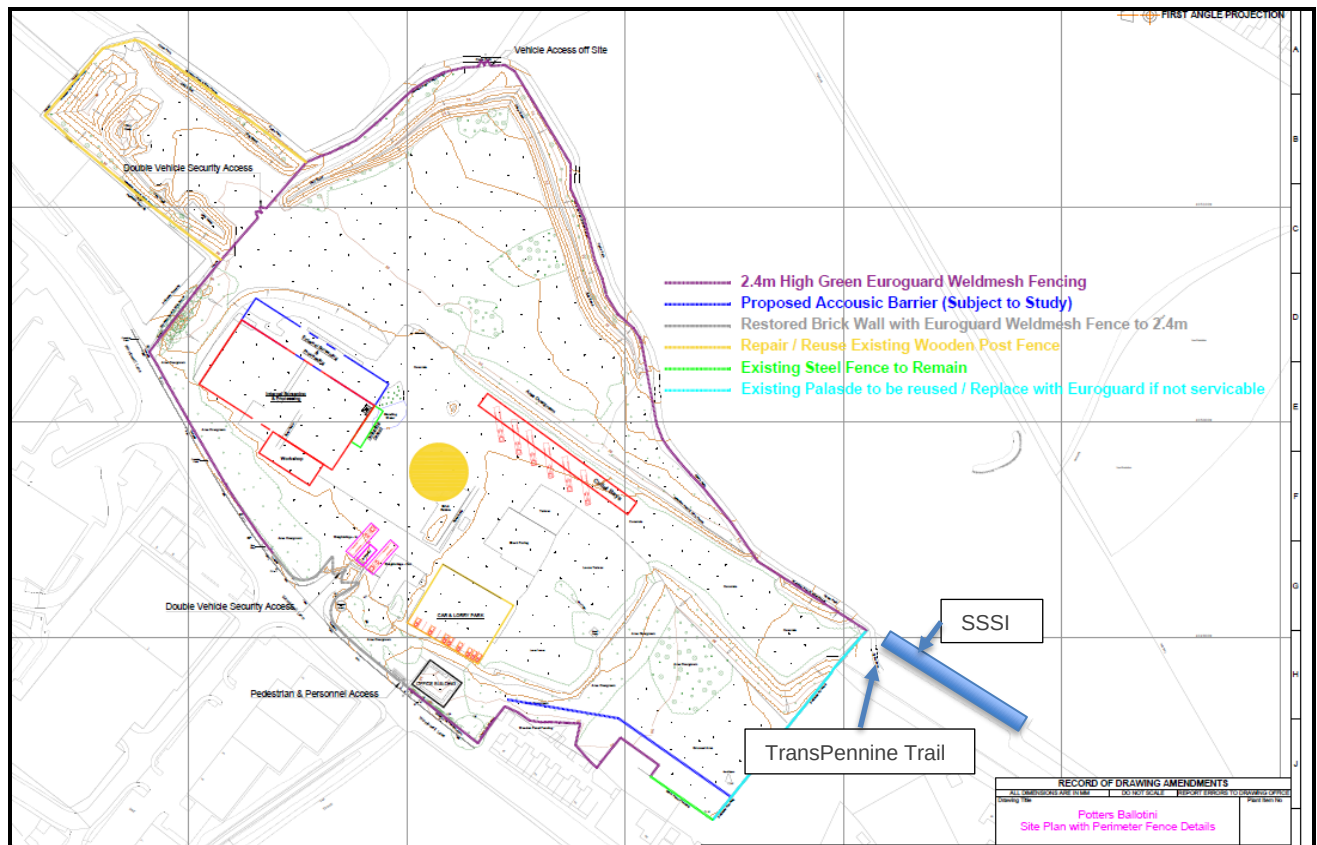
**Figure 10 Fencing detail around Proposed Development Site.**

The facility will deal with its own waste off site, there will be no dumping or disposing of soil or other materials on or in the region of the SSSI. The site will be fenced to prevent unauthorised access and to retain staff and materials within its boundaries.
