Project:	Barnsley Children's Hospital		
Our reference:	BCAU-MMD-00-XX-TN-D-0001		
Prepared by:	J Lea-Wilson	Date:	05/02/2020
Approved by:	A Precious	Checked by:	A Precious
Subject:	Surface Water Planning Conditions

1 Project Background

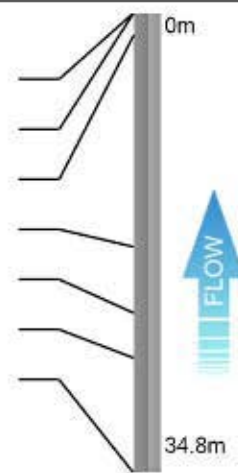
Position	Code	Description	CD	Pic	Video Ref
00.00m	MH	Start node type, manhole			
00.00m	WL	Water level 0%			0:00:00
01.70m	JDM	Joint displaced medium		1_2	0:00:18
17.70m	WL	S1 Water level 20%	S1	1_3	0:00:56
22.70m	JDM	Joint displaced medium		1_4	0:01:15
26.10m	JDM	Joint displaced medium		1_5	0:01:25
34.80m	SA	Survey abandoned

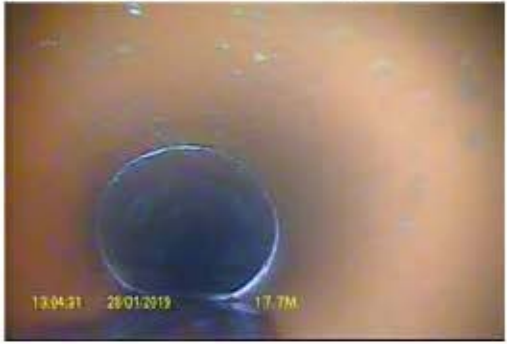
17.70m	0:00:56	S1 WL	Water level 17.7m - 34.8m: 20% Height/Diameter	<p>Image Provided - Ref: 1_3</p>

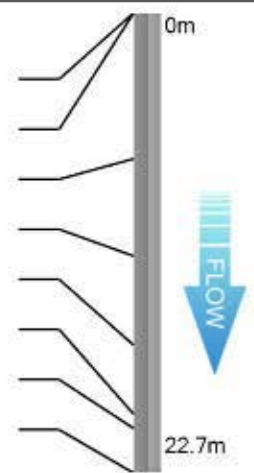
Position	Code	Description	CD	Pic	Video Ref	
00.00m	MH	Start node type, manhole				
00.00m	WL	Water level 0%			0:00:00	
07.20m	WL	S1 Water level 20%	S1		0:00:33	
12.00m	JDM	Joint displaced medium		2_3	0:00:43	
16.40m	JDM	Joint displaced medium		2_4	0:00:58	
19.80m	JDM	Joint displaced medium		2_5	0:01:34	
20.50m	JDM	Joint displaced medium		2_6	0:02:17	
22.70m	SA	Survey abandoned

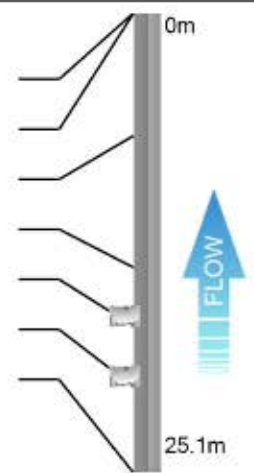
Position	Code	Description	CD	Pic	Video Ref
00.00m	MH	Start node type, manhole			
00.00m	WL	Water level 0%			0:00:00
06.70m	JDM	Joint displaced medium		3_2	0:00:33
13.90m	JDM	Joint displaced medium		3_3	0:01:04
17.10m	JN	Junction 03 : 100mm Diameter		3_4	0:01:16
20.40m	JN	Junction 02 : 100mm Diameter		3_5	0:01:35
25.10m	MHF	Finish node type, manhole

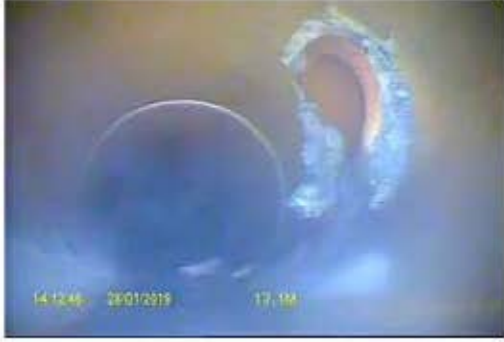
17.10m	0:01:16	JN	Junction at 03 o'clock: 100mm Diameter	<p>Image Provided - Ref: 3_4</p>

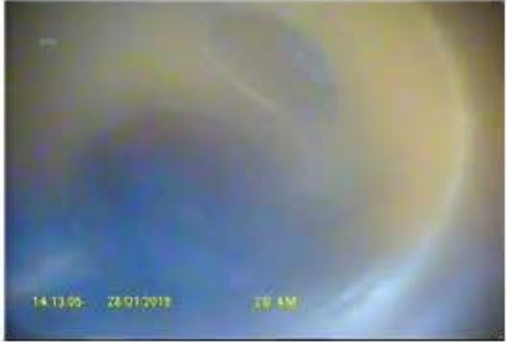
Pos	Video Ref	Code	Description	Image
20.40m	0:01:35	JN	Junction at 02 o'clock: 100mm Diameter	Image Provided - Ref: 3_5

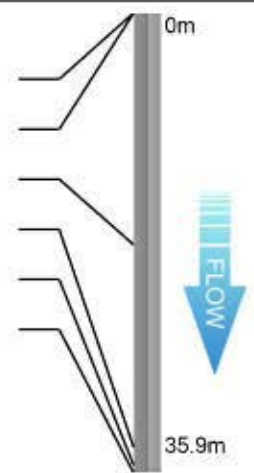
Position	Code	Description	CD	Pic	Video Ref
00.00m	MH	Start node type, manhole			
00.00m	WL	Water level 0%			0:00:00
18.10m	JDM	Joint displaced medium		4_2	0:00:41
33.90m	JDM	Joint displaced medium		4_3	0:01:11
35.30m	JDM	Joint displaced medium		4_4	0:01:20
35.90m	SA	Survey abandoned

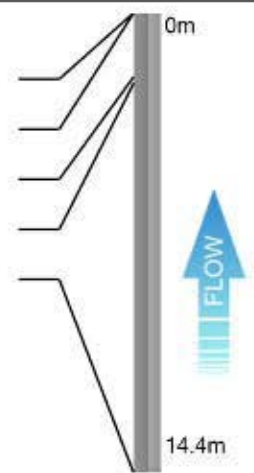
Position	Code	Description	CD	Pic	Video Ref
00.00m	MH	Start node type, manhole			
00.00m	WL	Water level 0%			0:00:00
02.00m	LLQ	Line of drain/sewer deviates left [quarter]		6_2	0:00:14
02.20m	JDM	Joint displaced medium		6_3	0:00:27
14.40m	GYF	Finish node type Gully		6_99

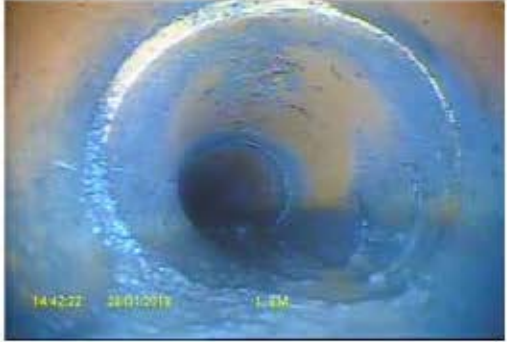
Pos	Video Ref	Code	Description	Image
00.00m		MH	Start node type, manhole MH02	
00.00m	0:00:00	WL	Water level: 0% Height/Diameter	
02.00m	0:00:14	LLQ	Line of drain/sewer deviates left [quarter]	Image Provided - Ref: 6_2

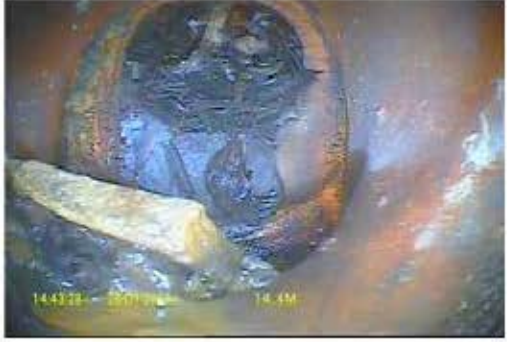
14.40m		GYF	Finish node type Gully GULLY	Image Provided - Ref: 6_9999

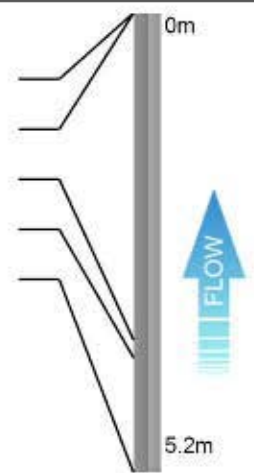
Position	Code	Description	CD	Pic	Video Ref
00.00m	MH	Start node type, manhole			
00.00m	WL	Water level 0%			0:00:00
03.70m	JDM	Joint displaced medium		7_2	0:00:27
03.90m	LUQ	Line of drain/sewer deviates up [quarter]		7_3	0:00:28
05.20m	GYF	Finish node type Gully		7_99

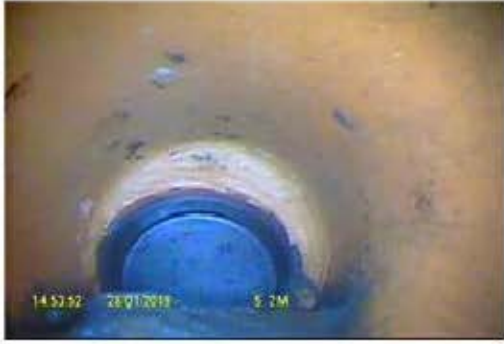
05.20m		GYF	Finish node type Gully GULLY	Image Provided - Ref: 7_9999

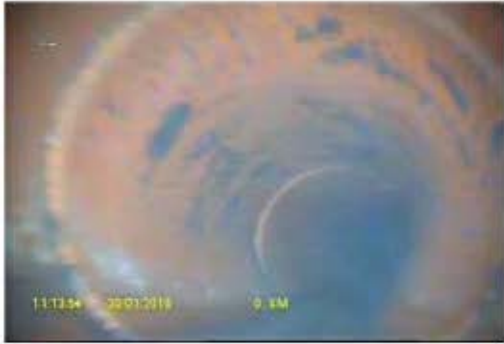
Pos	Video Ref	Code	Description	Image
00.00m		MH	Start node type, manhole MH03	
00.00m	0:00:00	WL	Water level: 0% Height/Diameter	
00.80m	0:00:11	LRQ	Line of drain/sewer deviates right [quarter]	Image Provided - Ref: 8_2

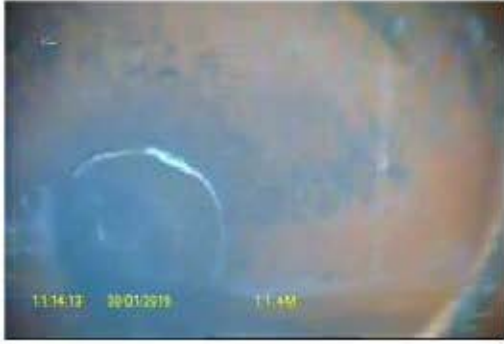
11.40m	0:00:30	LLH	Line of drain/sewer deviates left [half]	Image Provided - Ref: 8_4

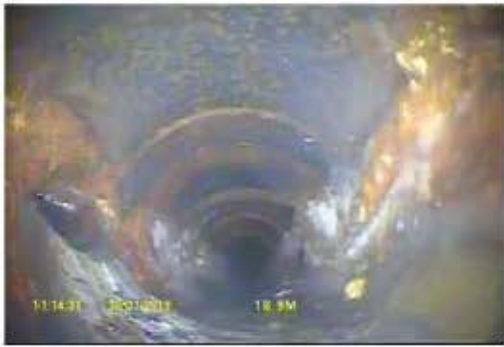
Pos	Video Ref	Code	Description	Image
18.90m	0:00:48	JN	Junction at 09 o'clock: 100mm x 50mm Diameter	Image Provided - Ref: 8_5

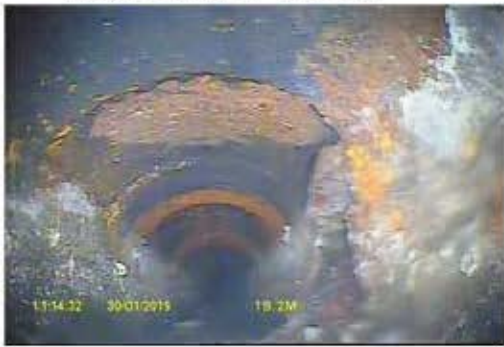
19.20m	0:00:49	JN	Junction at 03 o'clock: 100mm Diameter	Image Provided - Ref: 8_6

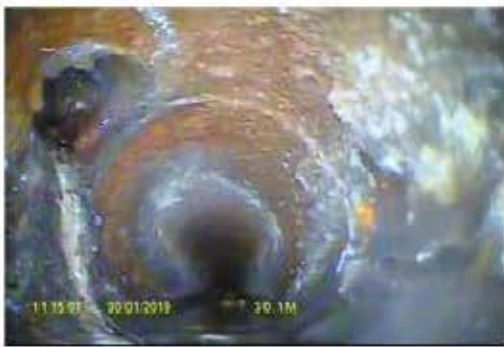
30.10m	0:01:18	JN	Junction at 11 o'clock: 100mm Diameter	Image Provided - Ref: 8_7

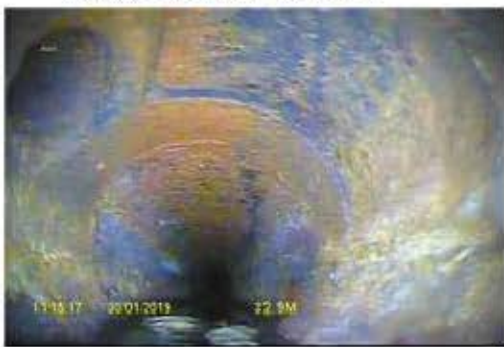
32.70m	0:01:33	JN	Junction at 11 o'clock: 100mm Diameter	Image Provided - Ref: 8_8

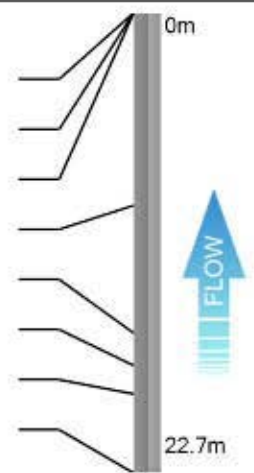
Position	Code	Description	CD	Pic	Video Ref
00.00m	MH	Start node type, manhole			
00.00m	WL	Water level 0%			0:00:00
00.00m	WL	S1 Water level 40%	S1		0:02:18
09.50m	JDM	Joint displaced medium		9_2	0:00:50
15.80m	JDM	Joint displaced medium		9_3	0:01:24
17.40m	JDM	Joint displaced medium		9_4	0:01:29
18.80m	JDM	Joint displaced medium		9_5	0:01:33
22.70m	SA	Survey abandoned

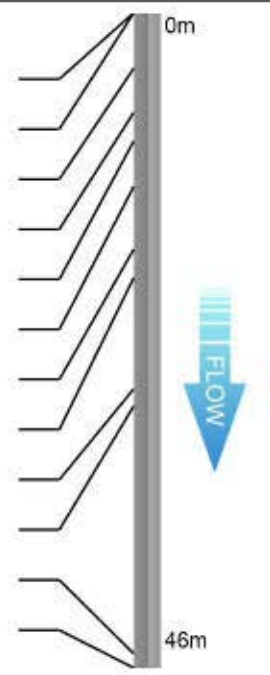
Position	Code	Description	CD	Pic	Video Ref
00.00m	MH	Start node type, manhole			
00.00m	WL	Water level 0%			0:00:00
03.90m	JDM	Joint displaced medium		10_2	0:00:19
07.00m	CU	Loss of vision			0:00:25
09.00m	JDM	Joint displaced medium		10_4	0:00:34
12.20m	JDM	Joint displaced medium		10_5	0:00:39
16.60m	JDM	Joint displaced medium		10_6	0:00:46
18.60m	WL	S1 Water level 40%	S1		0:00:54
26.40m	CM	Cracks, multiple 12-06		10_8	0:01:04
27.60m	CM	Cracks, multiple 09-03		10_9	0:01:31
45.00m	CU	S2 Loss of vision	S2		0:02:34
46.00m	SA	Survey abandoned

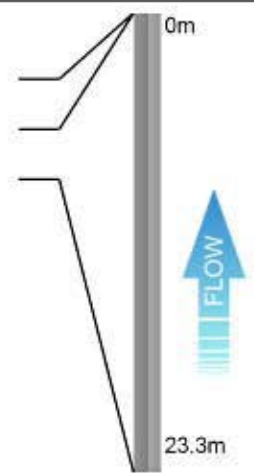
Position	Code	Description	CD	Pic	Video Ref
00.00m	MH	Start node type, manhole			
00.00m	WL	Water level 0%			0:00:00
23.30m	SA	Survey abandoned

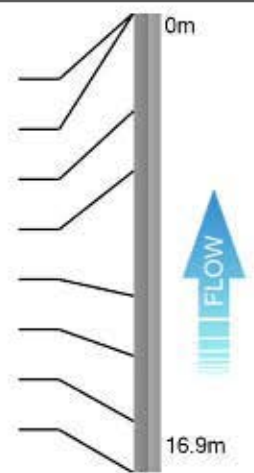
Position	Code	Description	CD	Pic	Video Ref
00.00m	MH	Start node type, manhole			
00.00m	WL	Water level 0%			0:00:00
03.60m	LRQ	Line of drain/sewer deviates right [quarter]		13_2	0:00:17
05.80m	JDM	Joint displaced medium		13_3	0:00:23
10.40m	JDM	Joint displaced medium		13_4	0:00:31
12.60m	JDM	Joint displaced medium		13_5	0:02:45
15.00m	LLQ	Line of drain/sewer deviates left [quarter]		13_6	0:03:04
16.90m	SA	Survey abandoned
