# Arboricultural Consultancy for Aviva

| Insured | Mr Ian Clifton | Address | Two Oaks, 152 Intake Lane, Barnsley, S75 2HU | | |

**Scope of Report:** To survey the property and determine significant vegetation contributing to subsidence damage, make recommendation for remedial action and assess initial mitigation and recovery prospects. The survey does not make an assessment for decay or hazard evaluation.

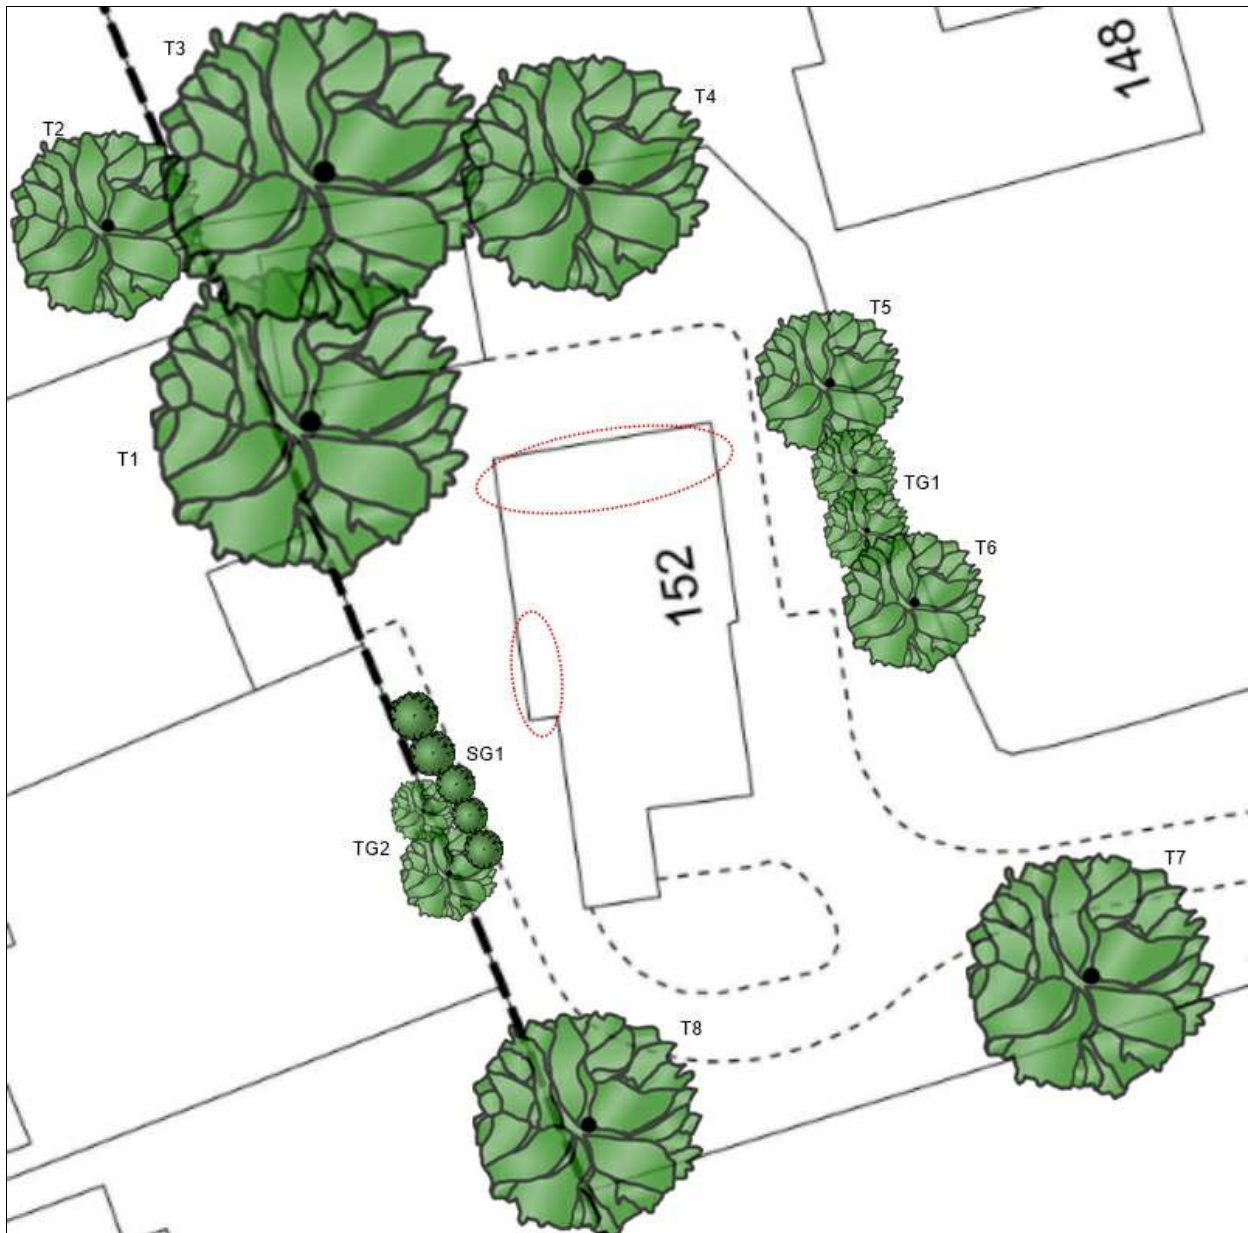
7. Site Plan

The size and proximity of the above vegetation is consistent with the advised locations of damage and it is our opinion, on balance of probability, that roots from the above vegetation will be in proximity to the footings of the insured property.

Given the above and considering the suspected mechanism of movement, in order to mitigate the current damage thereby allowing soils beneath the property to recover to a position such that an effective engineering repair solution can be implemented, we recommend a program of vegetation management as detailed by this report.
