W L Anderson. Dip.Arb(RFS). M Arbor A.

TREE LOCATION PLAN
CROSS STREET, WORSBOROUGH S70
NOT TO SCALE. JUNE 2026

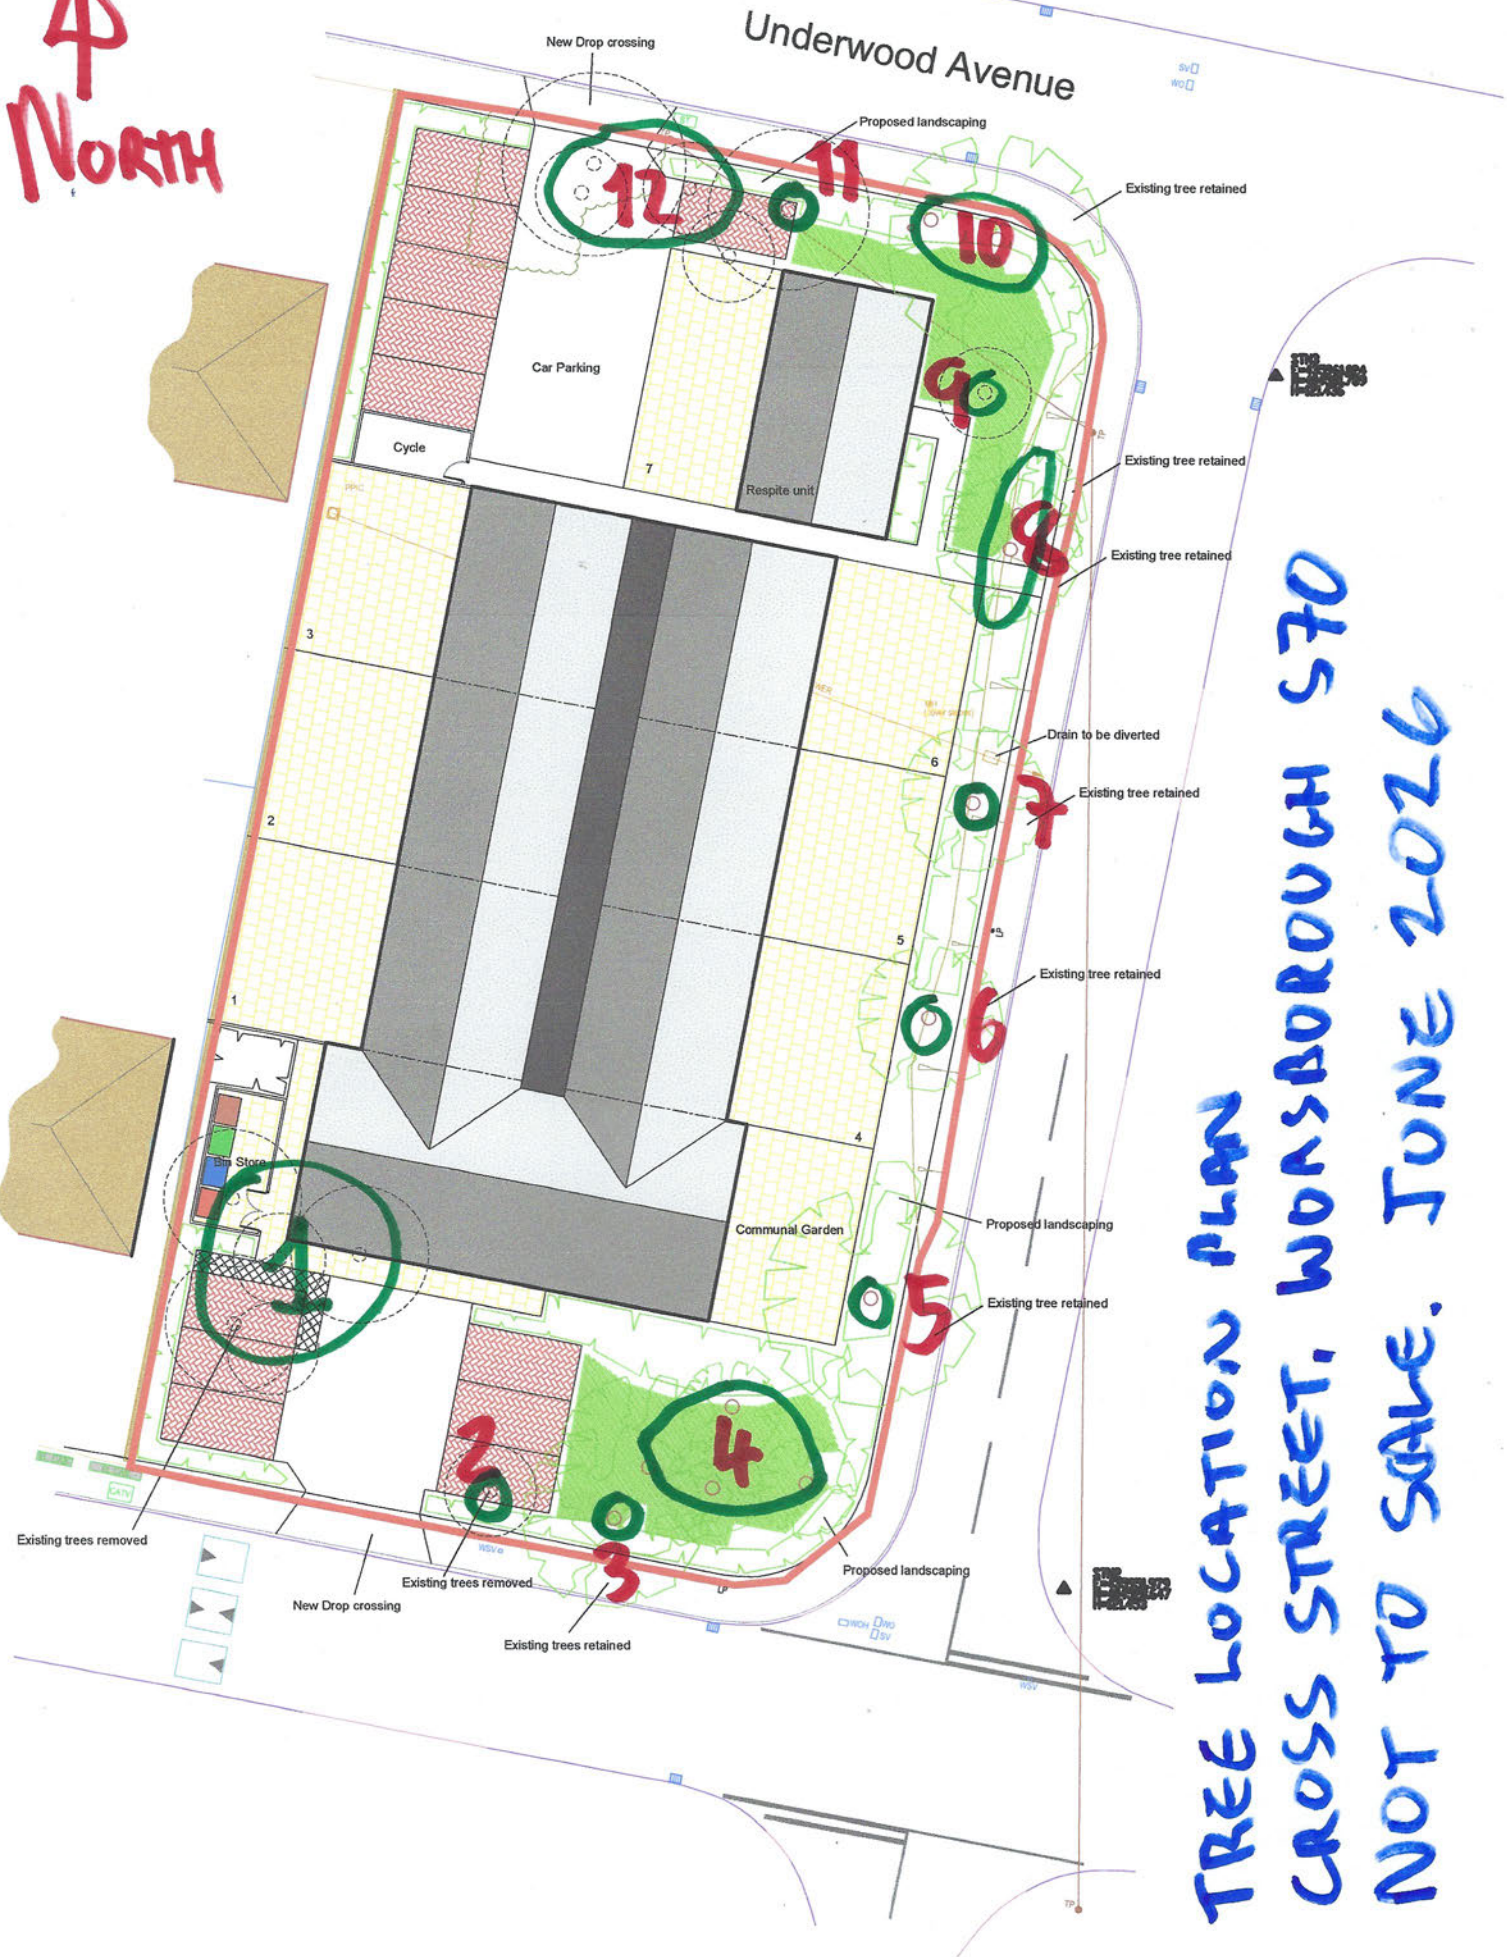
No.	Species	Comment
1.	Sycamore group	Approximately 9 metres tall, close to the neighbouring house. The proposal calls for their removal.
2.	Silver Birch	A poor tree, suppressed by tree 3. The proposal calls for its removal.

3.	Lime	This tree is approximately 13 metres tall and 620 mm diameter, which gives it a root protection area (RPA) radius of 7.5 metres. (See the discussion about Lime cultivars below.)

4.	Group.	Mainly Sycamore but a nearly-dead Holly and a hollow Cherry can be seen in the midst of the Sycamores. The trees are all considerably smaller than the Lime tree 3. There has been much fly-tipping at the base of the trees.

5.	Lime	This tree is coppice growth. There are several smaller stems that have grown from the stump of a now removed tree. this tree would require the same RPA as tree 3. There has been some significant soil disturbance at the base of this tree. (And with trees 6 to 8 as well.) It seems a new footpath has been installed alongside the highway and this has almost certainly caused root damage to the road side trees. The plan seems to call for the garden area to be paved, which means almost all of the RPA will be paved.

6.	Sycamore	Coppice growth, will require a similar RPA to tree 3, and if the garden is paved; as tree 5.
7.	Sycamore	More coppice growth, as tree 6. Additionally, there is a drain inspection chamber at the base of the tree. if this is to be relocated or modified, root damage is inevitable.

8.	Group	Mainly Sycamore, the largest is a similar size to tree 7, and will require a similar RPA. The plans do not require quite as much paving nearby as the previous trees, but the building will be within the RPA.

1. The most sensible option for this site is to remove all the existing trees, and replant once building work is complete.
2. Although it would be feasible to try and keep some of the trees, many have already suffered root damage, and further disturbance is likely to lead to decline.
3. The worst-case scenario here is that we try to keep trees and then end up watching them decline slowly over the coming years. Planting new trees in good topsoil, in positions specifically created for growing trees and hedges, is likely to give the best long-term outcome.
