Our Ref: 2017/436/TI

11<sup>th</sup> January 2018

**Structural Conditional Report for 319-323 Barnsley Road & 2 Haigh Lane, Hoylandswaine, S36 7HA**

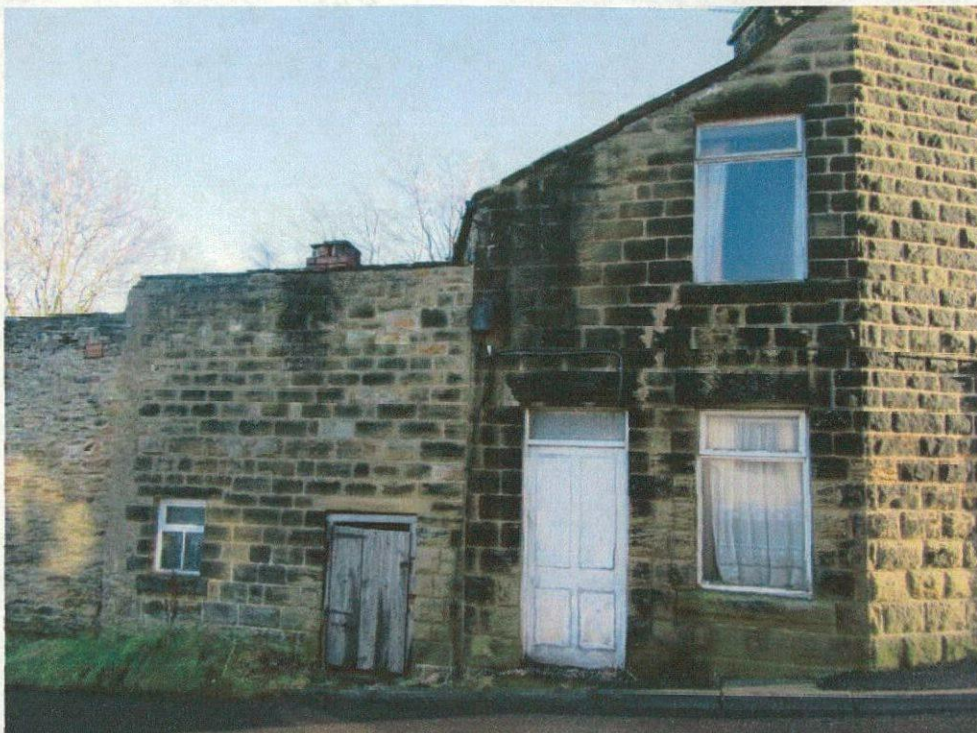
Photo 21 – Left hand gable wall of 2 Haigh Lane (outbuildings start to the left of the front door)

5. Cracking to the left hand gable wall should be made good with a weak mix mortar. Underpinning cannot be ruled out. The cost of undertaking this is considered '**Moderate to High**'.

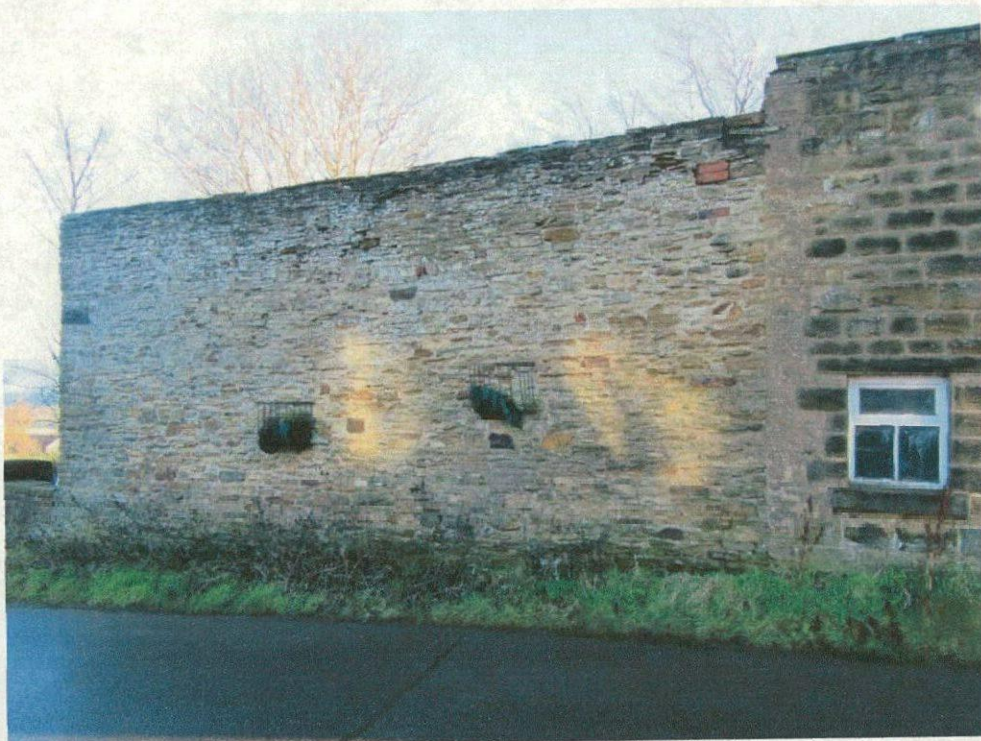
Photo 24 – Left hand wall of garage and outbuildings off 2 Haigh Lane.
