## STRUCTURAL REPORT

| Location | Knabbs Hall Farm, Silkstone Common, Nr Barnsley, S75 4RD |
| application | Re-development, Reinstatement of Dwelling and Conversion of Agricultural Buildings to form 4 dwellings |
| job number | 16/372 |

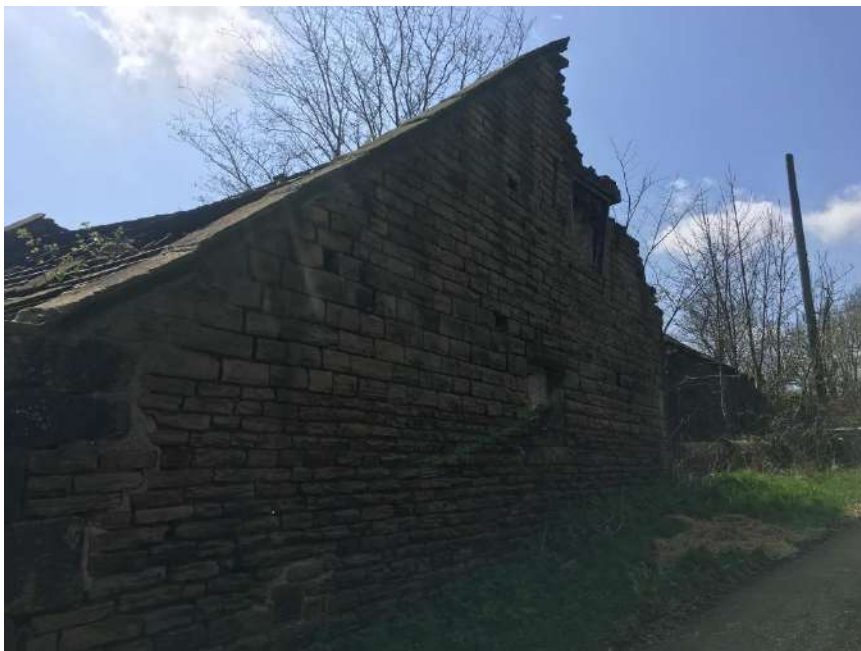
Partly collapsed  
North gable peak  
of Unit 1

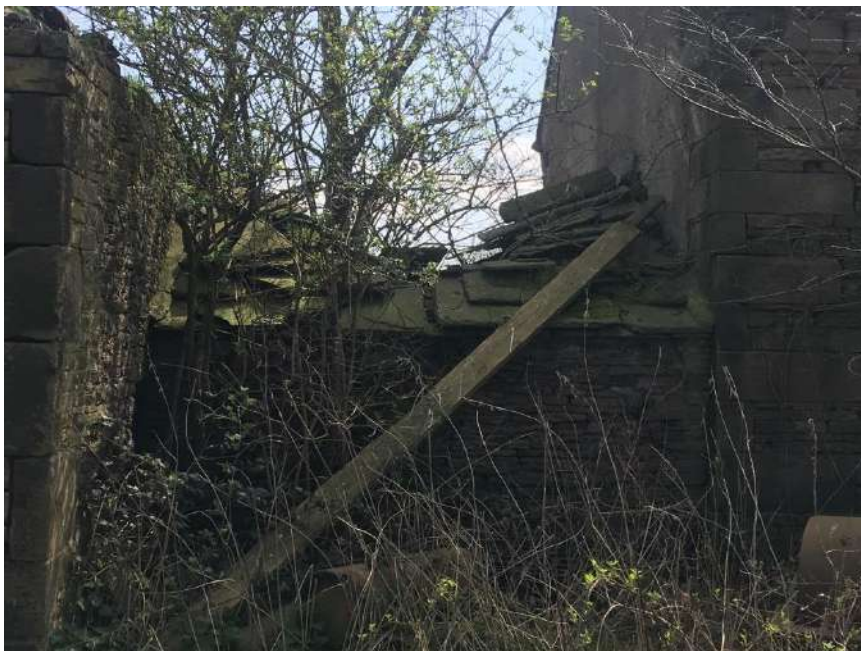
Close up of collapsed  
duo pitch building  
between Unit 1 &  
Unit 2 (viewed from  
North)

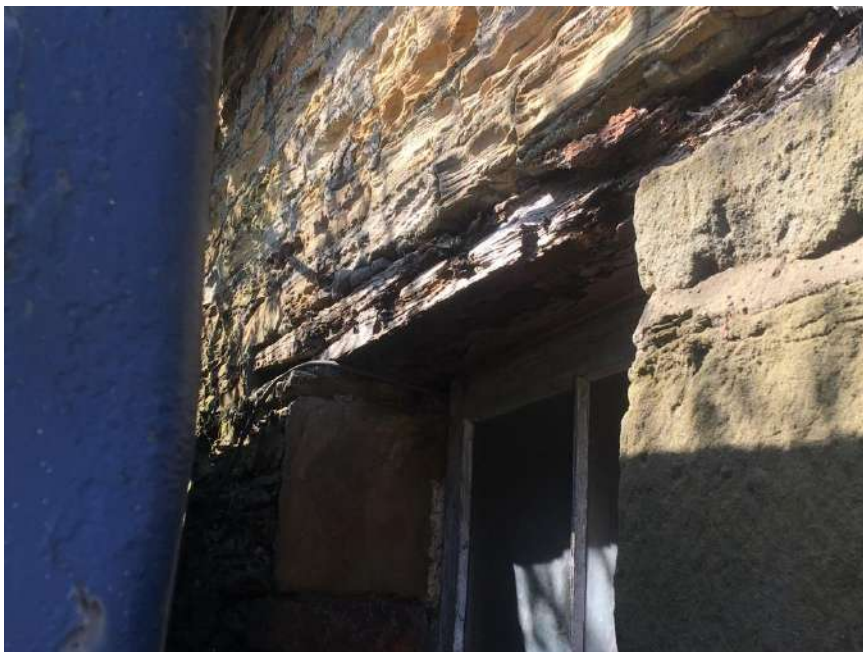
Rotten window head  
to front of Unit 2

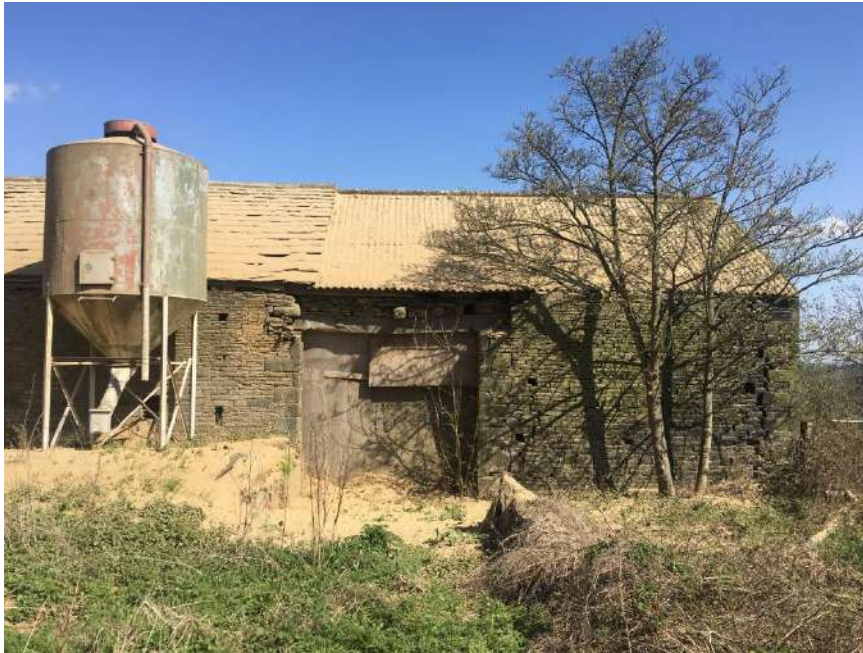
The westerly one third (left hand side viewed from the front) of unit 3 has had its original roof covering removed at some point with corrugated sheeting replacing the stone slate. Additional timber purlins have been incorporated to support this more modern roof covering. This roof covering is to be removed with Yorkshire stone slate re-laid on the roof. It is acknowledged the original roof covering will most likely have been stone slate. The original roof structure is predominantly intact to this area so the reinstatement of a Yorkshire stone slate roof should not have cause for concern with regards to loading.

Extent of profiled  
sheeting to Unit 3

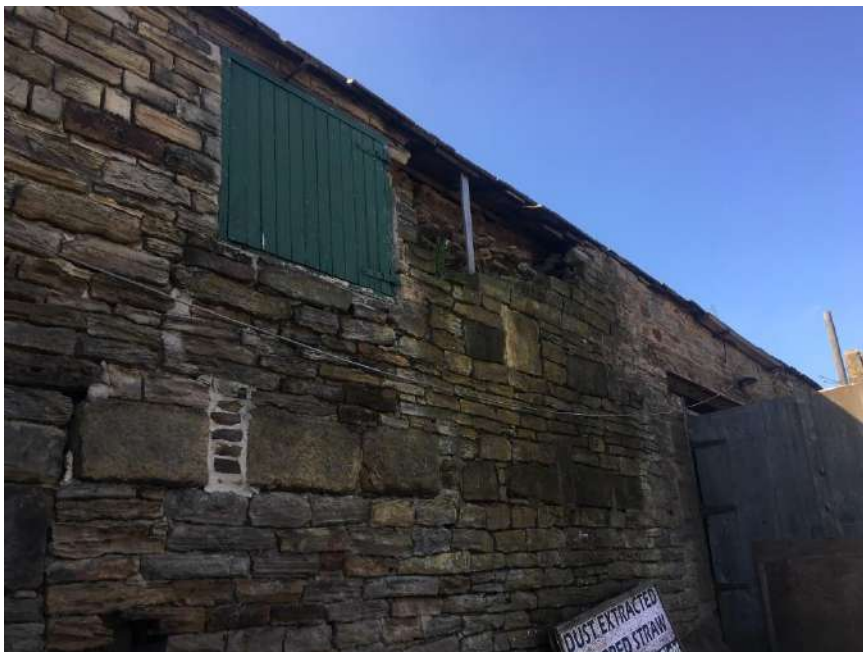
- Front elevation, just left of the principle opening
- Eaves level to front where tin roof covering abuts stone slate roof covering
- Masonry above opening to LHS of front elevation (far left hand side). The original timber lintel has dropped causing the masonry above to also dislodge. It may be the end bearing to this timber lintel has failed, this is currently covered by a stack of pallets that prop the roof of the adjacent/perpendicular building.

Masonry displacement at  
eaves level to LHS of  
principle opening to Unit 3

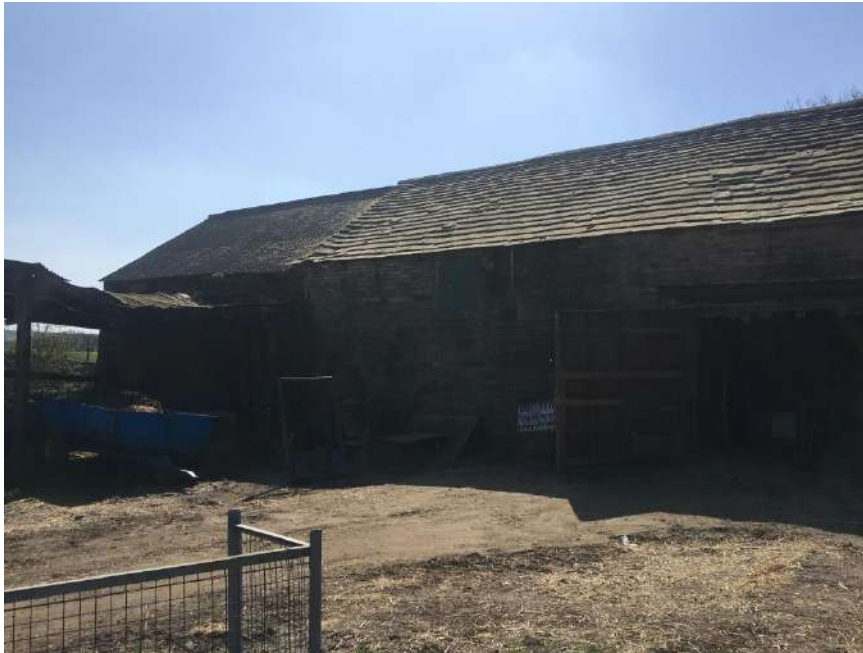
Unit 3 Viewed from  
North East

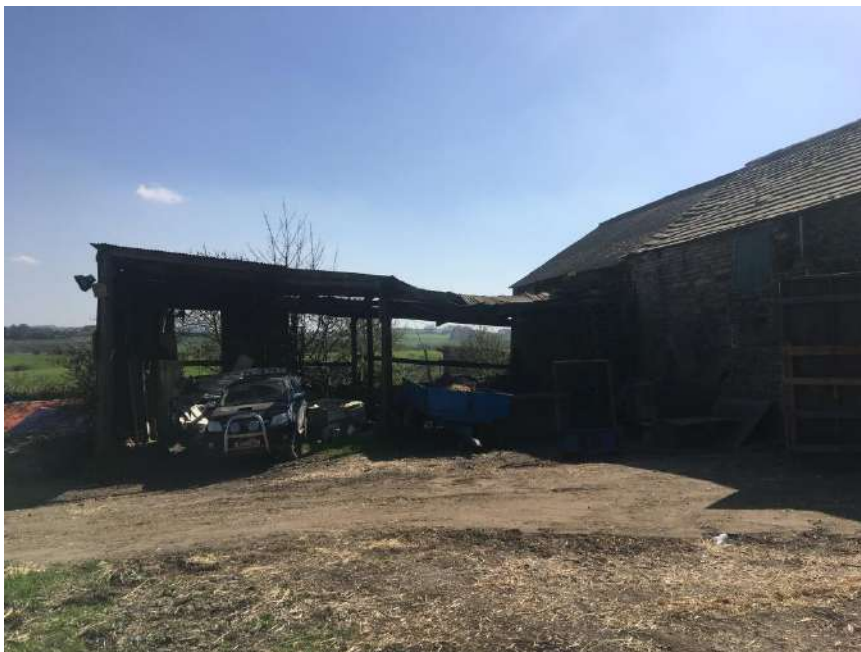
Perpendicular pole  
building to East of Unit 3  
(to be removed)

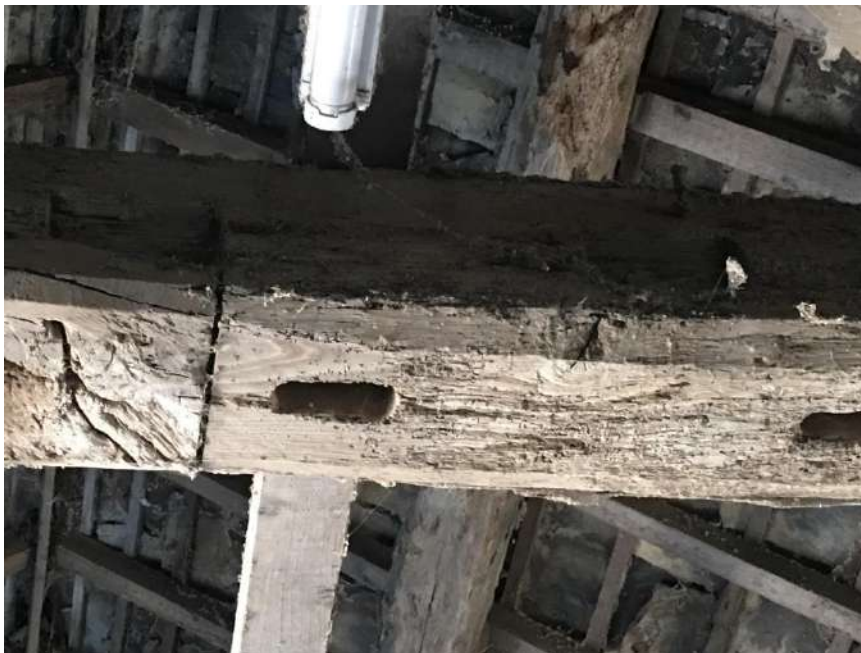
Insect infestation to  
bottom chord of truss  
within Unit 3

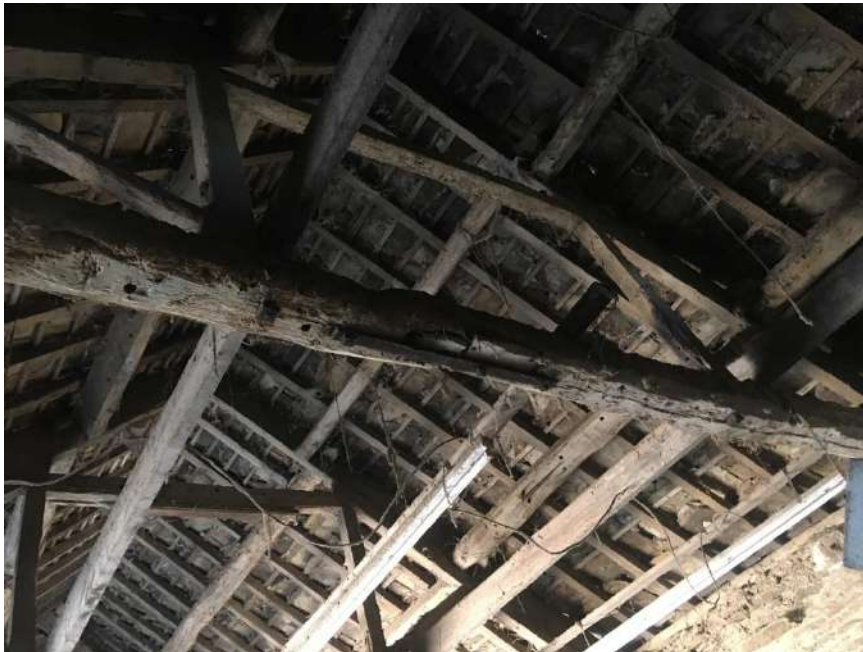
1<sup>st</sup> truss within Unit 3.

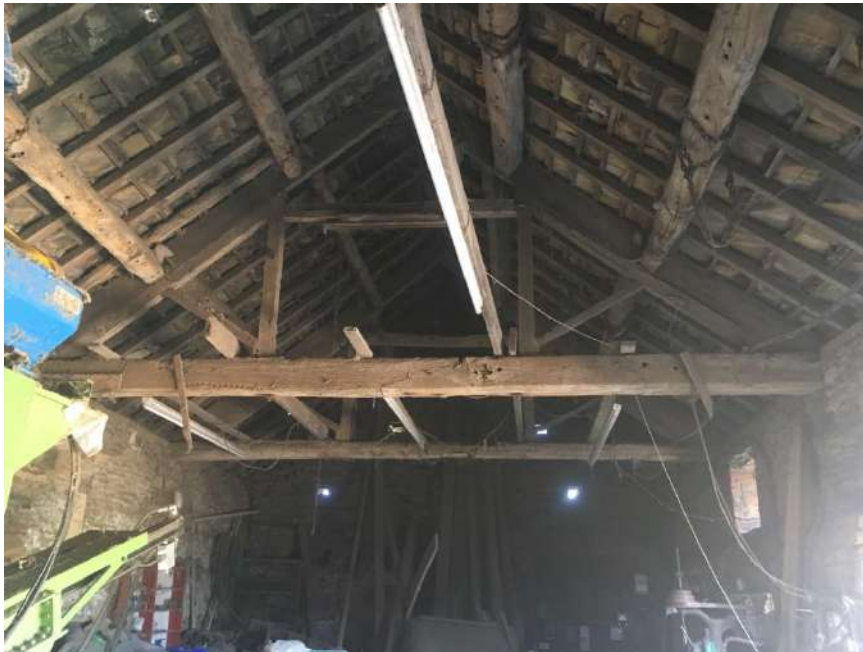
Roof trusses within Unit 3.

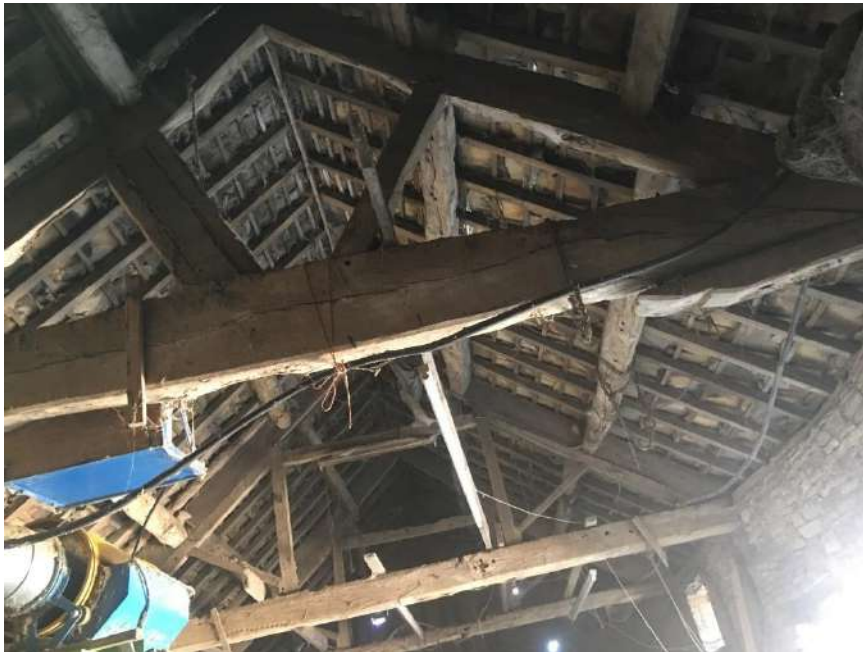
Roof trusses within  
Unit 3.
