## STANCLIFFE HOUSE FARM, S35 7DA

### STRUCTURAL ASSESSMENT OF EXISTING BUILDING

YK0024-EMPACE-XX-XX-RP-S-0001

31/05/2024

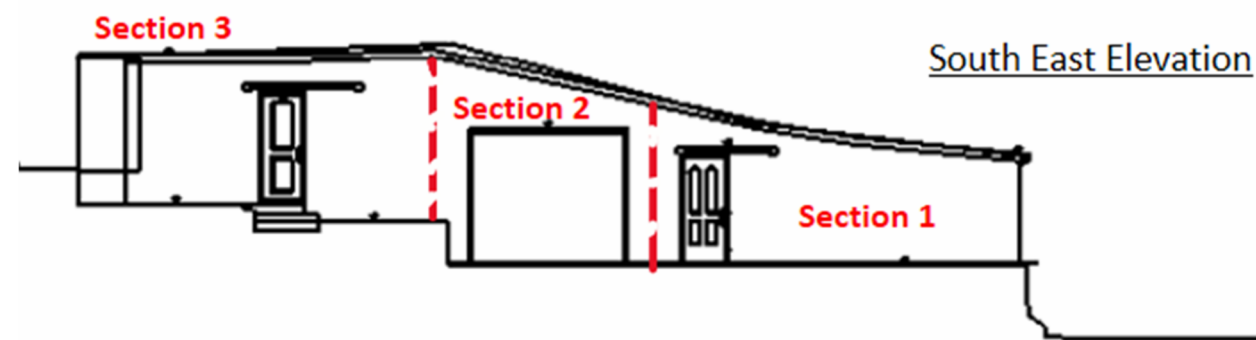
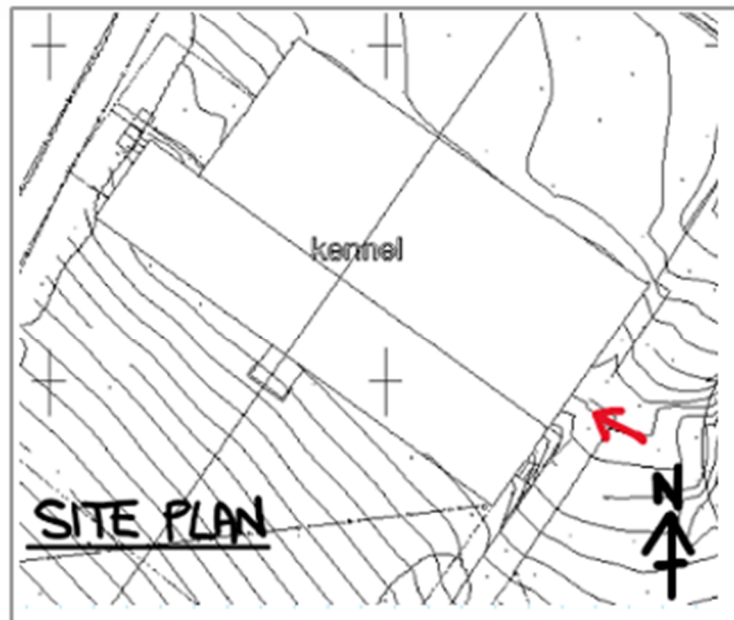
The building appears to have been segmented into 3 primary sections and the following reporting will be based on these 3 segmented sections as indicated below.
