**RE: Bolton Hall Nursing Home, Carr Head Lane, Rotherham (Application Number 2016/0926)**

On the morning of Thursday 6<sup>th</sup> April 2017, Bell Munro Consulting Limited visited the site known as Bolton Hall Nursing Home, Rotherham to conduct a highway condition survey in accordance with planning condition number 8 of planning application number 2016/0926.

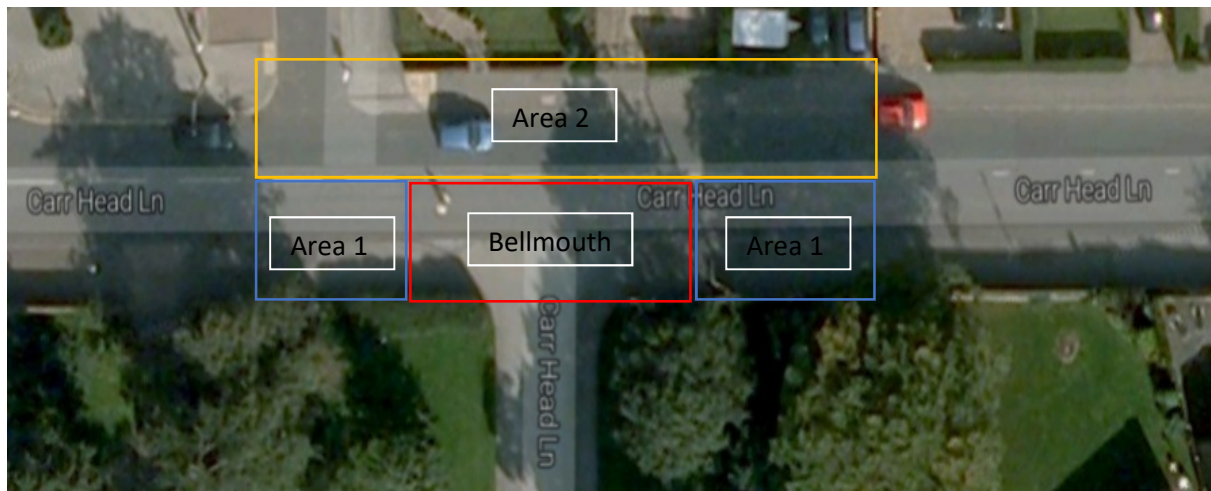
For simplicity, the report is broken down into three sections shown in figure 1; Bellmouth, area 1 (road each side of the bell mouth) and area 2 (road opposite the bell mouth). Comments on the general condition of the existing highway as well as comments on any structural defects visible. It should be noted that on the day of the inspection the weather was fine with little cloud cover and no rainfall had occurred in the previous days, so no comments will be made on the adequacy of the existing road gullies.

*Figure 1 Carr Head Lane, Rotherham (Image Google Earth)*
