Fall Head Farm, Fall Head Lane, Silkstone, Barnsley S75 4LB

You have asked that I make a structural inspection of redundant farm buildings at Fall Head Farm to advise on their condition in connection with proposed conversion/renovation plans.

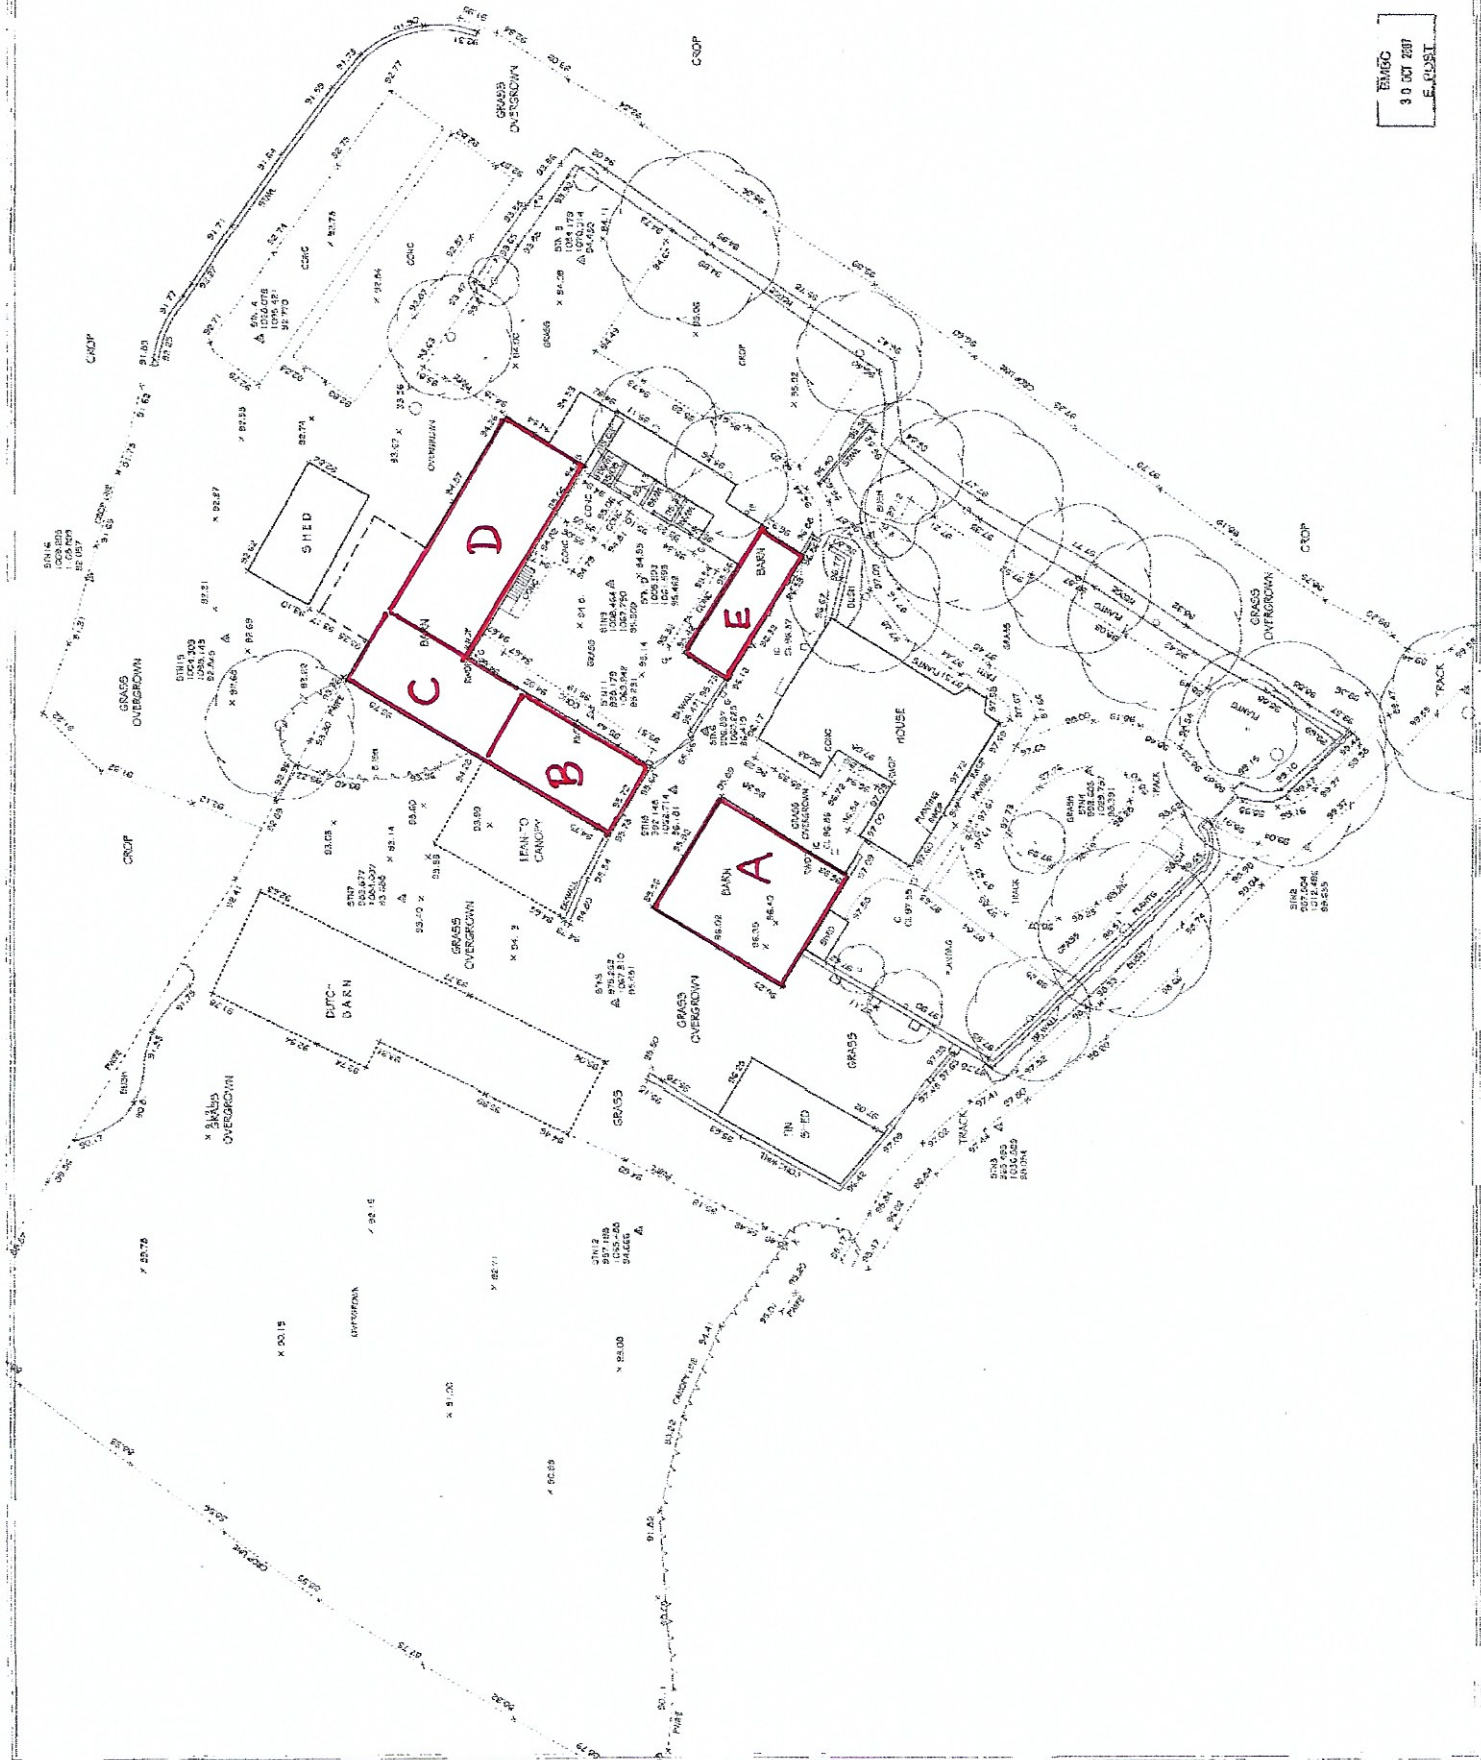
3327/S/1

These are identified on the marked-up survey plan ref B327/S/1 as buildings A, B, C, D and E shown in Appendix A.
