Ref: AWA5872

# **Arboricultural Risk Report**

## **THE LAITHE, 38 HAIGH LANE, HOYLANDSWAINE, SHEFFIELD, S36 7JJ**

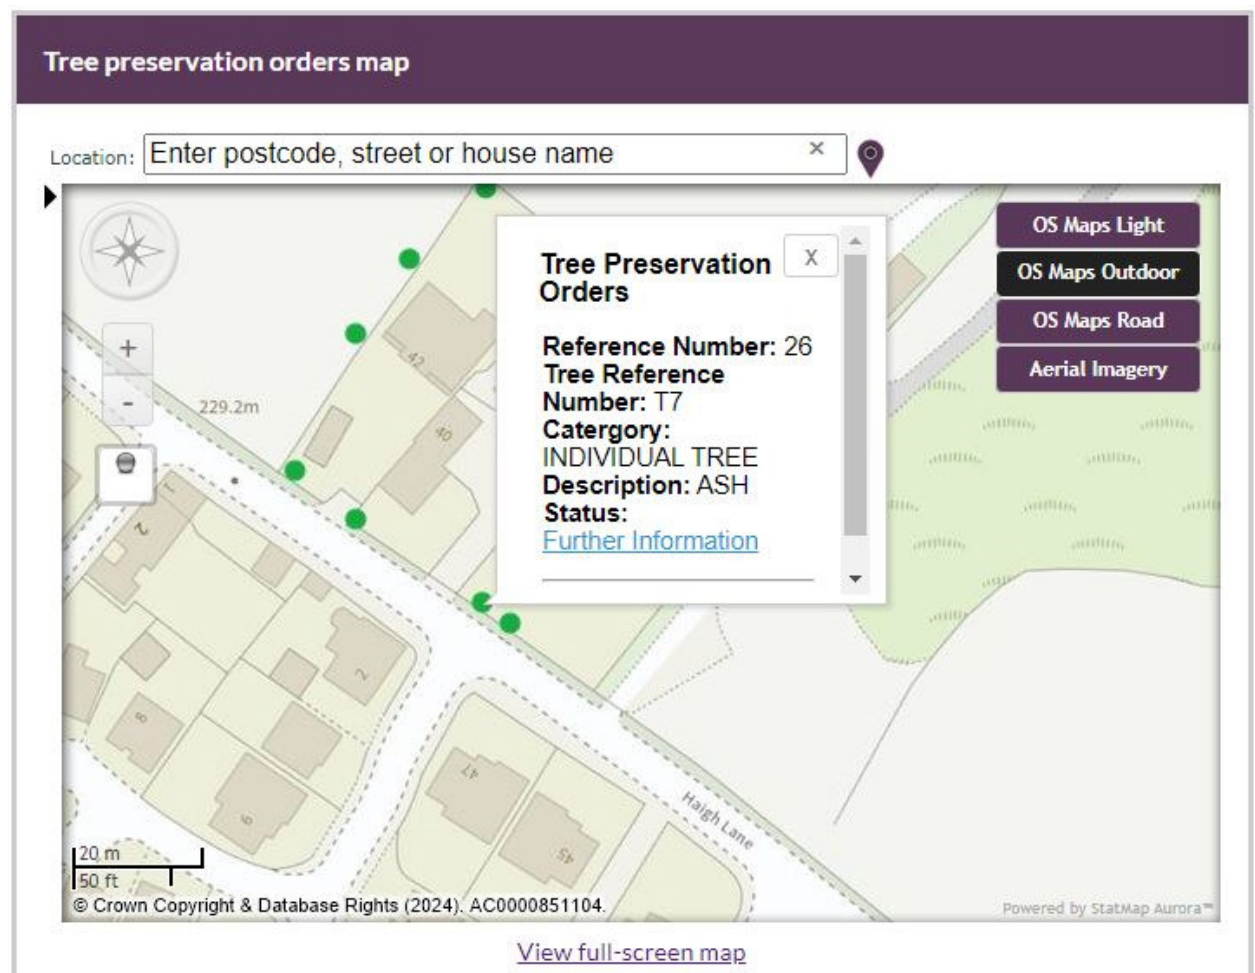
An online search was undertaken with Barnsley Metropolitan Borough Council on 2/04/24 to check whether any trees at the site are protected by a Tree Preservation Order or are located within a Conservation Area. T1 is protected by a Tree Preservation Order (TPO) (T7 Ref:26). Due to the large potential penalties for illegally carrying out work to protected trees, before authorising any tree works statutory permission is required before any works can take place. The accessed map image from Barnsley Metropolitan Borough Council is detailed below:

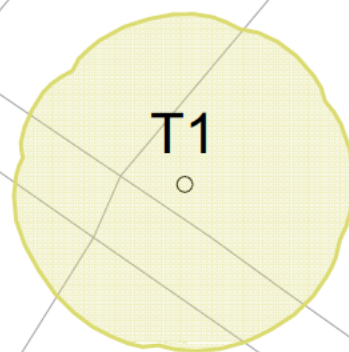
## Tree Plan

The surveyed tree is numbered **T1** on the attached plan and tree inspection forms. Other vegetation was not surveyed in detail in this instance.
