Our Ref: TCH/JM/311

28 March 2012

Structural Inspection - 27/29 George Street & 1 Kings Croft, Worsbrough Dale, Barnsley

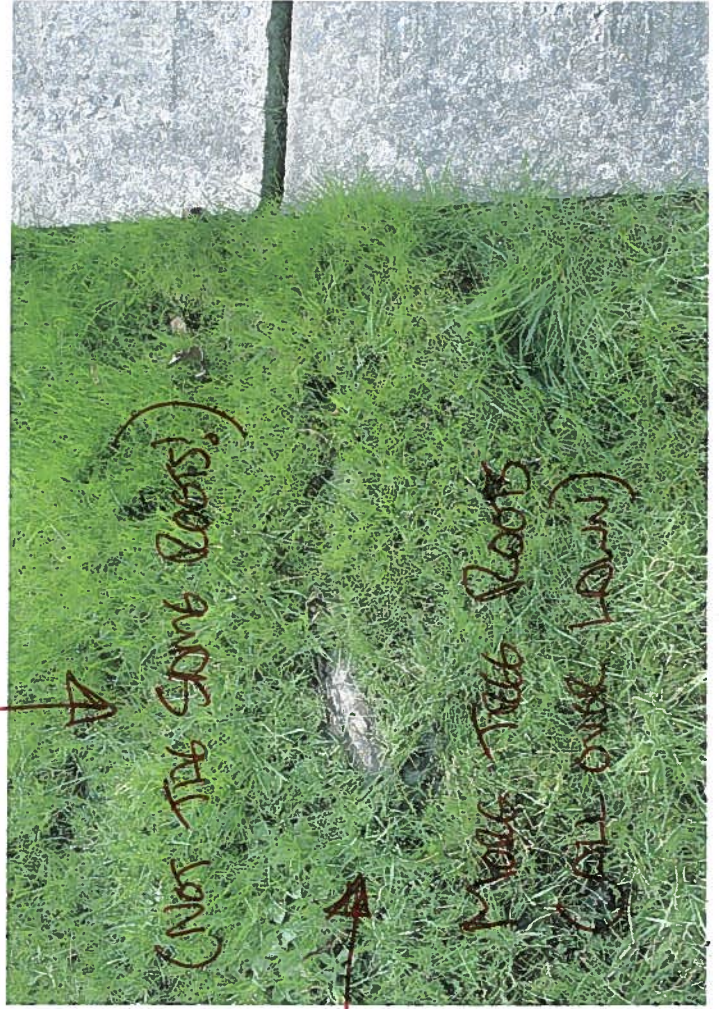
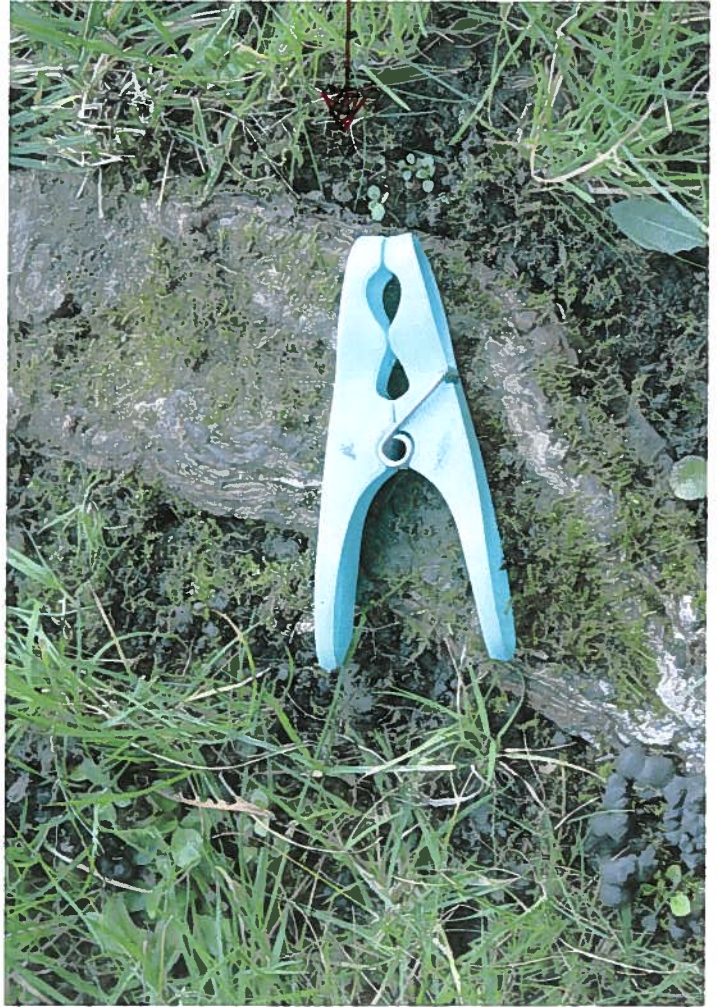
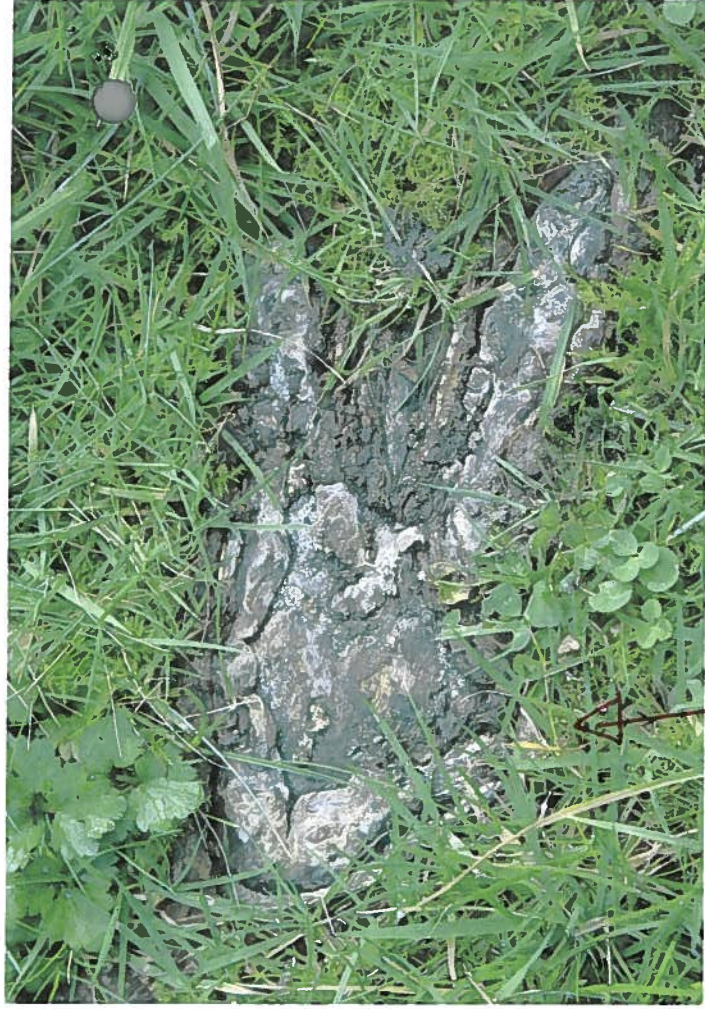
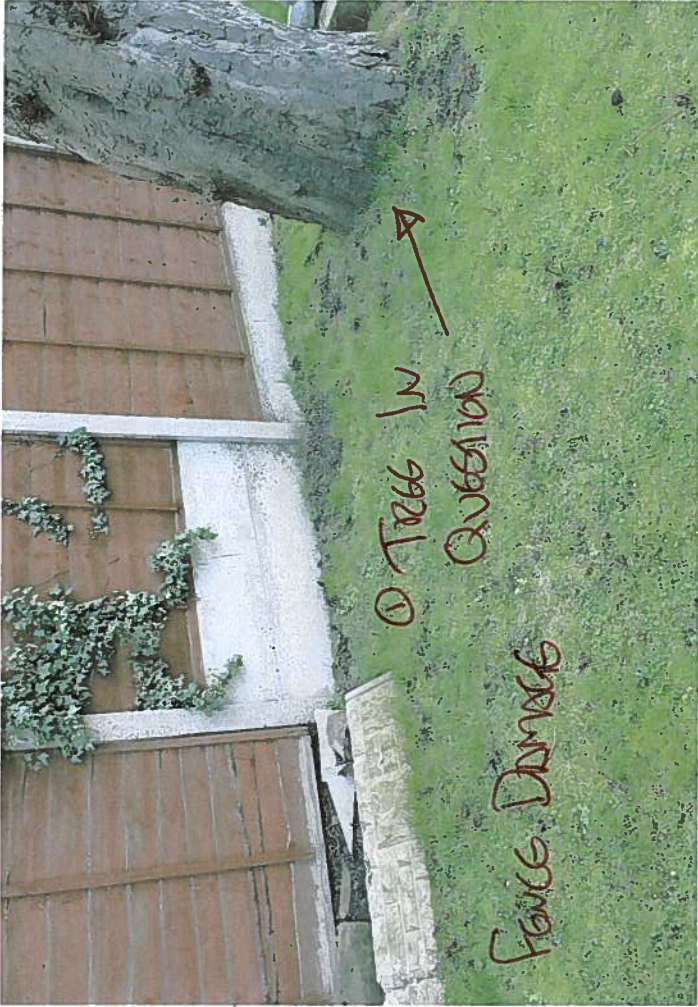
TREE ROOTS
(SEE OVER LEAF)

This wall displayed relatively pronounced stepped and bed joint fracturing consistent with a differential foundation movement of the wall.

In addition to the cracking along the brick jointing, individual bricks were sheared at a number of positions. The cracking was considered to be recently active and in view of the proximity of the two trees must be assumed to be associated with seasonal ground moisture changes due to the vegetation possibly compounded by the physical presence of roots immediately beneath the apparently relatively shallow foundations of the wall.

In addition to the cracking of the wall the physical presence of the substantial roots to the trees was noted within the lawn area with this again demonstrating the potential for structural damage to occur to the boundary wall due to the presence of the vegetation.
