# **Structural Conditional Report for Existing Boundary Retaining Wall to Plot 2 Delf Garth, Dodworth**

Prepared for:  
Mr & Mrs D Whitaker

**Design - it**  
**Structural Solutions Ltd**

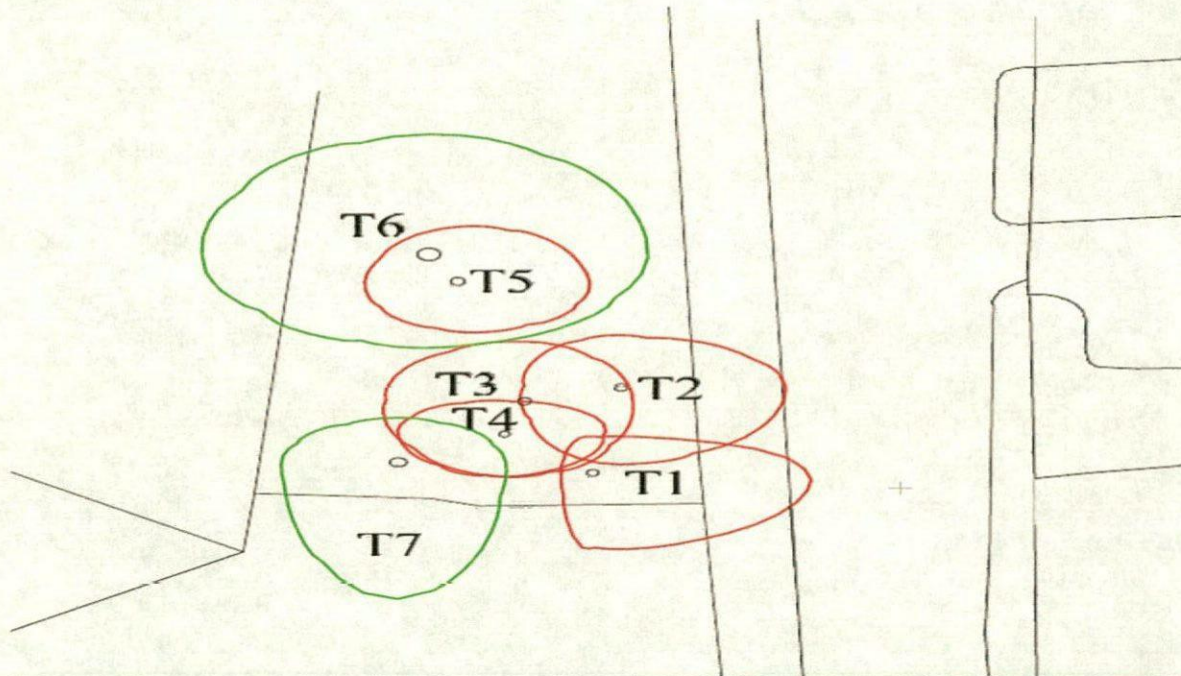
## Existing Tree Plan

It is very likely that roots from the tree T1 to T2 will be growing up to and along the boundary wall. It is also probable that roots from the trees T3 to T5 will be growing up to the boundary wall. It is likely that the roots of T1 to T5 will have contributed to the damaged the boundary wall, from the result of the direct pressure of the tree roots pressing against the retaining wall. In the future, as the tree roots continue to grow, it is foreseeable that the damage to the wall will increase. Trees T6 and T7 are situated further away from the damaged wall and so will be less likely to have impacted upon the walls poor condition.

**It is likely that the trees T1 to T5 are contributing to the current damage to the boundary wall, and it is foreseeable this will increase over time. The excavations required to repair the wall will result in the severing of tree roots. It is likely this will lead to a loss of tree vigour of trees T1 to T5 and make the trees T1 and T2 unstable. As such, it is recommended to remove trees T1 to T5 prior to repairing the wall and to undertake suitable replacement planting.**
