# **91a High Street, Dodworth, Barnsley, S75 3RQ**

## **Preliminary Roost Appraisal**

Final Report

30 November 2024

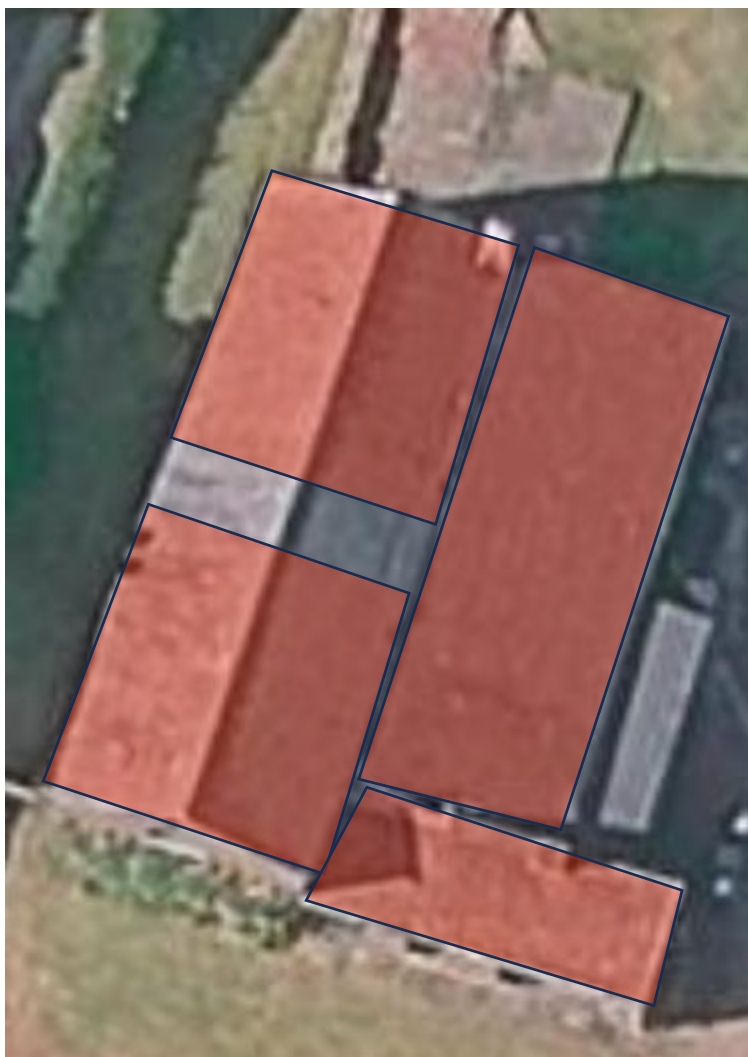
3.10 Internally the building is open to the rafters in the majority of places, with dense cobwebbing along the beams showing multiple years of dust accumulation on the cobwebs. The interior of the tiles was viewed in large portions of the building and no evidence of bats or physical bats were present. The areas where tiles could be checked internally are shown on the aerial image below. There are some areas of the building which are used for storage, but the majority of the building is currently not in use. It was possible to check the majority of the features present in the building for presence of roosting bats and no bats or signs of bats were recorded.

- 3.11 There were a small number of crevice features which could not be assessed due to their location. As such outbuilding 1 is considered to hold low potential to support roosting bats.
