# Arboricultural Appraisal Report

## Subsidence Damage Investigation at:

12 North Field  
Silkstone  
S75 4NQ

| REPORT DATE: | 10 July 2013 |

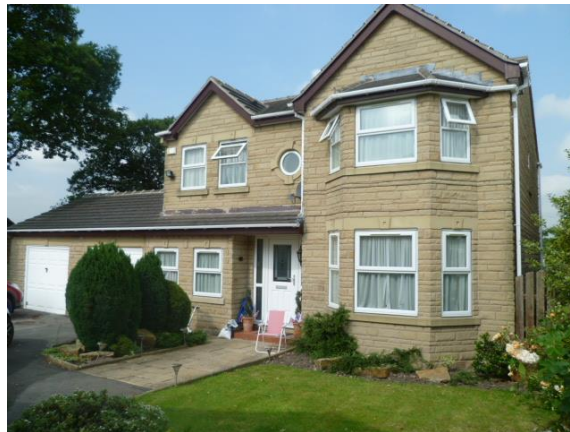
The focal area of the damage is to the single storey utility room to the rear left corner. The damage was first noticed 01/09/2009 and insurers notified in 09/09/2011.

At the time of the engineers' inspection (03/06/2013) the structural significance of the damage was found to fall within Category 3 (moderate) of BRE Digest 251.
