# **Replacement of Roof Coverings with Subsequent Alterations to:**

**Springfield House, Springfield Street,  
Barnsley, S70 6EQ**

Design and Access Statement

August 2023

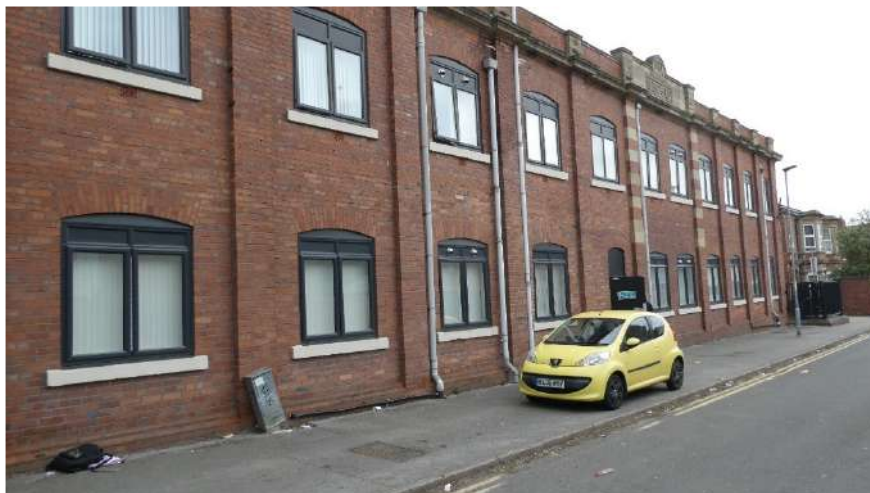
*Figure 1 - Front elevation*

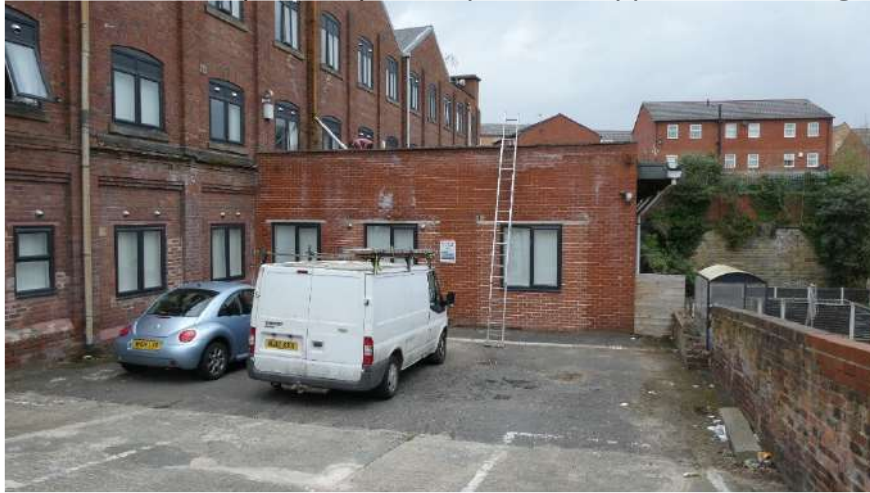
- 2.6 To the eastern side of the building there is a projecting single storey extension which is formed at lower ground floor level. It is unclear when this was added but the extension was present prior to previous applications being submitted.

*Figure 2 - Single storey extension to the east*

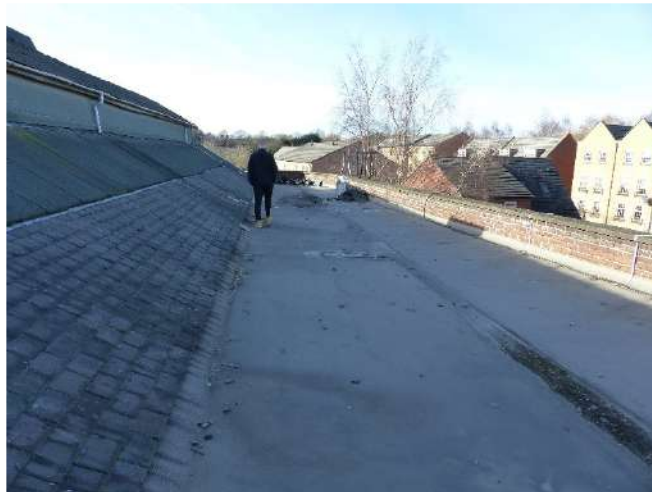
- 2.7 To the rear (north) of the main building, there is a section of flat roof surrounded by a brickwork parapet wall.

*Figure 3 - Flat roof to the rear (north) of the building*
