APPENDIX A

- 01.** Further to **Background** set out in the preceding document, this section sets out the initial detailed recording of the fabric and structure of the building as opened up, so as to inform the detailed constructional changes needed to achieve both fire and acoustic compartmentation/separation of the additional guest accommodation which is to be formed for the current unused attic ranges.

Andrew Shepherd, Dip. Arch (Manc.), Dip. Cons. (A.A.), R.I.B.A., I.H.B.C., F.R.S.A. carried out a visit on 6th December 2017 to survey the existing floors now they had been opened up, so as to devise a methodology of producing the necessary fire precautions and acoustic separations required for the residential use of the rooms.

ADWS/TJC/TAM/03.22.15-16
13th February 2018
Rev 1 22nd May 2018

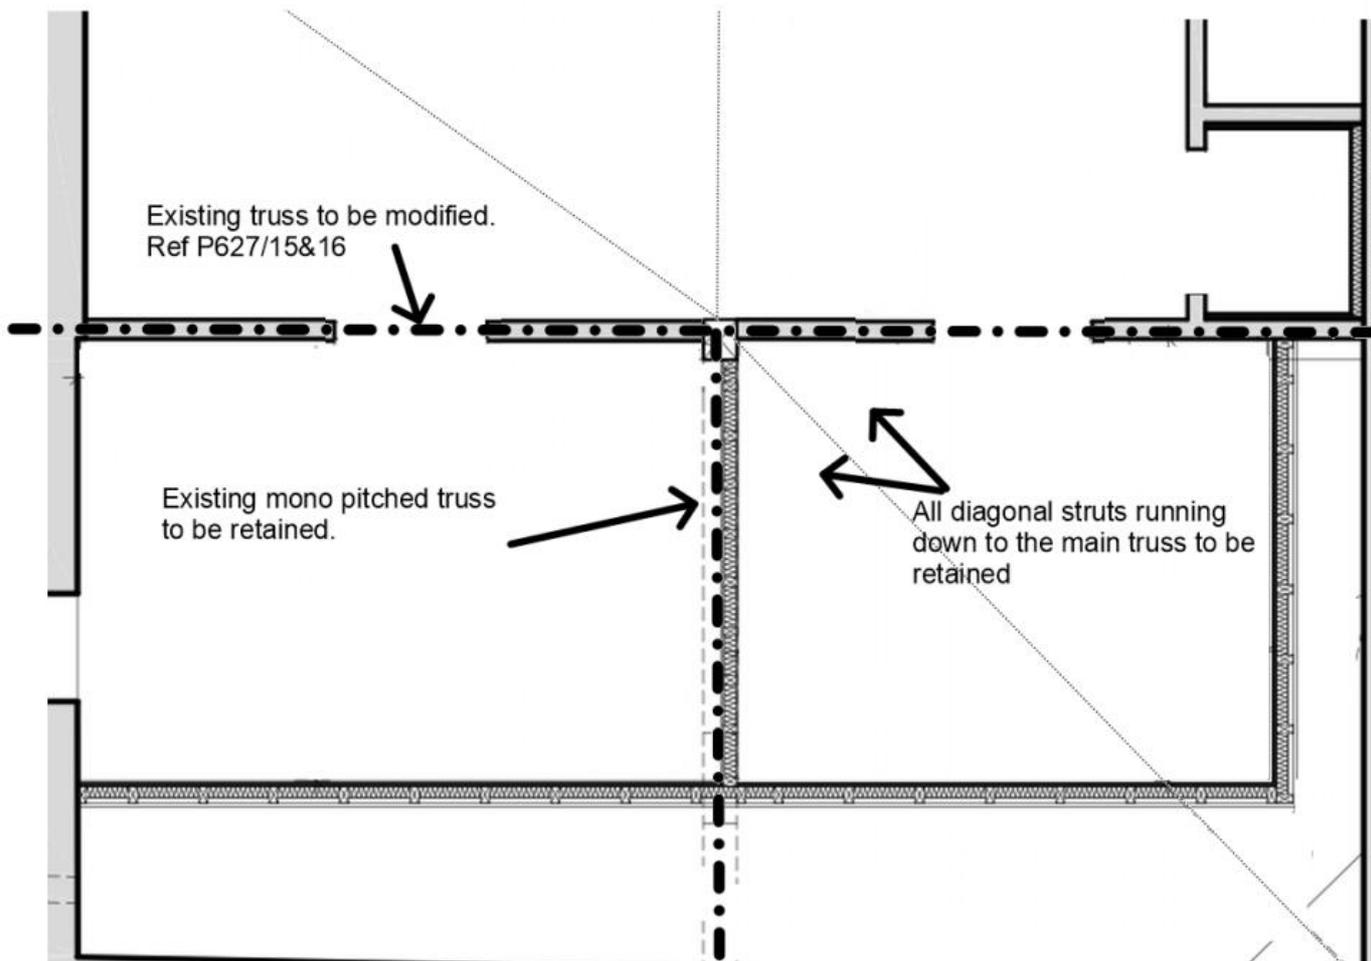
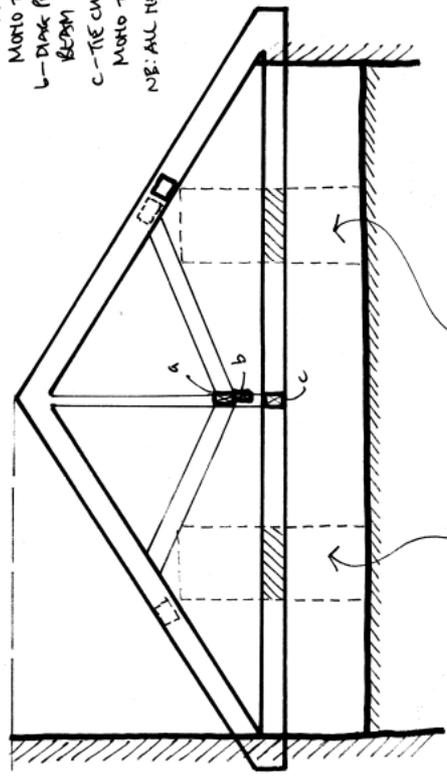
- a - DIAG. PROP TO MONO TRUSS
- b - DIAG. PROP TO HIP BEAM
- c - TIE CHORD TO MONO TRUSS
- NOTE: ALL NEEDED TO REINFORCE

PREFORMED DOOR OPENINGS MUST BE POSITIONED TO AVOID DIAGONAL STRUTS AS SHOWN. ENSURE ALL STRUCTURING WORK UNDERTAKEN TO TRUSS/FLOOR PLATE TO CUTTING THROUGH TIE CHORD IS THE 2 LOCATIONS SHOWN. KEEP THE PROPOSED DIMENSIONS.
