# Wentworth Castle, Stainborough

## Bat Survey Report

8<sup>th</sup> January 2021

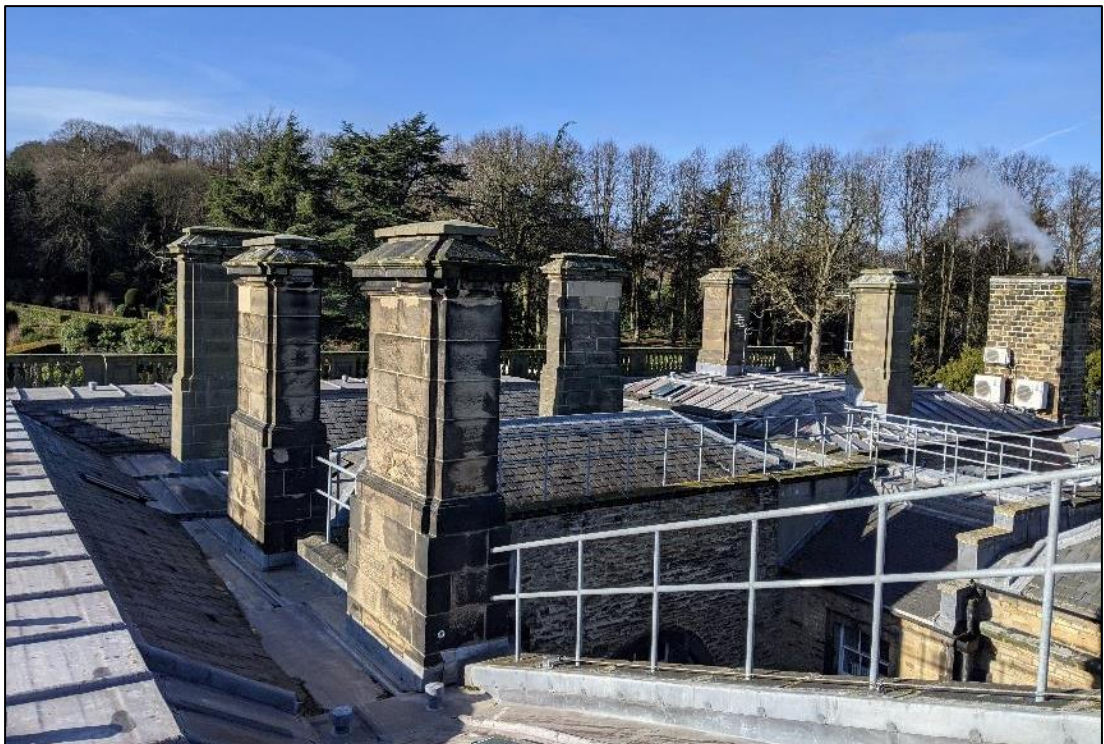
**Plate 2. Looking north across Wentworth Castle roof**

- 5.2.6 Wentworth Castle was re-roofed after the 2004 bat survey and consequently the pitched roofs are in a very good state of repair (Plate 1 & 2). Potential bat access points appear limited to missing or damaged birdproof screens on internal rainwater launders and occasional slightly lifted slates (due to shape of underlying roof timbers) (Plate 2).

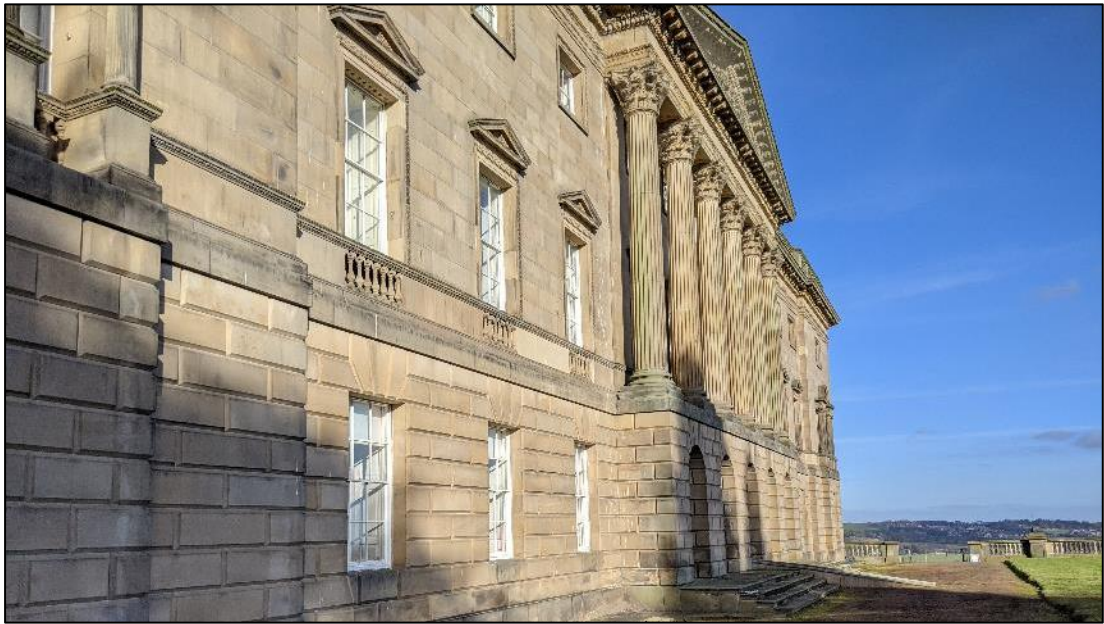
Plate 6. Looking across south elevation

- 5.2.10 In general, the south elevation is well-pointed and there are few open joints between the large ashlar blocks. An inspection was undertaken from ground level using a high-power torch and binoculars. The highest level of bat roost potential appeared to be associated with extended crevices between the curved roof and recessed walls of entrances, within the centre of this elevation (Figure 2; Plate 6), however, no bats or signs of use were recorded. Additional open crevices were few in number and mainly associated with areas where the wall steps-out. These crevices could be inspected with a torch and no evidence of bat use was seen from the ground.

- 5.2.12 One of the identified potential roosting features on the south elevation comprised a crevice between a wooden window frame and the adjacent masonry at the west end of this elevation.
