# STRUCTURAL REPORT

Bank House Farm, A628  
Silkstone, Barnsley  
S75 4FZ

NE5559

**STRUCTURAL REPORT ON** Bank House Farm, A628, Silkstone, Barnsley, S75 4FZ

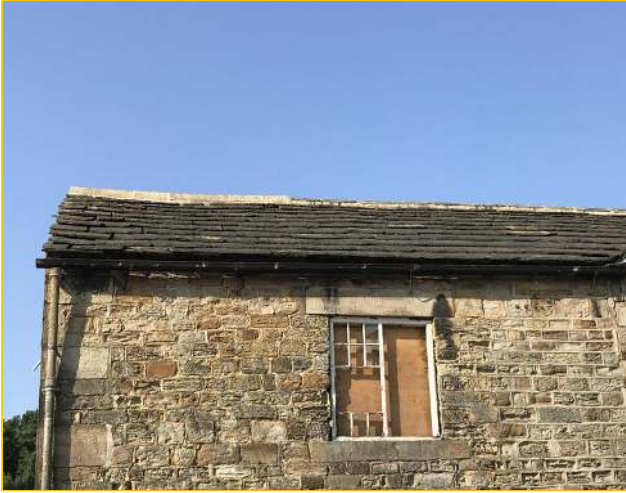
Observations from ground level did not identify any excessive distortions to the roof slopes, however observations of the inner facing pitches was restricted due to the site constraints.

Photograph - 7 - Left hand slope

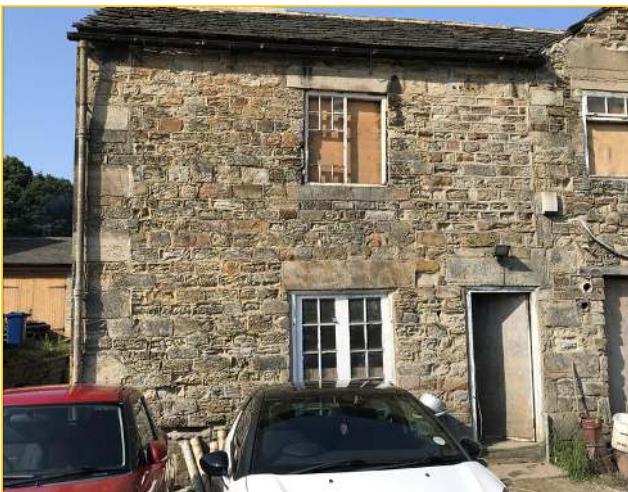
Photograph - 11 - Left extension left wall

It was noted that the lintel to the ground floor window opening, in the left hand wall of the left hand extension, has limited bearing. A minimum of 150mm is recommended.

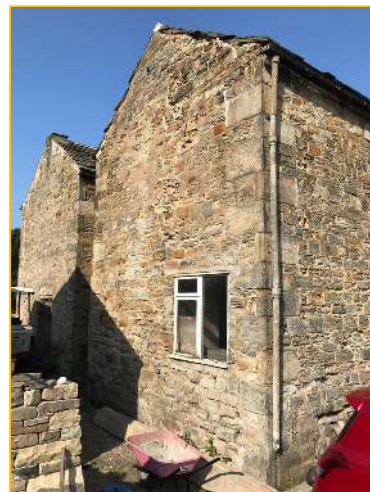
Photograph - 12 - Left extension rear gable

On the rear wall corners of the two extensions there is evidence of past and more recent movement (shown by reopened repairs), between the wall panels and the corner quoin stones. The recent movement is not significant at this time but will progress with age.

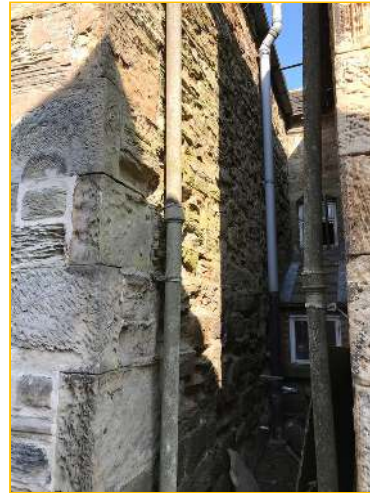
Photograph - 14 - Right extension left wall

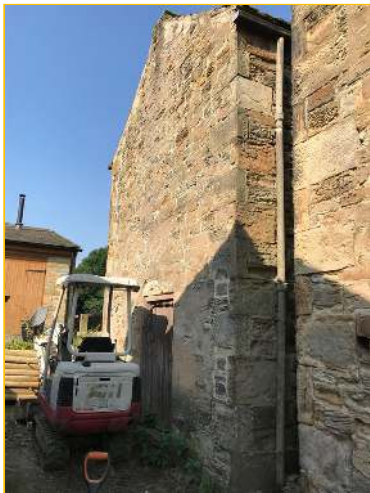
Photograph - 15 - Right extension rear gable

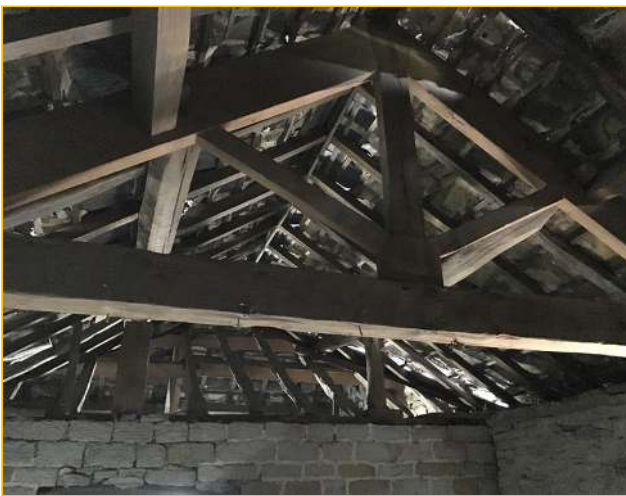
The roof structures to the extensions are exposed within the first floor rooms as the ceilings have been removed. The roof structures are timber framed comprising king post trusses supporting purlins. The left hand extension roof is framed into the original rear roof slope and with intermediate support provided to the purlins by timber struts. The right hand extension roof has a Queen post truss supporting the purlins over the original building.

Internal observation of the main purlins and rafters indicates deflections within acceptable limits and no evidence of structural distress. The roof structure appears stable and sound.

Photograph - 43 - Left hand extension roof

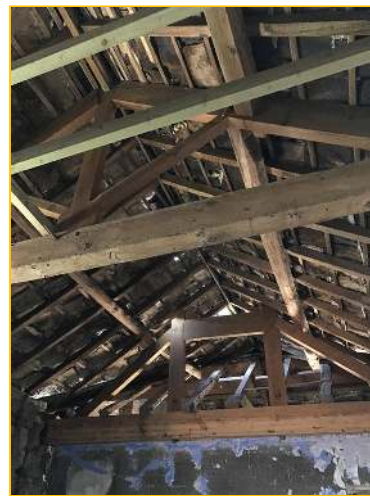
Photograph - 44 - Right hand extension roof
