# Princess Theatre, Hoyland

## Bat Survey Report

11<sup>th</sup> August 2026

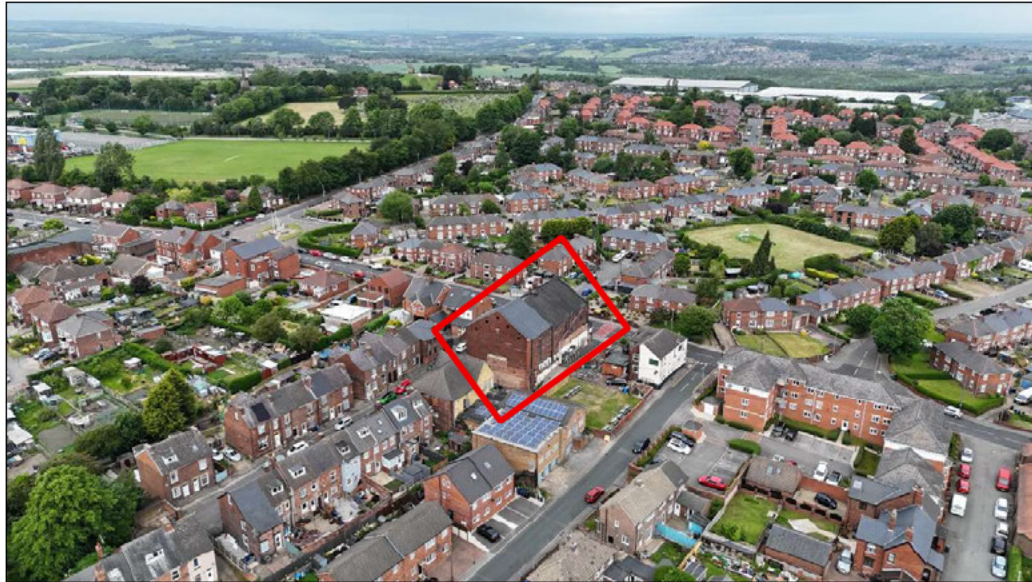
**Plate 1. The building (outlined red), and surrounding landscape viewed from the southeast**

- 3.1.1 The building was located in Hoyland town centre in South Yorkshire. The survey area comprised the building and a side and rear hard standing area (Figure 1).
- 3.1.2 Houses and gardens, allotments and parks with numerous trees were present in the local area (Plate 1).
- 3.1.3 The site and surrounding area was considered to comprise below average<sup>1</sup> habitat quality for foraging and commuting bats. The area was considered likely to support low levels of bat activity, with the species present largely limited to those tolerant of relatively high levels of artificial lighting.

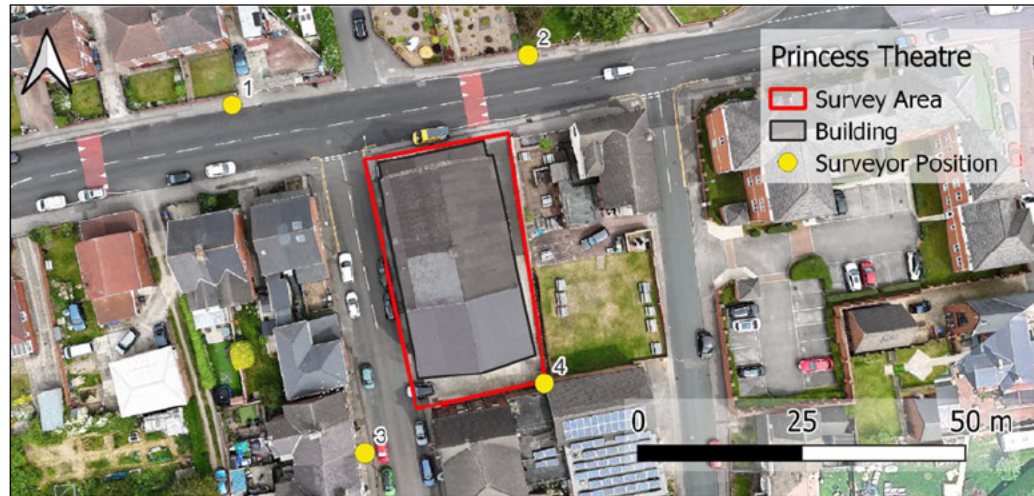
**Figure 2. Surveyor Positions**

- 4.2.4 The nocturnal bat survey was completed on 22<sup>nd</sup> July 2026. The surveys were completed in compliance with relevant Bat Survey Guidelines (Collins, 2023; and BCT, 2026).
- 4.2.5 Three surveyor positions were covered during the survey. The surveyor positions are shown on Figure 2. The following personnel conducted the nocturnal survey and were equipped with Wildlife Acoustics EM Touch bat detectors and tablet recorders:
- Greg Slack (MCIEEM, Natural England Bat (WML-A34-Level 4, licence number: 2025-84759-CL20-BAT);

As shown on Figure 2, the survey positions provided overlapping or complementary views of the building. The distance between Surveyor Position 3 and the furthest part of the northern elevation not covered by the camera at Position 1 was approximately 22 m. The equivalent distance between Surveyor Position 4 and the area not covered by the camera at Position 2 was approximately 5 m. Surveyor Positions 3 and 4 were approximately 30 m apart.

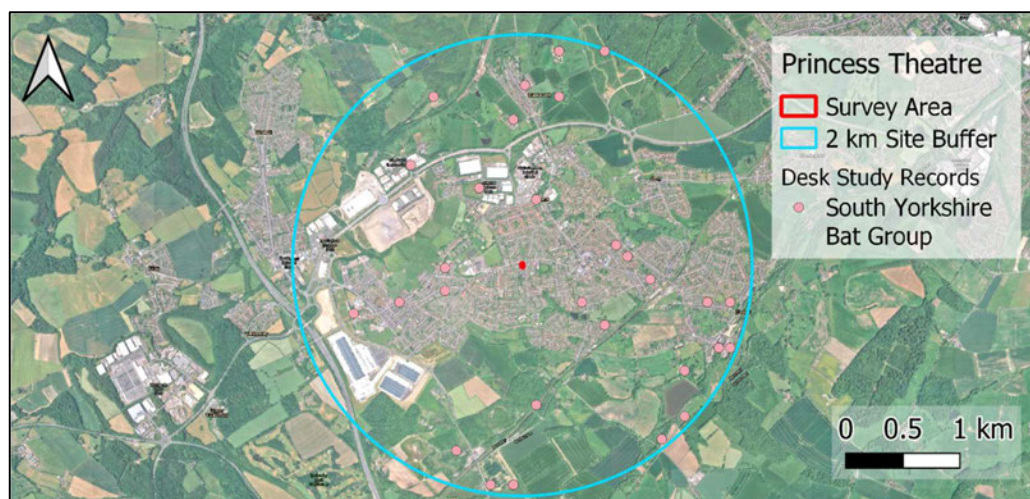
**Figure 3. Distribution of bat records in the vicinity of the site**

- 5.1.1 South Yorkshire Bat Group provided 55 bat records for the surrounding 2 km. The species included in the records comprised: common pipistrelle *Pipistrellus pipistrellus*; soprano pipistrelle *Pipistrellus pygmaeus*; brown long-eared bat *Plecotus auritus*; Daubenton's bat *Myotis daubentonii*; noctule *Nyctalus noctula*; and Leisler's bat *Nyctalus leisleri*.
- 5.1.2 The records were distributed across fringes of Hoyland and the more rural locations in the wider area (Figure 3). The closest record was a common pipistrelle in flight located c. 590 m southeast of the site. The record dated from June 2017.

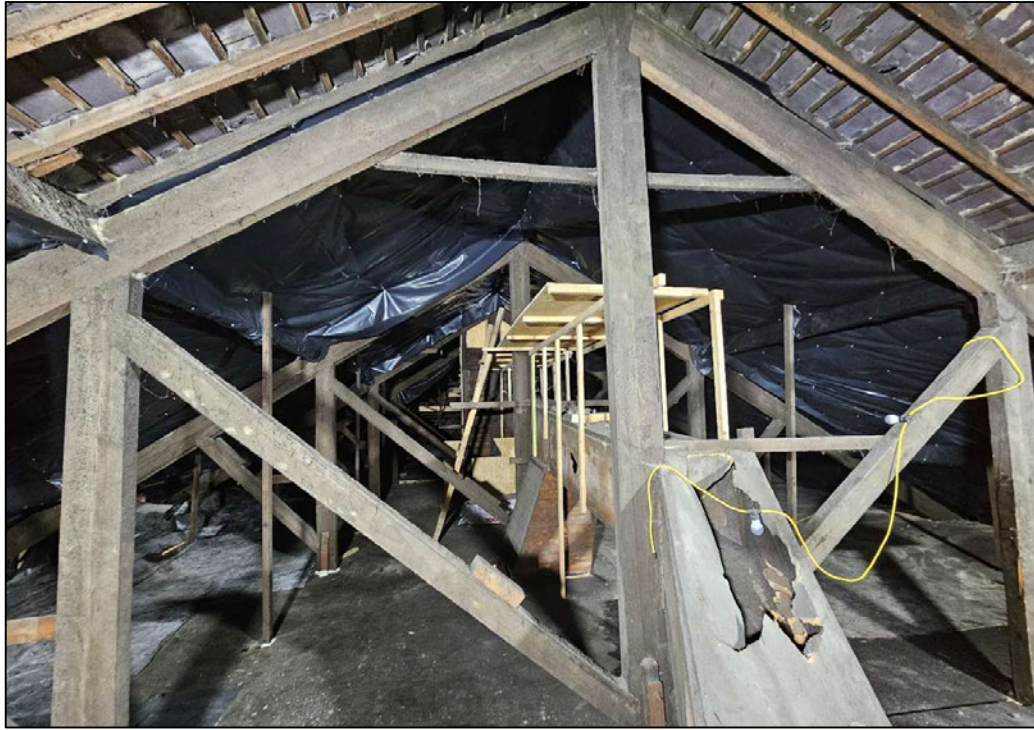
**Plate 3. The interior of the roof void viewed from the northern end of the building**

- 5.2.2 Coping stones were present on the front gable, with verge capping present on the rear and stepped sections of the roof. Plastic guttering was supported by fascia boards. Bargeboards were present beneath the verge capping on the rear elevation.
- 5.2.3 The roof was supported by a combination of king post trusses, modern W-trusses, purlins, rafters and battens (Plate 3). The reroofed southern section was lined with a breathable roofing membrane. The older sections of the roof had been partially lined internally with plastic sheeting below the rafters and purlins in the winter of 2025/2026 to reduce water ingress. Where exposed sections were still visible traditional torching was visible beneath the slates.
