THE BARN, CLIFFE HOUSE FARM, CUBLEY,  
PENISTONE, SOUTH YORKSHIRE S36 9FR

for GEMMA GARNHAM & KEVIN COOPER

MAY 2017 (Rev A OCT 2017)

## 1.0 CONDITION REPORT

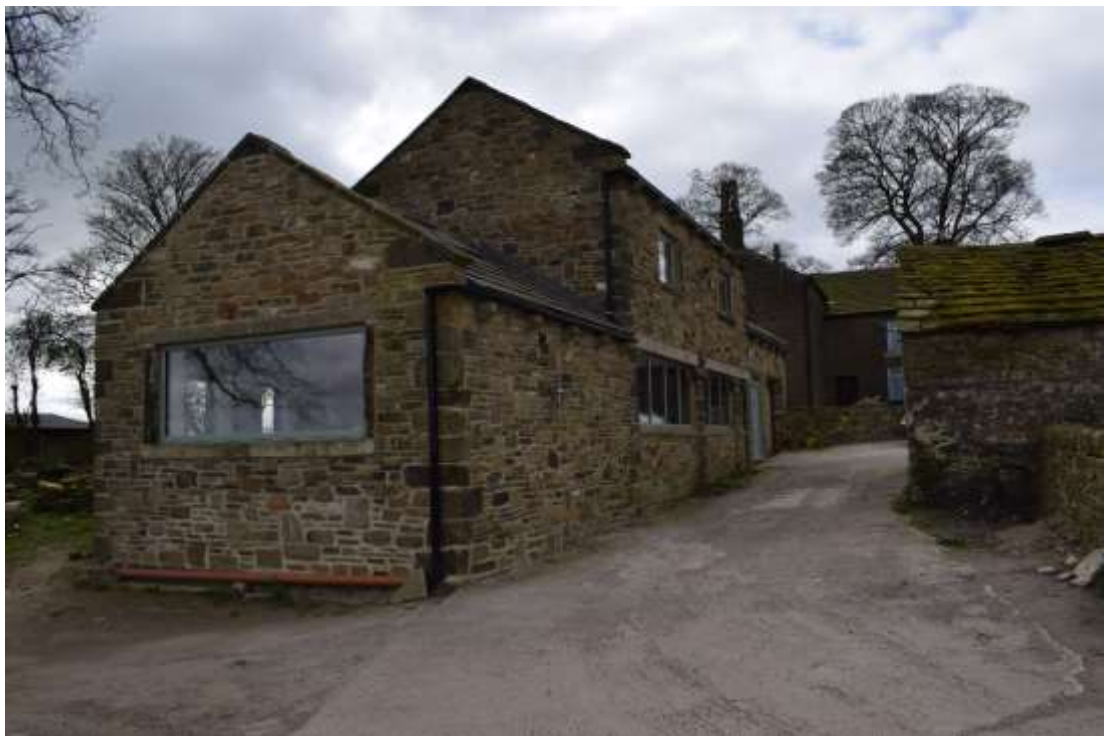
**Fig 04.** The converted tractor shed and pig-sty block looking from the north (the gap between the tractor shed and the cart shed provides access into the yard).

The gap between the cart shed range and the converted stable (**Fig. 04**) is incredibly narrow and as it will serve all three properties facing onto the yard (the farmhouse, the converted tractor shed and the barn) and to allow sufficient turning for fire and waste vehicles, it would be beneficial if the eastern gable of the cart shed were set back by a metre which will shorten the length of the cart shed range but increase the width of the vehicular access slightly. As there is a reasonable quantity of stonework repair/re-building required to both the eastern end of the northern elevation, the north-eastern corner and the eastern gable of the cart shed, the detrimental impact of dismantling and re-building this gable further west is substantially lessened.

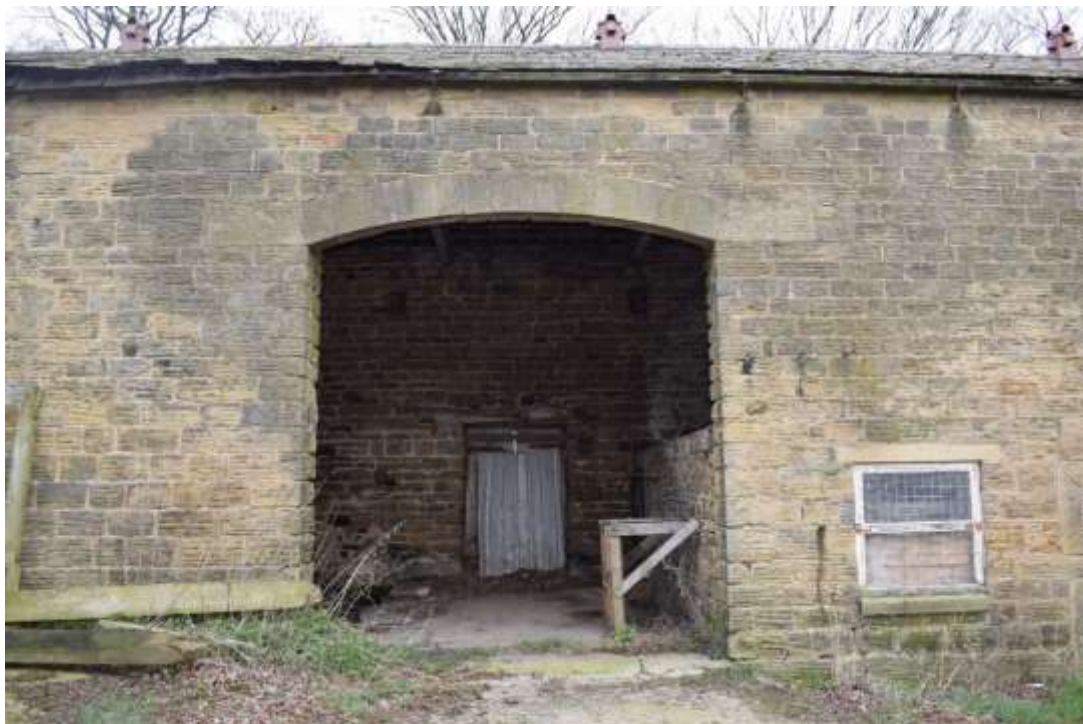
**Fig 06.** *The central cart opening*

The blue Welsh slate roof generally is in reasonable condition with very little evidence of rainwater ingress internally. The front pitch (**Fig's 01, 06, 08 & 10**) has some undulation to the slating above the spine wall between the threshing floor and the southern hay loft and above the southern hay loft truss which is allowing rainwater to blow up the slates and into the building.

The roof is to be stripped, the moss and lichen cleaned off the slates, a breather membrane introduced and the roof re-laid on treated softwood battens with copper or stainless steel fixings ensuring as many of the existing slates as possible are retained and those missing or crack are replaced with like for like (ensuring a good match to avoid the finished roof looking patchy). The ridge tiles are to be bedded on lime mortar finished to a neat fillet. The rotten moulded timber gutter and any missing cast iron gutter brackets are to be replaced with like for like.

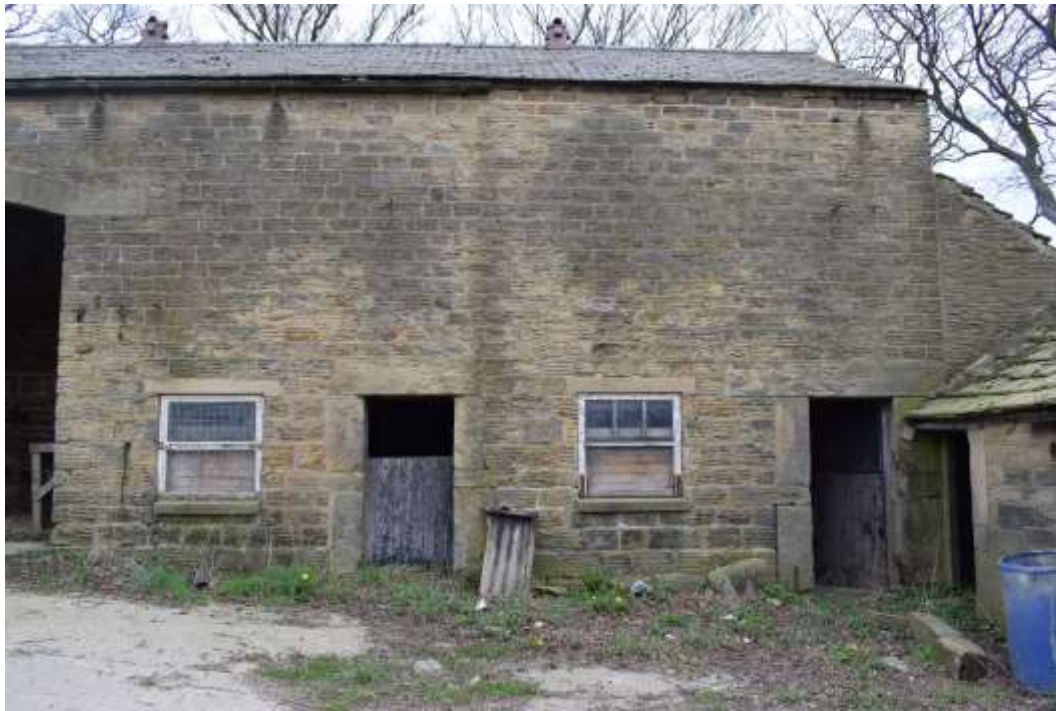
**Fig 08.** *The cowhouse at the northern end of the barn with its two doors facing the yard*

A number of stone jambs have split (the door and window at the top of the external staircase, both cowhouse doors facing the yard, the cowhouse door to the rear elevation and all three pitching eyes to the rear elevation) and require some repair. Some will simply require pinning with stainless steel ties but others, where parts of the stone have come away, will require some careful piecing-in. Repairs should be minimal to ensure as much historic fabric as possible is retained.

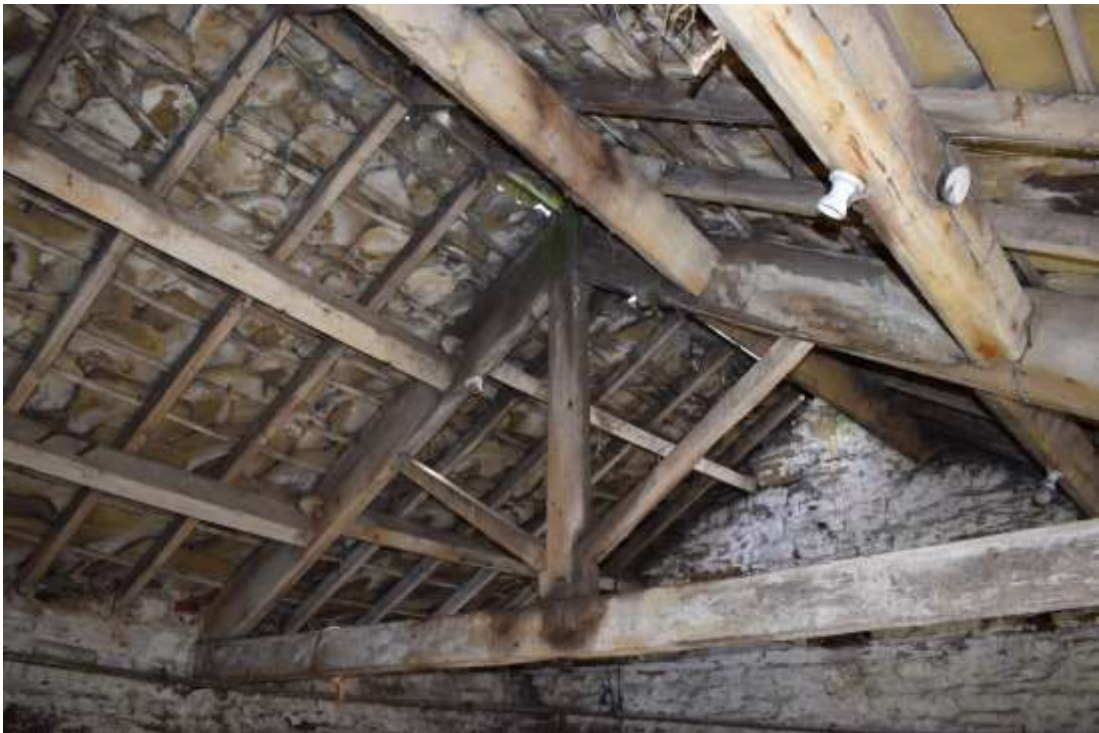
**Fig 18.** The cart shed roof structure (looking east)

The roof structure of the cart shed comprises bolted king post trusses with raking struts which, as in the barn, support a pair of purlins to each pitch, a slender ridge timber and common rafters. The tie beams are set low (indicating it was used for cows and not horses), their undersides being level with the door lintels.

The southern pitch, facing the yard, (**Fig's 16 & 17**) is in a similarly poor condition with a high proportion of slipped slates. The roof is of truss, purlin and rafter form but the tie beams are set low (around 2m which is level with the door lintels) which restricts the headroom and potential use of this range.
