Pudding Hill, Park View, Brierley, Barnsley

Yorkshire Housing Ltd c/o  
Acanthus Architects  
Woodhall  
Woodhall Lane  
Leeds  
West Yorkshire  
LS28 5NY

25<sup>th</sup> November 2012

BA3857

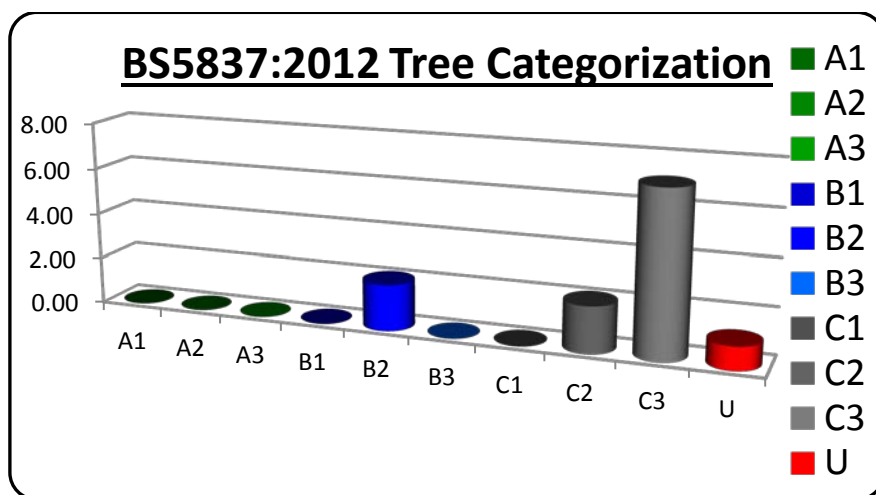
2.7.3 The graph opposite provides a breakdown of the tree categories on site and shows the trees to have a predominately landscape value. With the individual category's totals being:

Category B = 2 Trees  
Category C = 9 Trees  
Category U = 1 Tree

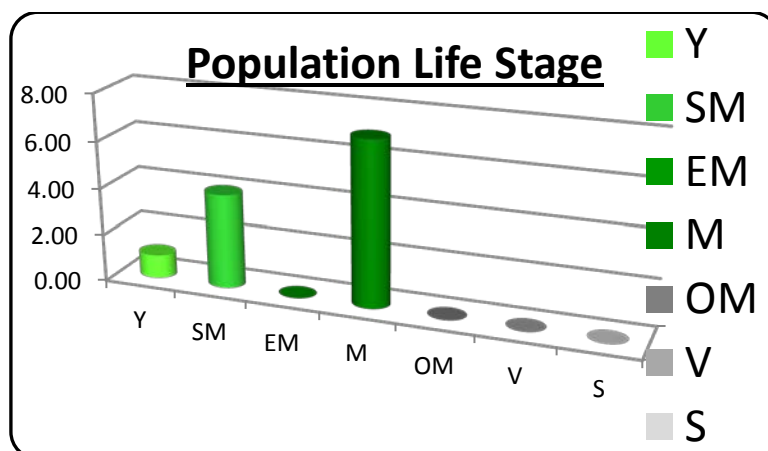
2.9 **Age Class.** The trees on site as shown in the graph opposite are predominately-young to mature trees. These have the potential to develop and provide future tree cover. The lack of significant numbers of older trees is assumed to be the result of the development of the site recently.

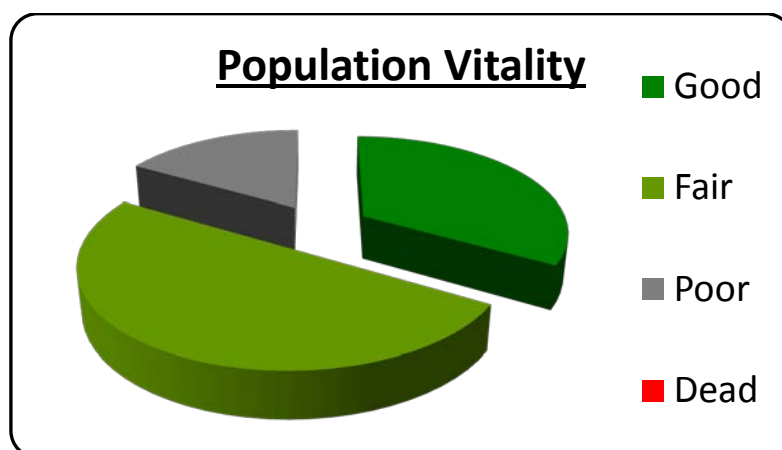
2.10 **General Health.** The majority of the trees are in good to fair condition, as shown in the graph opposite. Only two trees are classed as having poor vitality. This is assumed to be the result of the sites trees being young.

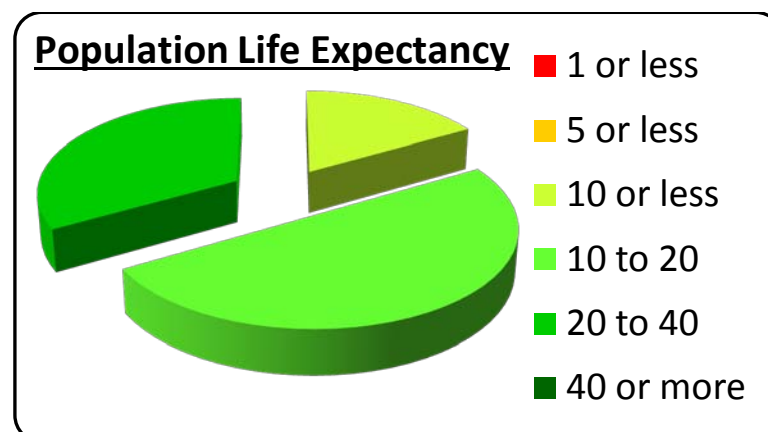
2.11 **Life Span.** An assessment of the population's general life expectancy again highlights the trees as being young, with the vast majority of trees having a life expectancy of 10 years or more as indicated in the graph opposite.
