STRUCTURAL REPORT - EXISTING BARN BUILDING RESIDENTIAL ANNEXE CONVERSION FOR WOODLAND VIEW

Proposed Two Bedroom Annexe ancillary to an existing property known as
Woodland View, Anchor Farm, Elmhirst Lane, Dodworth, S75 4LD

Report Ref: TH/Woodland View/Struct/02/Sept2020/v.01

2nd September 2020

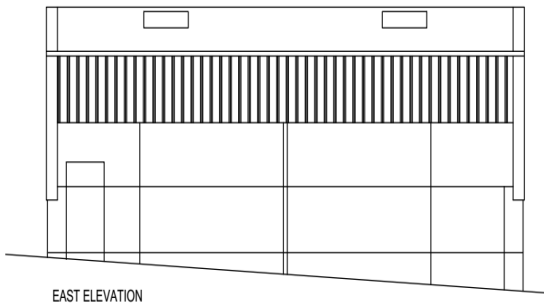
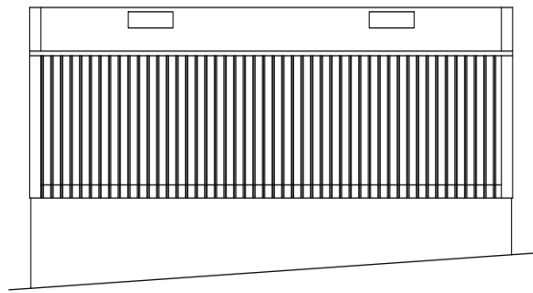
Fig 8 - Existing East Elevation & West Elevation

The west elevation (rear) is plumb and exhibits no signs of substantial (or any) movement and/or significant damage.
