**BARNBURGH LANE, GOLDTHORPE  
for Gleeson Homes & Regeneration**

**TREE SURVEY**

**Popplewell**

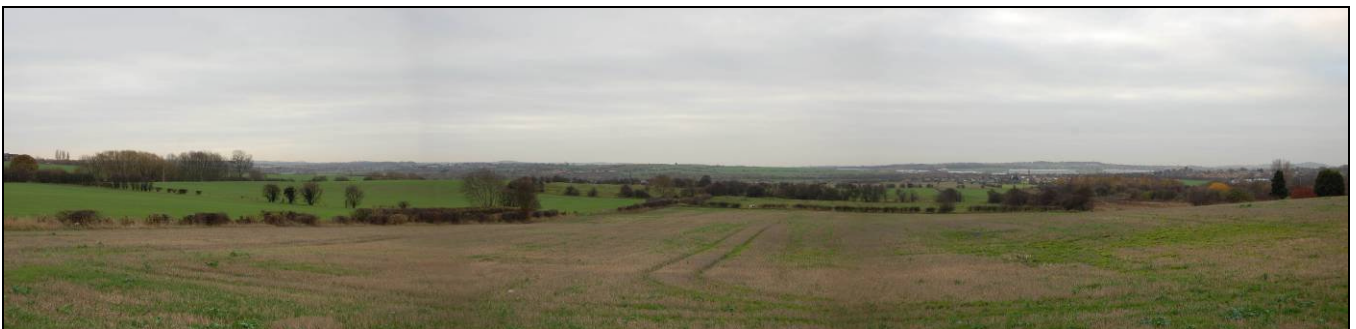
**Photo 4:**

| Tree number on dwg | Species | Height (m) | Stem diameter (mm) | Branch spread (m) | Age class | Crown clearance (m) | Physiological condition | Estimated remaining contribution (years) | Category grading | Notes / Structural condition | Preliminary management recommendations |
|---|---|---|---|---|---|---|---|---|---|---|---|
| H18 | Hawthorn | <2 | | 1m wide | M | 0 | Fair | 20-40 | C2 | Sporadic but uniformly pruned. Sections present are dense. Some decaying stubs. | Continue to maintain. |

View south from Barnburgh Lane looking at H18 to the left of the view which runs along the eastern boundary of the site. G16 and G17 can also be seen beyond this hedge. H13 can be seen to the centre of the view, located along the southern boundary with G9 and T10 also visible to the right.
