STRUCTURAL REPORT

location	Green Farm, High Lane, Ingbirchworth, Penistone, Sheffield, S36 7GG
application	Barn Conversion to Two Dwellings
client/applicant	Mr J Stafford & Mrs Crossfield
job number	22/779
date	August 2022

This Structural Report forms part of the planning application for the Prior Approval for the change of use of an agricultural building to two dwellings.

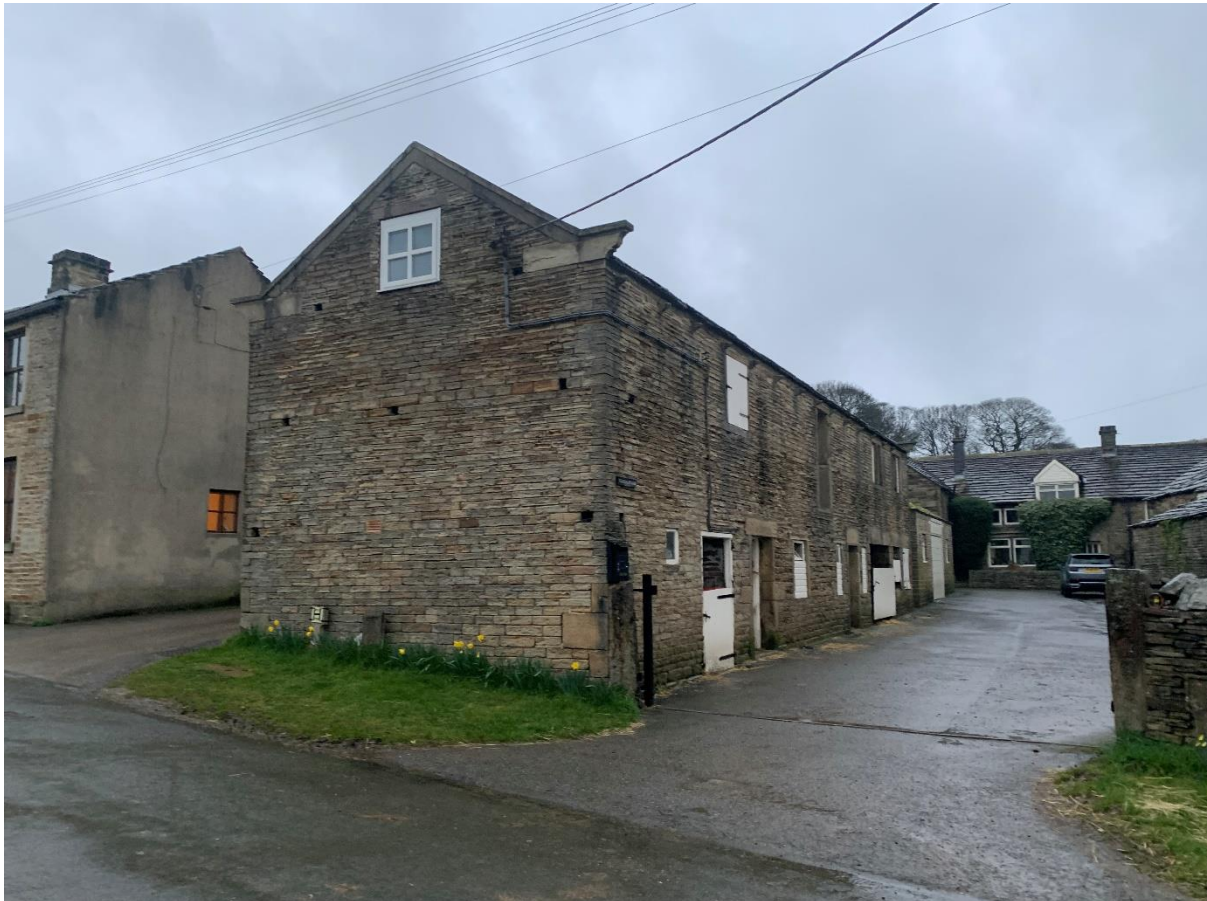
The building is circa 20.3m long and 5.7m deep. The property abuts the highway on the side (South) elevation with the rear (West) elevation directly abutting the private residential courtyard to the rear.

To the Norther side is an external stone staircase and a building used as a domestic garage. With the main outlook and principal elevation to the East looking out into the historical farm yard.

The building has eaves heights of 5.1m and a roof apex of 6.85m.
